**ILLINOIS DEPARTMENT OF NATURAL RESOURCES
CULTURAL RESOURCE MANAGEMENT PROGRAM
ABANDONED MINED LANDS RECLAMATION
CULTURAL RESOURCES EVALUATION**

**GALATIA COAL COMPANY MINE NO. 5
GALATIA, SALINE COUNTY**

January 2002

Project Type/Title: Phase II archaeological survey of Galatia Coal Company Mine No. 5 reclamation project.

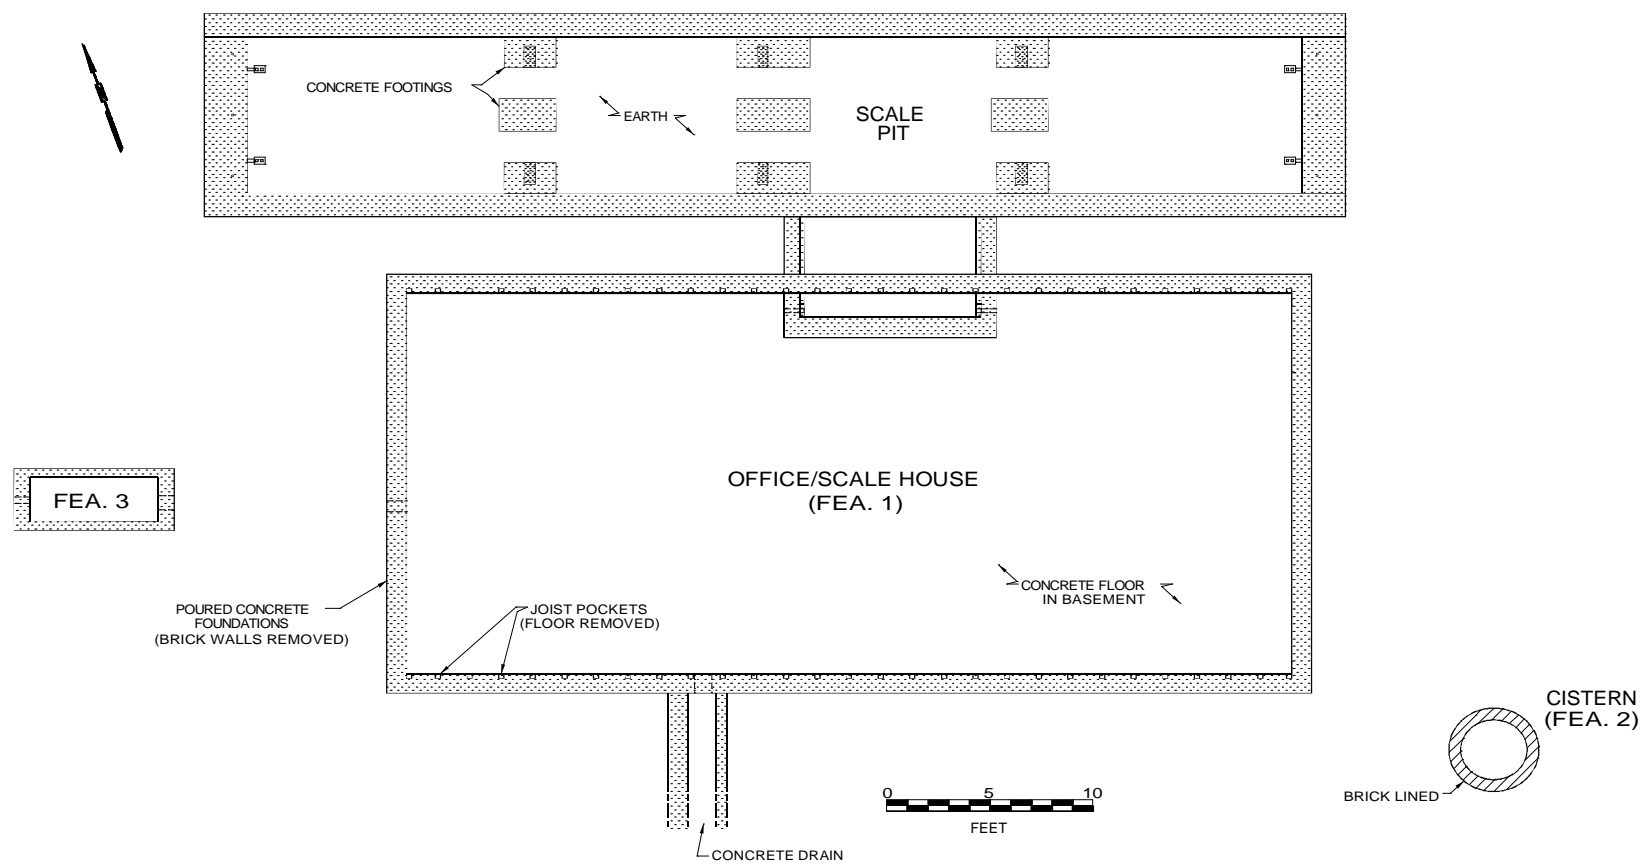
Feature 1 is the foundation remains of a combination office and scale house. The office proper was a one-story brick building that measured 20'-1" (north/south) by 44'-5" (east/west) and had a full basement beneath it. Like the rest of the buildings at the site, the office has been razed down to its foundations, which are 12"-thick poured concrete. Even though the brick walls have been completely removed, the mortar from the lowest course of brickwork remains intact and shows that the walls were three-bricks thick. The 1925 Sanborn indicates that the interior walls were plastered (Sanborn 1925). Holes have been cut into the south and east sides of the foundations, presumably for water or steam pipes servicing the building. A scale pit, constructed of poured concrete and measuring 9'-8" (north/south) by 54'-4", extends along the north side of the office. This scale pit was aligned to the railroad siding that serviced the mine. After being filled at the tipple/shaker, rail cars would pass over the scale pit before moving onto the Illinois Central Railroad. The scale mechanism itself has been removed, but the footings that supported its framework remain. The scale itself was positioned in a separate set of foundations (measuring 5'-10"x10'-2") that extended from the scale pit into the office (see Figures 10 through 12).

Figure 10. Plan view of Features 1, 2, and 3. Feature 1 represents the foundation remains of a combination office and scale house. Feature 2 is a brick-lined cistern. The function of Feature 3 is unknown (FRR 2000).

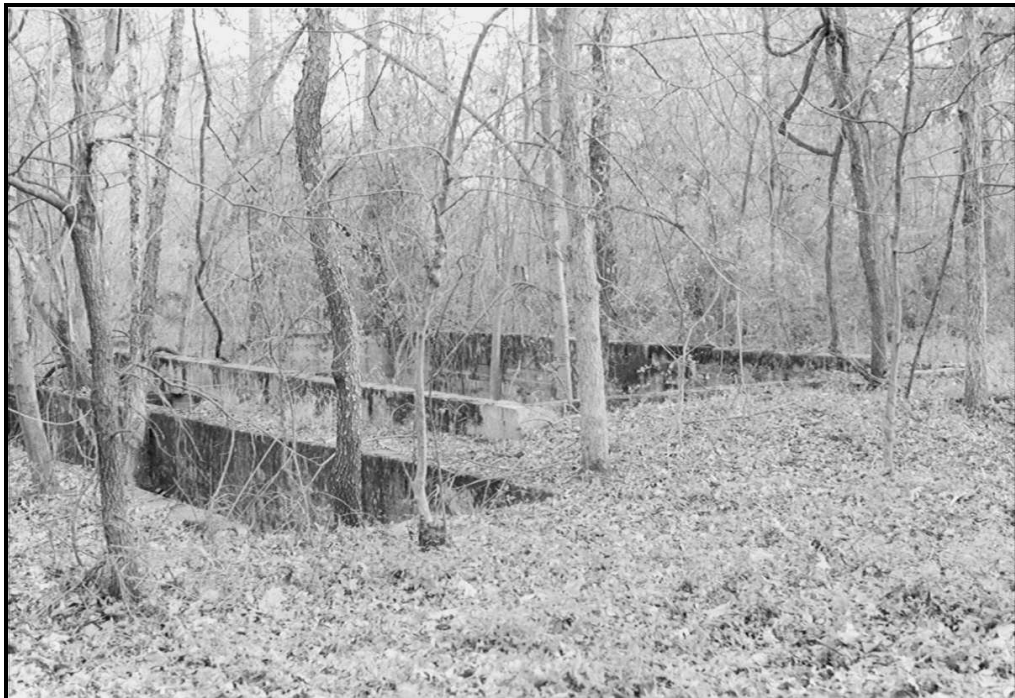
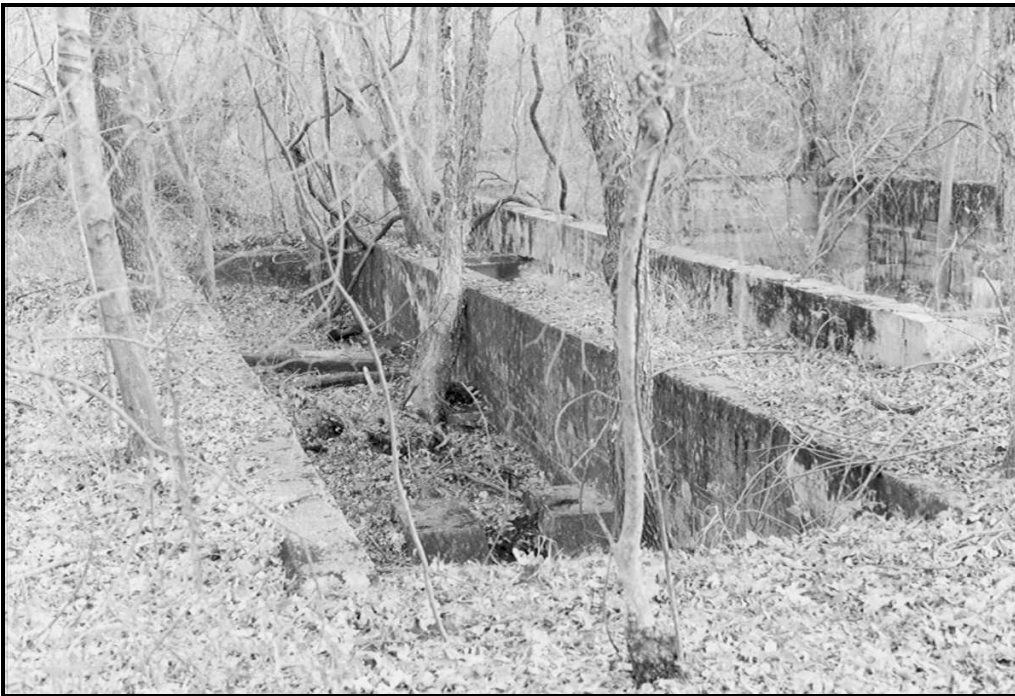
Figure 11. (TOP) View of the combination office and scale house (Fea. 1), looking southeast. (BOTTOM) View of the scale pit that is located on the north end of office/scale house. Railroad cars loaded with coal were weighed here before being moved onto the Illinois Central Railroad (FRR November 2001).

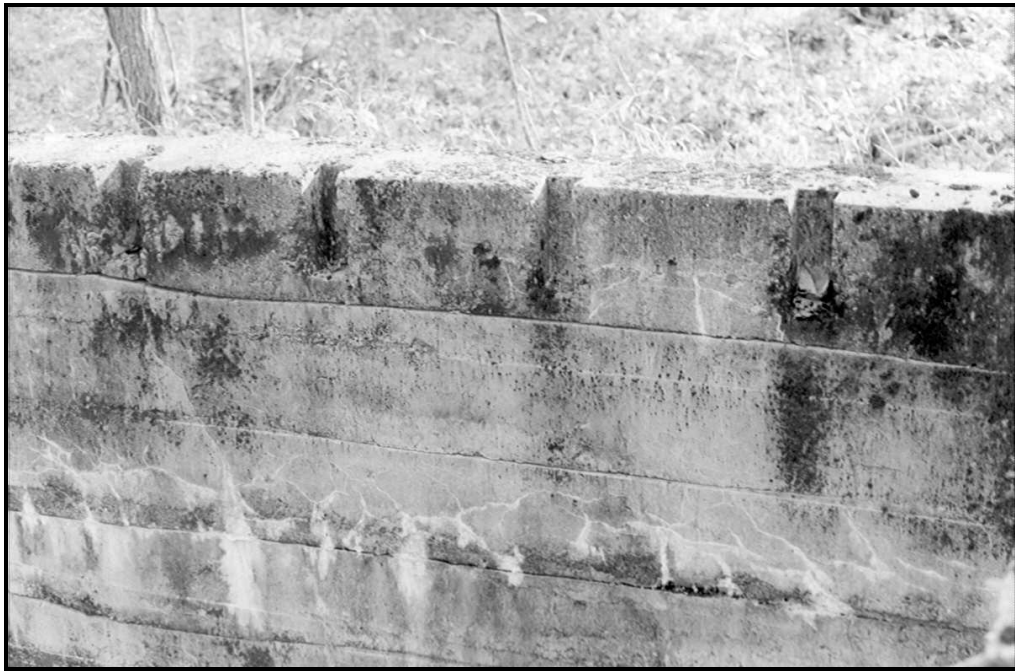
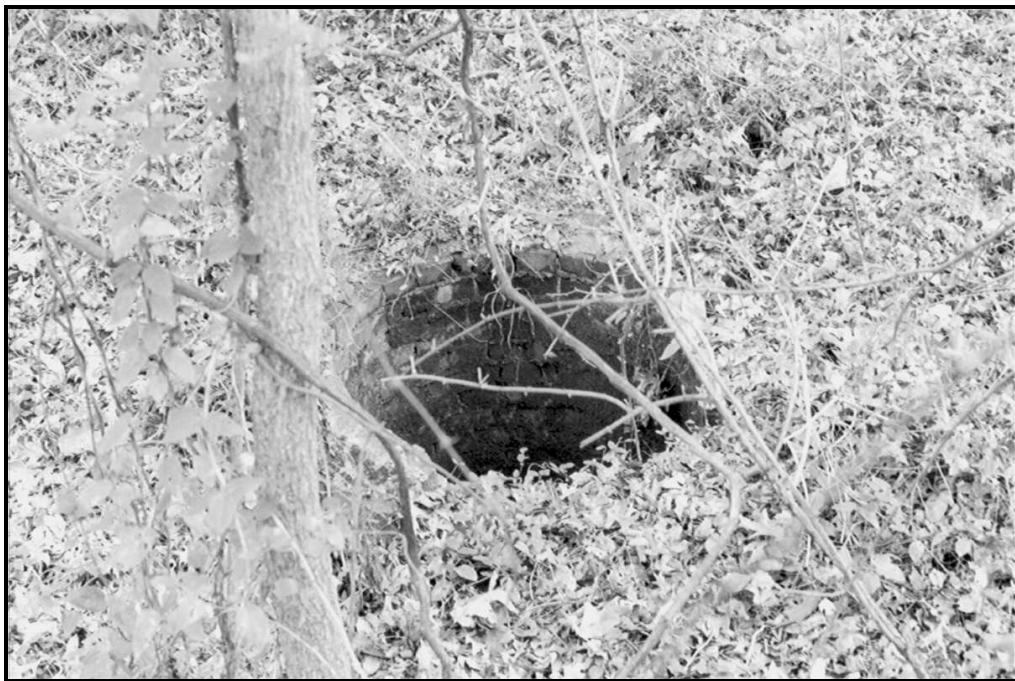
Feature 2 is a brick-lined cistern that is located approximately 12' southeast of the southeast corner of the office/scale house. The cistern has a slightly elliptical-shaped opening (2'-10" to 3'-2") and has been filled nearly to grade (see Figure 13).

Figure 12. (TOP) The office/scale house has been demolished down to its poured concrete foundations. The line of pockets at the top of the foundations originally accommodated floor joists. (BOTTOM) A brick-lined cistern, identified as Feature 3, is located off the southeast corner of the office/scale house (FRR November 2001).

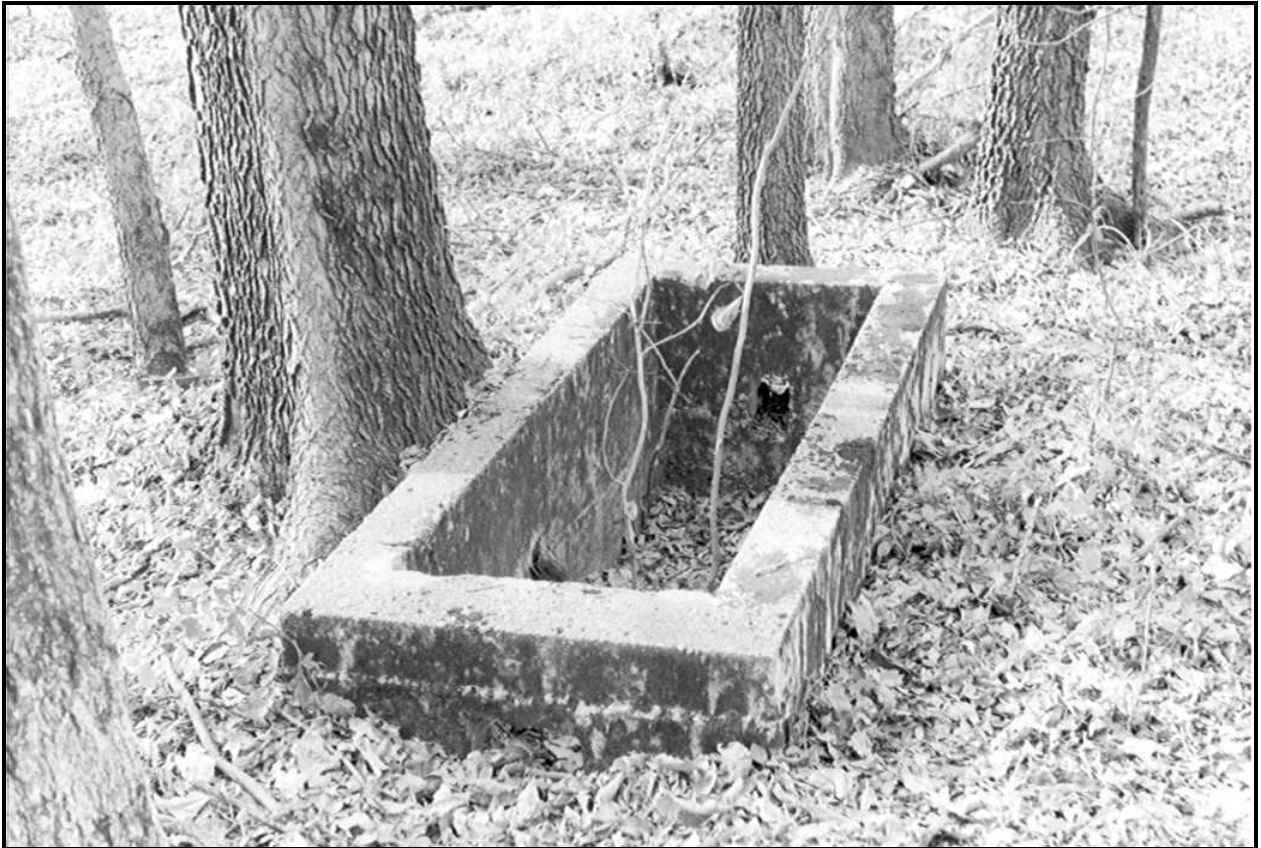
Feature 3 is a small, rectangular-shaped building foundation located 10' west of the office/scale house. The foundations are of poured concrete and measure 3'-1½" (north/south) by 7'-7" (east/west). Holes, perhaps meant for vents or to accommodate steam piping, have been cut through the east and west foundations walls. The narrow width of the foundations, coupled with absence of mortar, suggests that the upper walls of the building were of frame construction. This small structure is not illustrated on the 1925 Sanborn map, and its original use remains a mystery. Given its size and proximity to the office/scale house, it may have been an outbuilding associated with the latter building – perhaps as a storage shed or valve house. It also could have functioned as a privy, but its interior width (2'-1½") would have made it rather confining for this purpose (see Figure 13).

Figure 13. (TOP) View of Feature 3. The function of this small building is not known. Given its size, it could have served as a storage shed, valve house, or possibly as a privy (FRR November 2001).

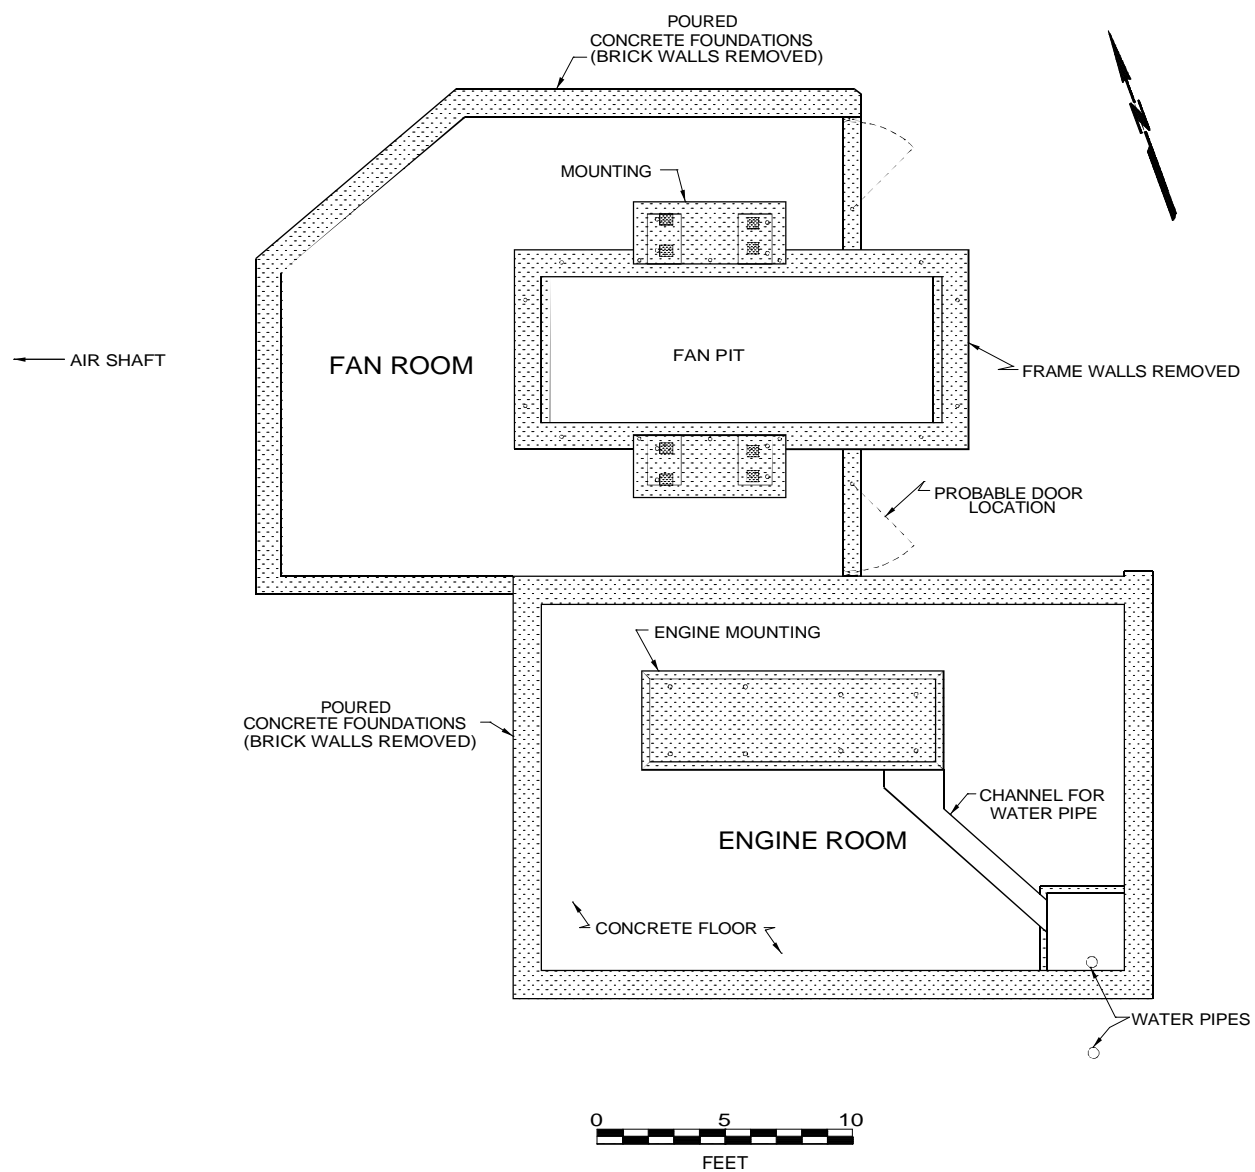
Feature 4 represents the remains of a fan house and was located immediately east of an air shaft for the mine. This irregularly shaped building had brick walls and poured-concrete foundations and was divided into two rooms on its interior. The northern half of the building was five-sided and served as the fan room. On its interior, the fan room measured 18'-0" (north/south) by 21'-10" (east/west) at its widest points. The fan, which circulated fresh air into the mine and drew impure air out, was mounted over a concave, concrete-paved pit which measured 5'-9½"x15'-2" and was centered along the east side of the room. Nothing remains of the fan assembly, other than the pit and the base of its mounts. Two exterior doorways are believed to have been located to either side of the fan, on the east wall of the room. According to the 1925 Sanborn map, the fan was driven by a steam engine that was located in the southern room of the building. This engine room measured 14'-8" (north/south) by 22'-10" (east/west) on its interior. The steam engine was mounted on a large, rectangular-shaped, poured-concrete mount. Water for the engine was piped in at the southeast corner of the room (see Figures 14 through 16).

Figure 14. Plan view of the fan house (Feature 4), showing existing conditions (FRR 2001).

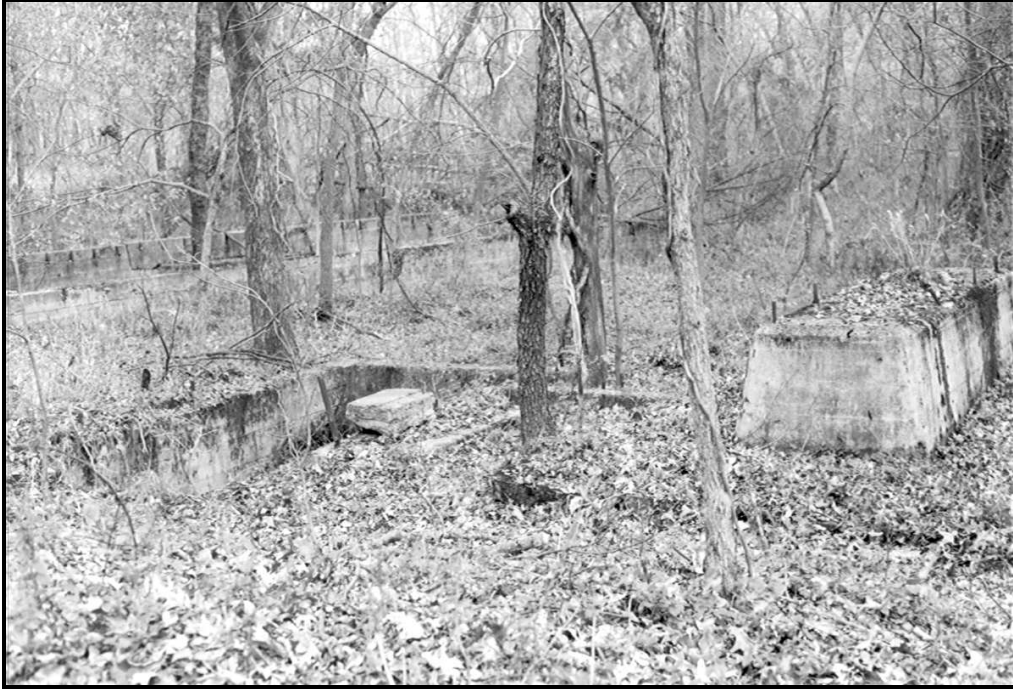
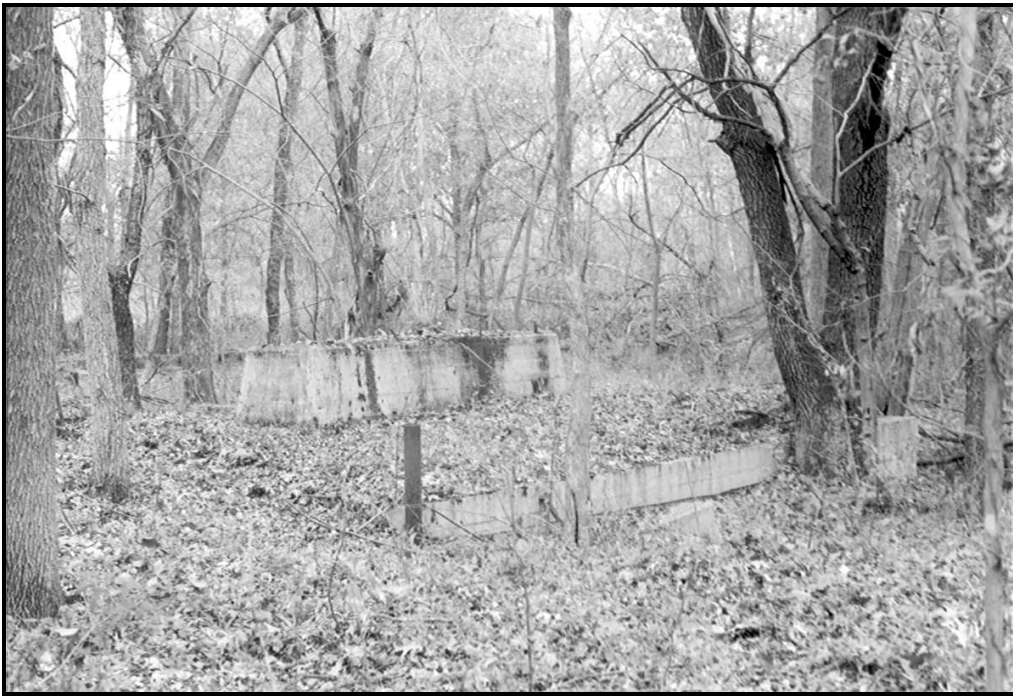
Figure 15. (TOP) View of the foundations remains of the fan house (Feature 4), looking northeast. The fan room (with pit) appears on the left, while the engine room (with mount) is to the right. The foundations of the office/scale house appear in the background. (BOTTOM) View of the southern side of the engine room of the fan house, looking northeast (FRR November 2001).

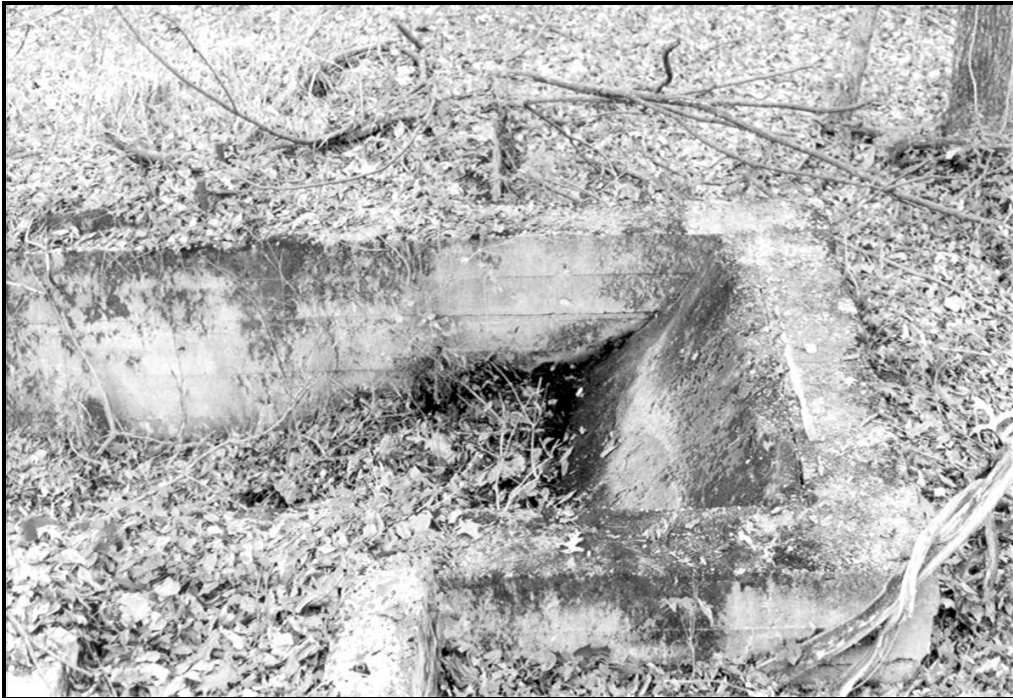
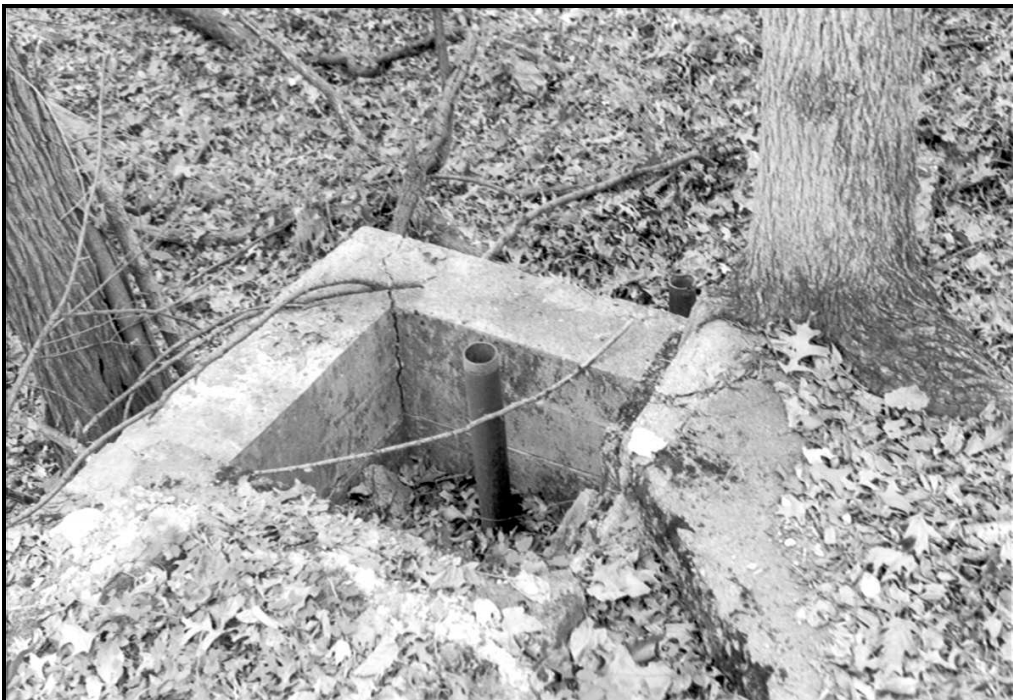
Figure 16. (TOP) View of the pit in the fan house in which the fan was located. This fan circulated clean air into the mine and drew out impure air in the process. (BOTTOM) View of the southeast corner of the fan house, showing the pit where water was piped into the building for the steam engine (FRR November 2001).

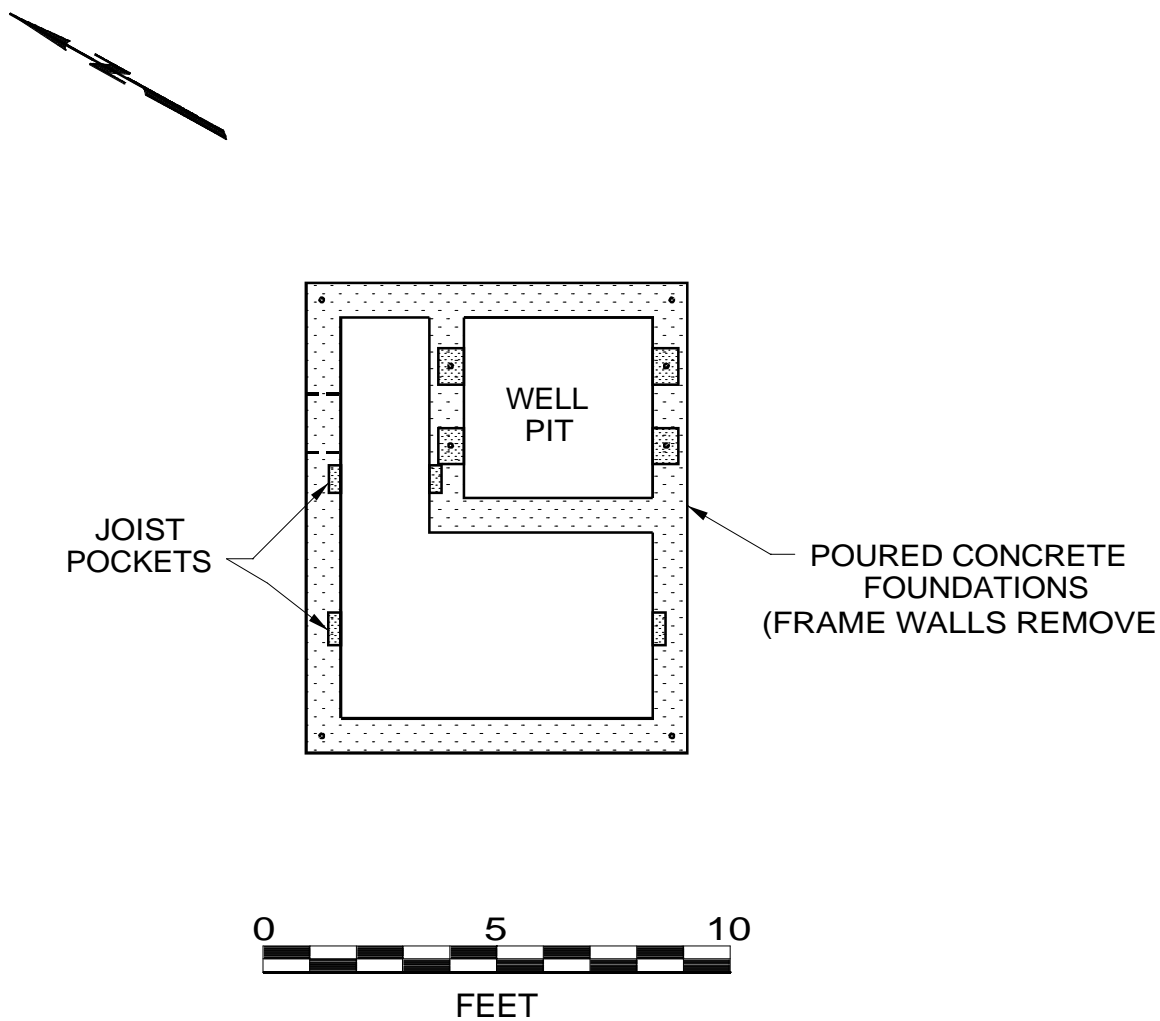
Feature 5 is a pump house foundation that is located at the upper end of the large impoundment pond created by the mine. The foundations measure 8'-1" (north/south) by 10'-1" and are constructed of poured concrete. Based on the presence of sill bolts on the top of the foundations, the walls of the building are suspected to have been frame rather than brick. The interior of the foundations is divided into two chambers: one, a square-shaped chamber, is a well shaft that is still open down to the water line; and the second, an L-shaped chamber that is now (and historically?) filled with soil. A water pipe formerly extended out from the well shaft through the west foundation wall. The main floor of the pump house probably consisted of single room that housed a pump. The weight of the pump required that heavy joists (6"x8") be utilized in the building. This pump house is not illustrated on the 1925 Sanborn map, but it is mentioned as one the improvements made to the mine in 1918 *Annual Coal Report* (Illinois Division of Mines and Minerals 1918:260) (see Figures 17 through 19).

Figure 17. Plan view of Feature 5, showing existing conditions. This feature is believed to have functioned as a pump house (FRR 2001).

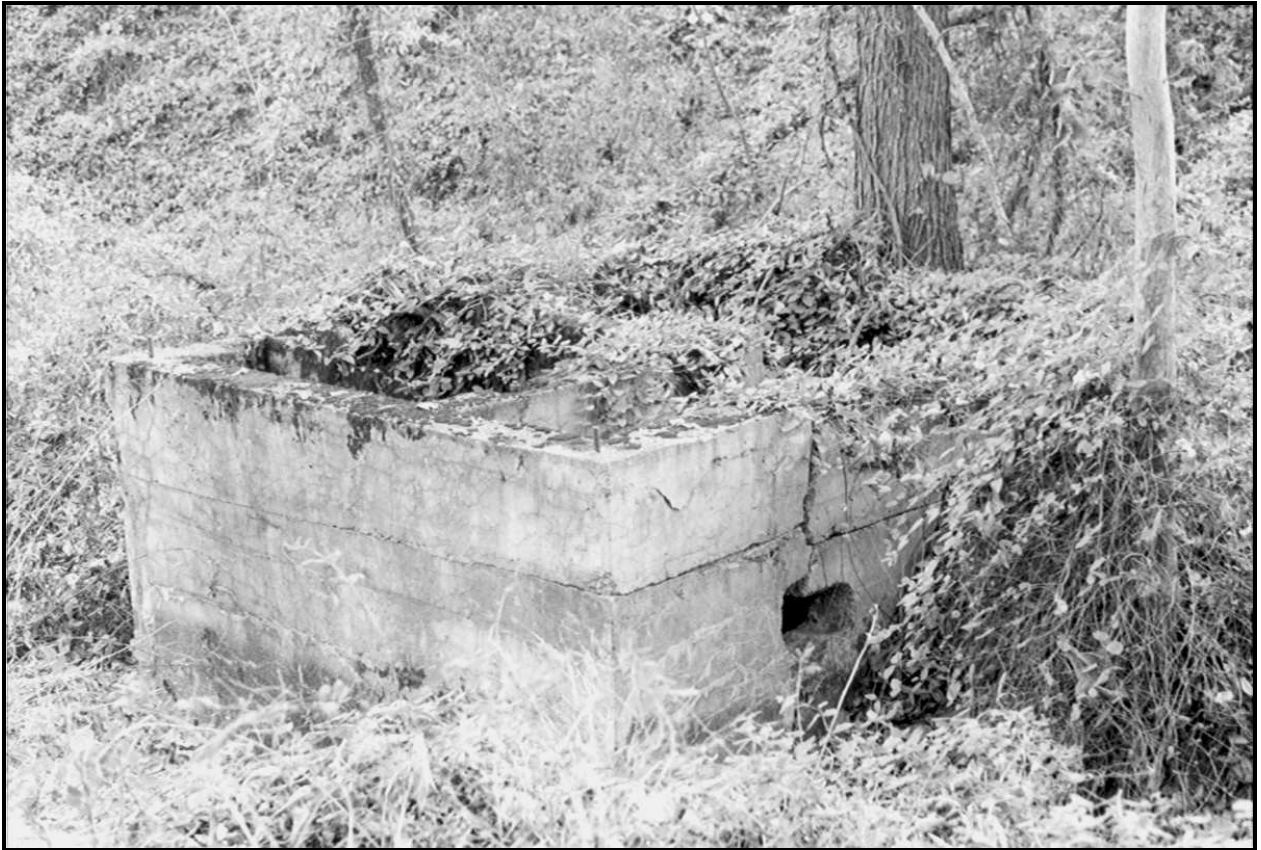
Figure 18. View of the pump house (Feature 5), looking south. Unlike Features 1 and 4, this building appears to have been of frame construction (note the anchor bolts for the sill on the corners) (FRR November 2001).

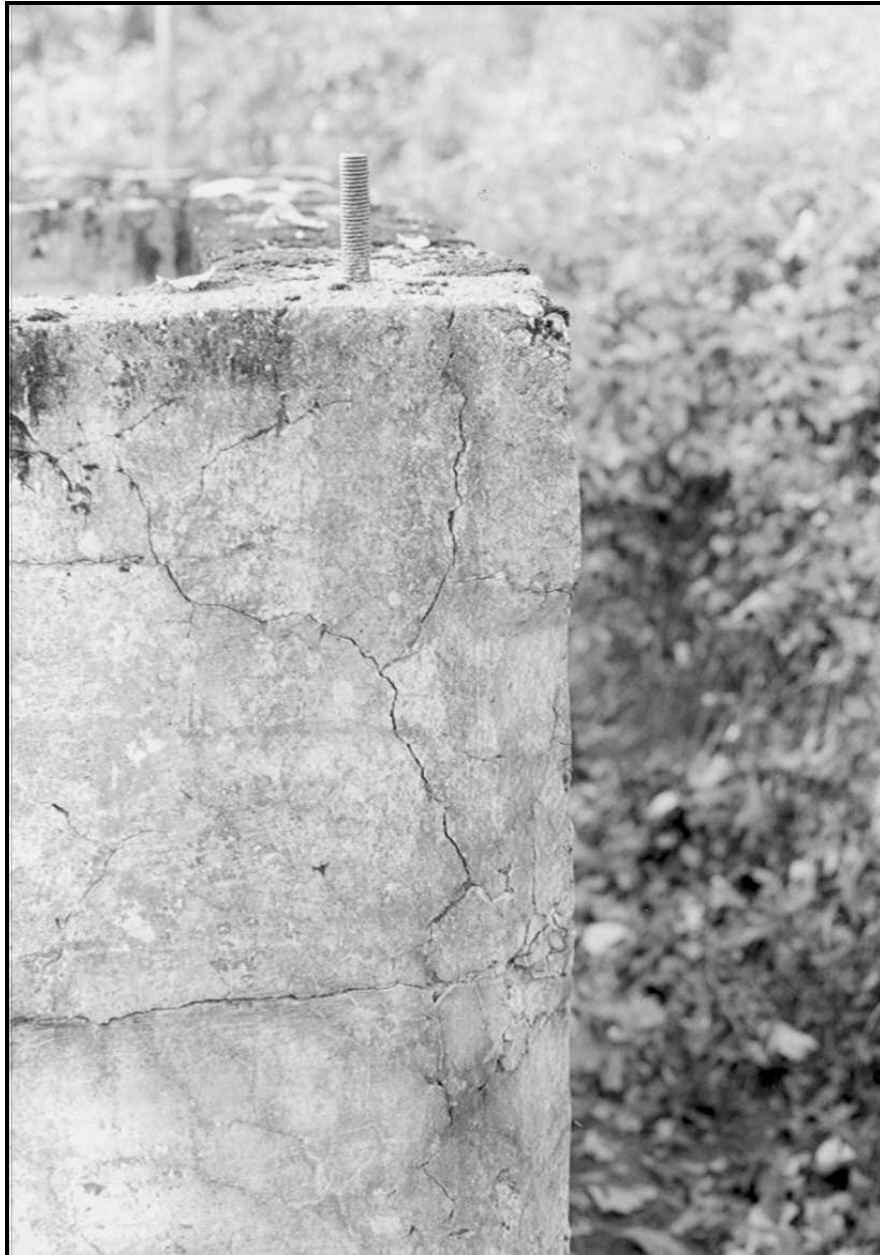
Figure 19. Corner detail of the pump house, showing the manner in which the concrete was chamfered at the corners. Several other building foundations at the site also have this type of corner finish (FRR November 2001).

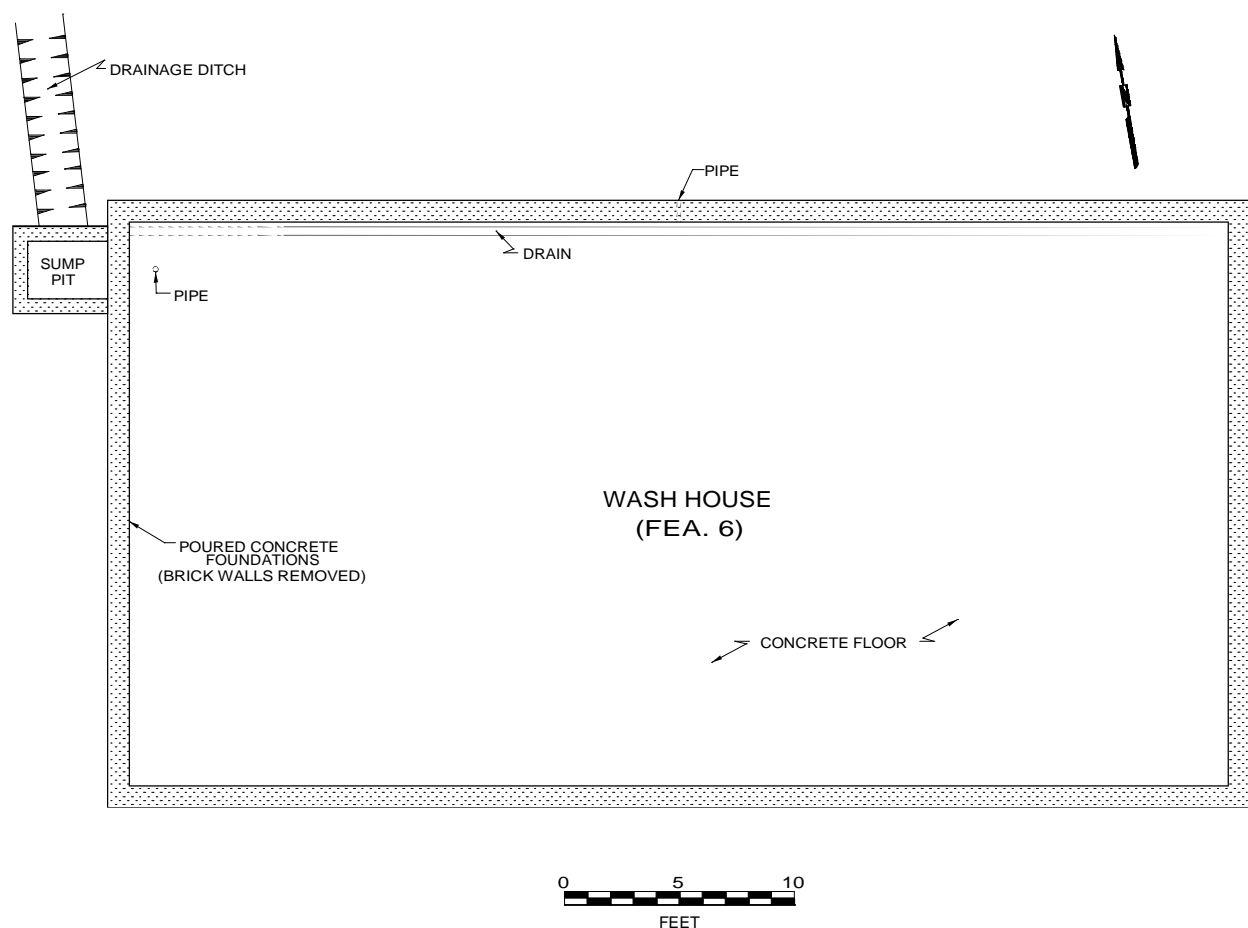
Feature 6 is the remains of a large building that is located on a hillside bordering the southern edge of the mine complex. All that remains of this 26' (north/south) by 49' (east/west) building are its foundations, which are poured-concrete and originally supported three-brick-thick walls. The 1925 Sanborn map notes that this structure had a

concrete floor and plastered walls but does not indicate its use. However, we suspect that it served as a wash house, where the miners would change their clothes before entering the mine and clean-up after the end their shift. Factors supporting Feature 6's use as a wash house include its large, open interior space, concrete floor, and --most significantly-- by the interior drain that runs along the north wall. A sump pit is located off the northwest corner of the building, and this pit opens into a drainage ditch that runs downslope to the north. Water was piped into the building through a 2" pipe that is centered on the north wall (see Figures 20 and 21).

Figure 20. Plan view of Feature 6, showing existing conditions. This large building is suspected to have served as the wash house for the mine. Note the drain on the north side of the building (FRR 2001).

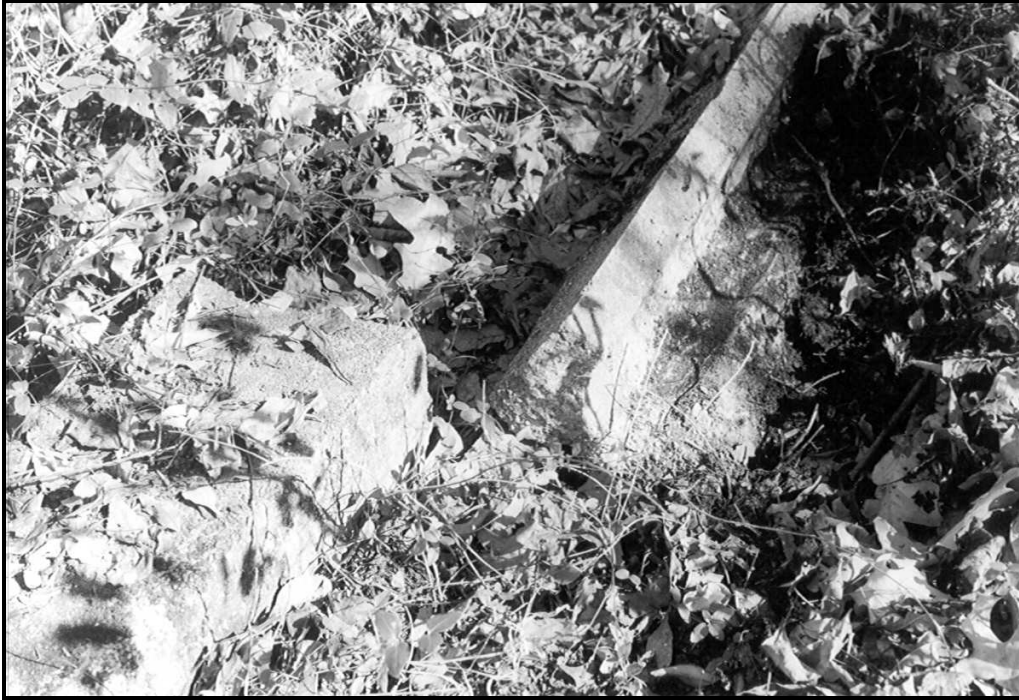
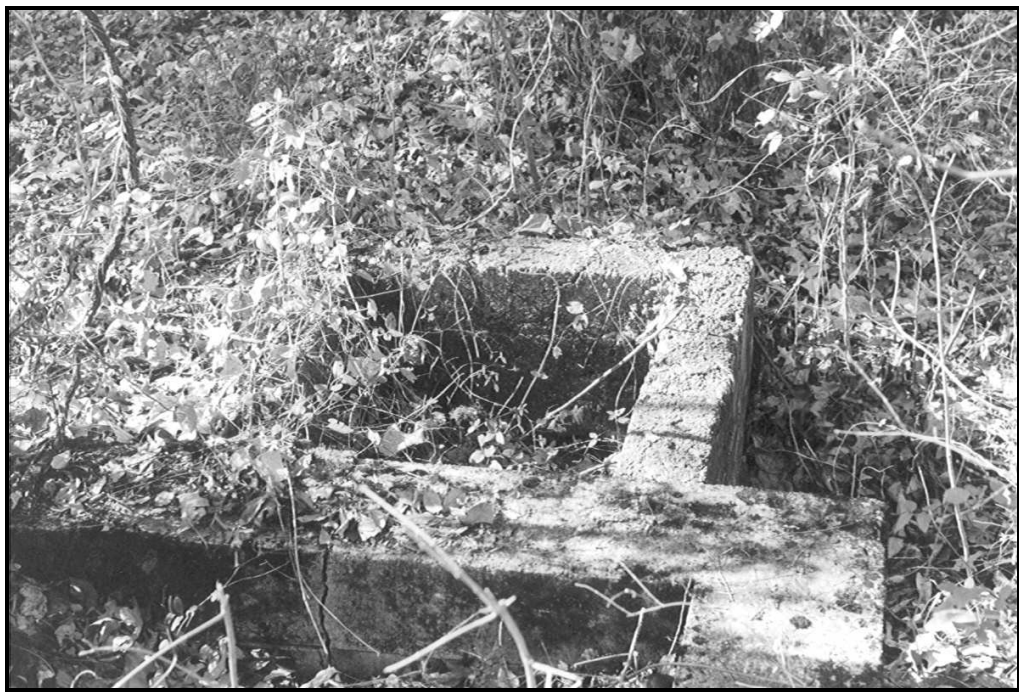
Figure 21. (TOP) Detail of the concrete drain that runs along the north side of Feature 6. (BOTTOM). This drain leads into a sump pit positioned off the northwest corner of the building (FRR November 2001).

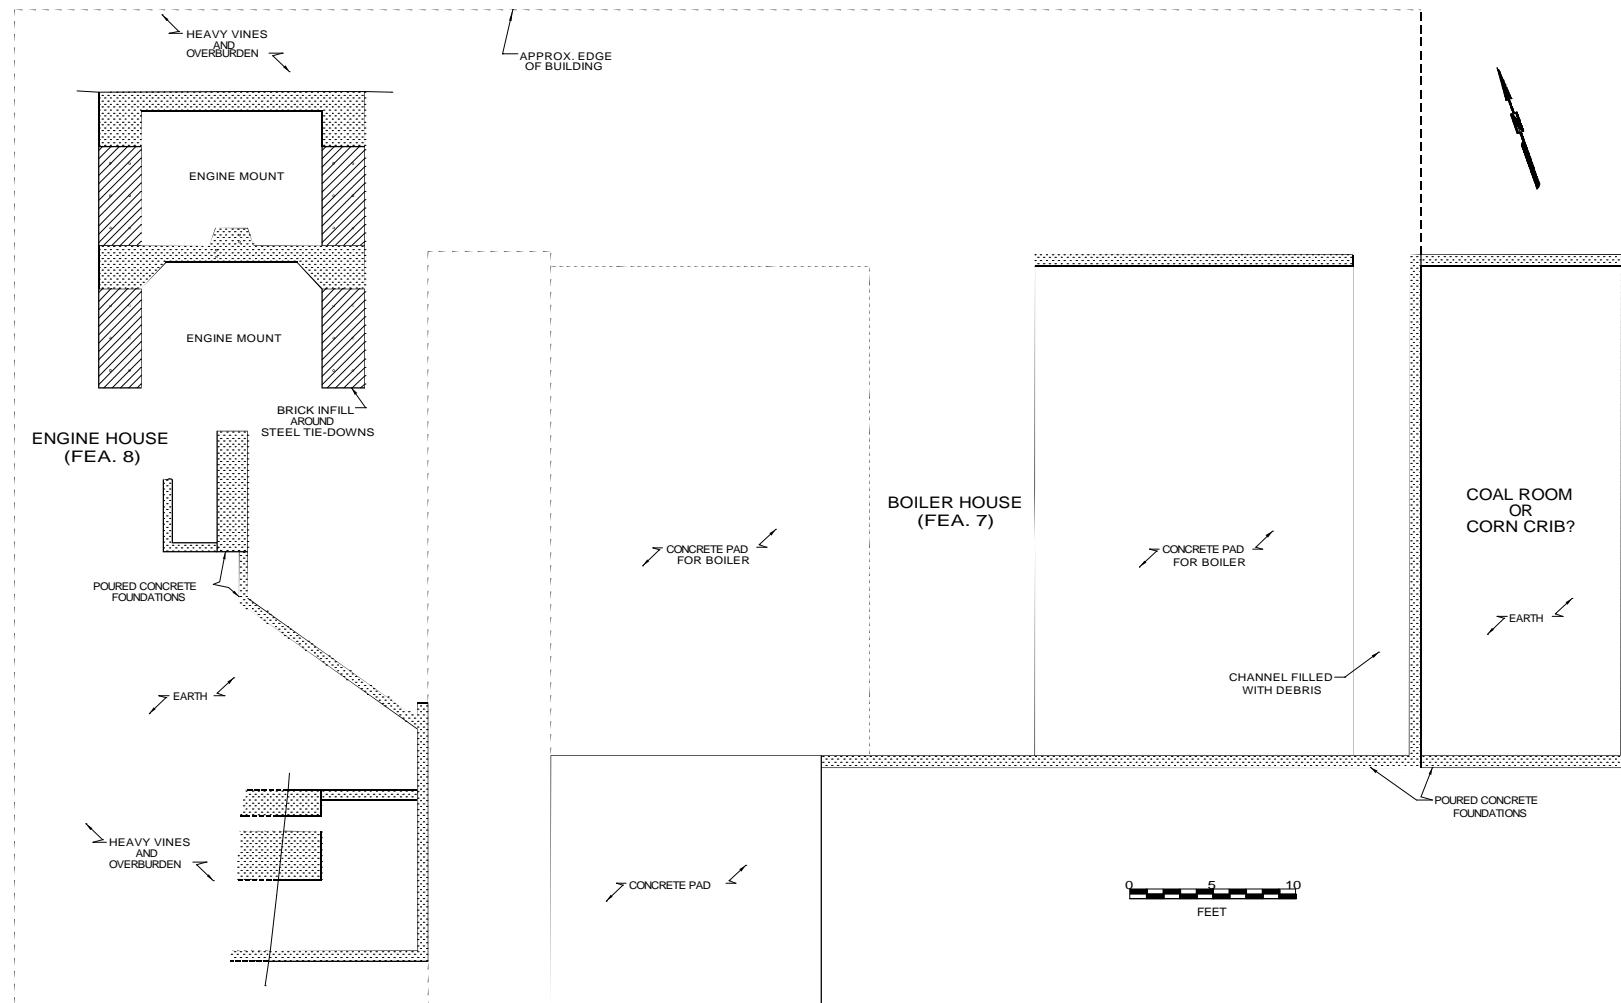
Feature 7 is the remains of the boiler house. The 1925 Sanborn map depicts this building as being a metal-clad frame building with an irregular footprint. The main part of the building measured approximately 45' (north/south) by 52' (east/west) and contained two large boilers. The boilers sat on 18'-wide concrete pads and each was equipped with two smokestacks. Nothing remains of the boilers. There were several extensions off the main part of the boiler house. One extension was located on the east and had a floor that was set at a slightly lower elevation than the boiler room. The use of this wing is unclear, though it is possible that it may have been a coal shed or even the corn crib that was reported as being built in the 1918 *Annual Coal Report*. Corn (or rather corn cobs) may have been used a secondary source of fuel at the mine. A second wing extended off the southwest corner of the boiler room and was positioned on a concrete pad; its function is unknown. Another wing connected the boiler house to the engine house (Feature 8) lying west of it. Documentation of the boiler house was hampered by the comparatively poor state of its remains and the overburden and heavy vegetation that covers it (see Figures 22 and 23).

Feature 8 is the deteriorated and overgrown remains of the engine house for the mine. Based on the 1925 Sanborn map, this building measured 60' (north/south) by 25' (east/west) and was steel-clad like the boiler house. The building formerly housed a hoist engine and an independent electric power plant, both of which were powered by the boilers in the adjacent building. The hoist engine was of a supreme importance at the mine since it moved men and material through the shaft leading into the mine, whereas the electric plant provided power to the surface buildings and powered the motor cars and lights down in the mine. The documentation of Feature 8 was rather limited in scope on account of the poor visibility of the building remains. However, two mounts used to support the hoist engine were documented. The mounts are C-shaped and are of composite construction; the ends of the C are brick laid around tie-down bolts, while the connecting arm is poured concrete (see Figures 22 and 23).

Figure 22. Plan view of Features 7 and 8, showing existing conditions. Feature 7 functioned as the boiler house for the mine, while Feature 8 was engine house. Full documentation of these features was hampered by overburden and vegetation (FRR 2001).

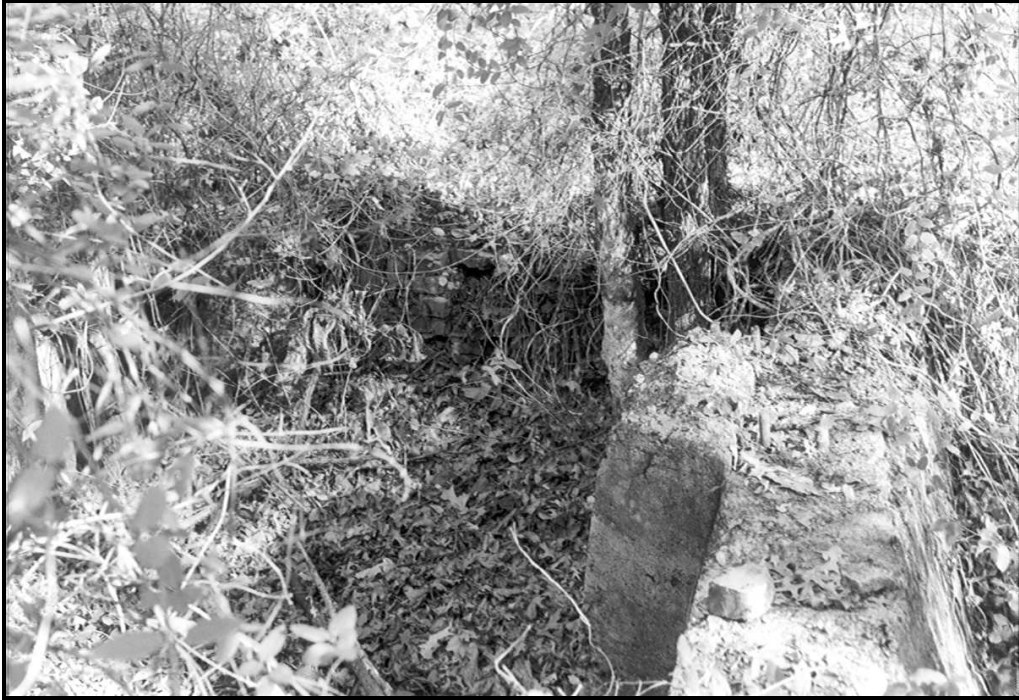
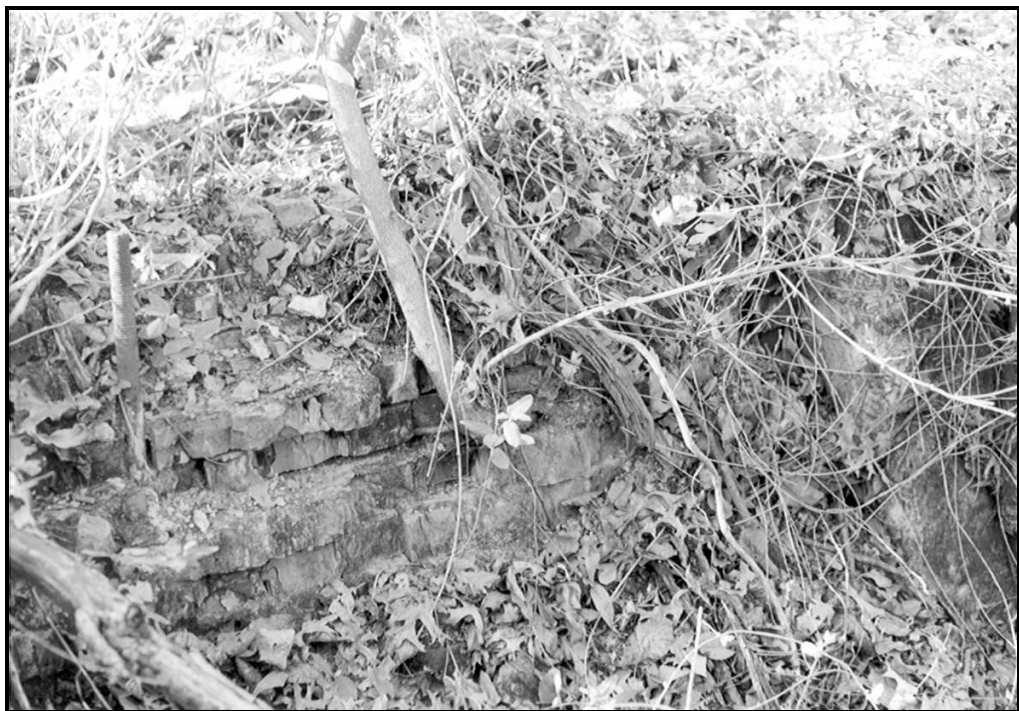
Figure 23. (TOP) View of the one of the engine mounts in Feature 8. The mounts are of composite construction (brick and poured-concrete). (BOTTOM) Brick was used as infill around the some the large bolts used to hold down the hoist engine (FRR November 2001).
