**ILLINOIS DEPARTMENT OF NATURAL RESOURCES
CULTURAL RESOURCE MANAGEMENT PROGRAM
ABANDONED MINED LANDS RECLAMATION
CULTURAL RESOURCES EVALUATION**

**GALATIA COAL COMPANY MINE NO. 5
GALATIA, SALINE COUNTY**

January 2002

Project Type/Title: Phase II archaeological survey of Galatia Coal Company Mine No. 5 reclamation project.

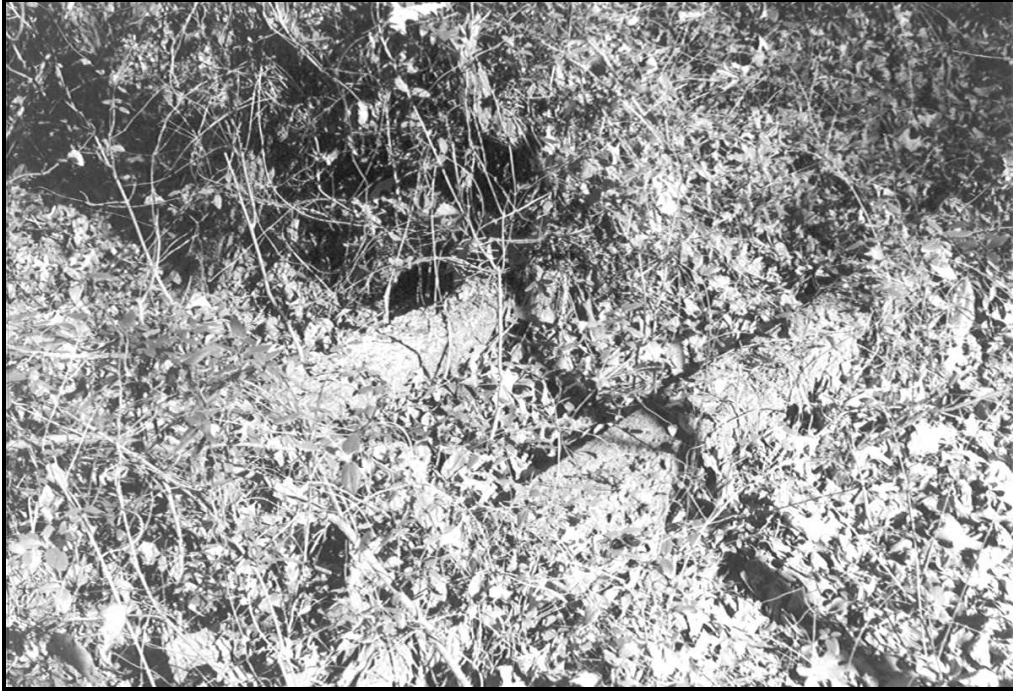
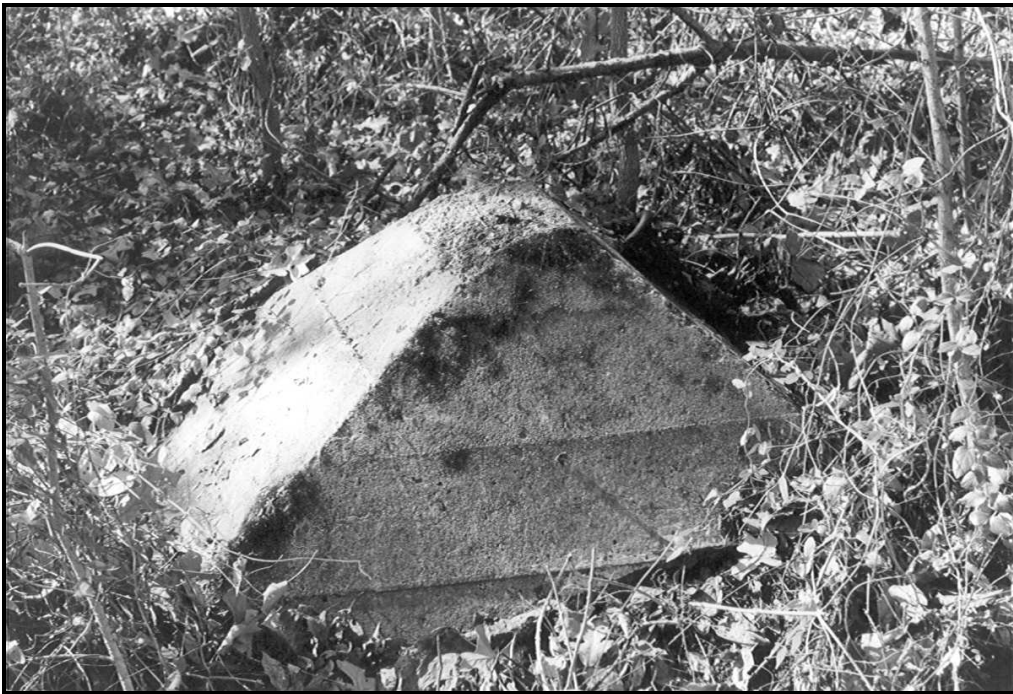
Feature 9 is a concrete conduit or drain that runs roughly east-to-west across the center of the site. It measures 1'-5" wide on its interior, has 6"-thick concrete sidewalls, and is open at the top. The original use of this feature is unclear, though it may have served as a conduit for steam heating pipes or been used as a box drain for runoff being discharged from the mine or surface buildings (see Figure 25).

Figure 25. (TOP) View of Feature 9, a poured-concrete channel that extends for 150' or more across the site. This feature may have served either as a conduit for steam heating pipes or as a box drain directing waste water toward the impoundment pond. (BOTTOM) One of the miscellaneous footings/piers present at site. The original use of this isolated feature is unknown (FRR November 2001).

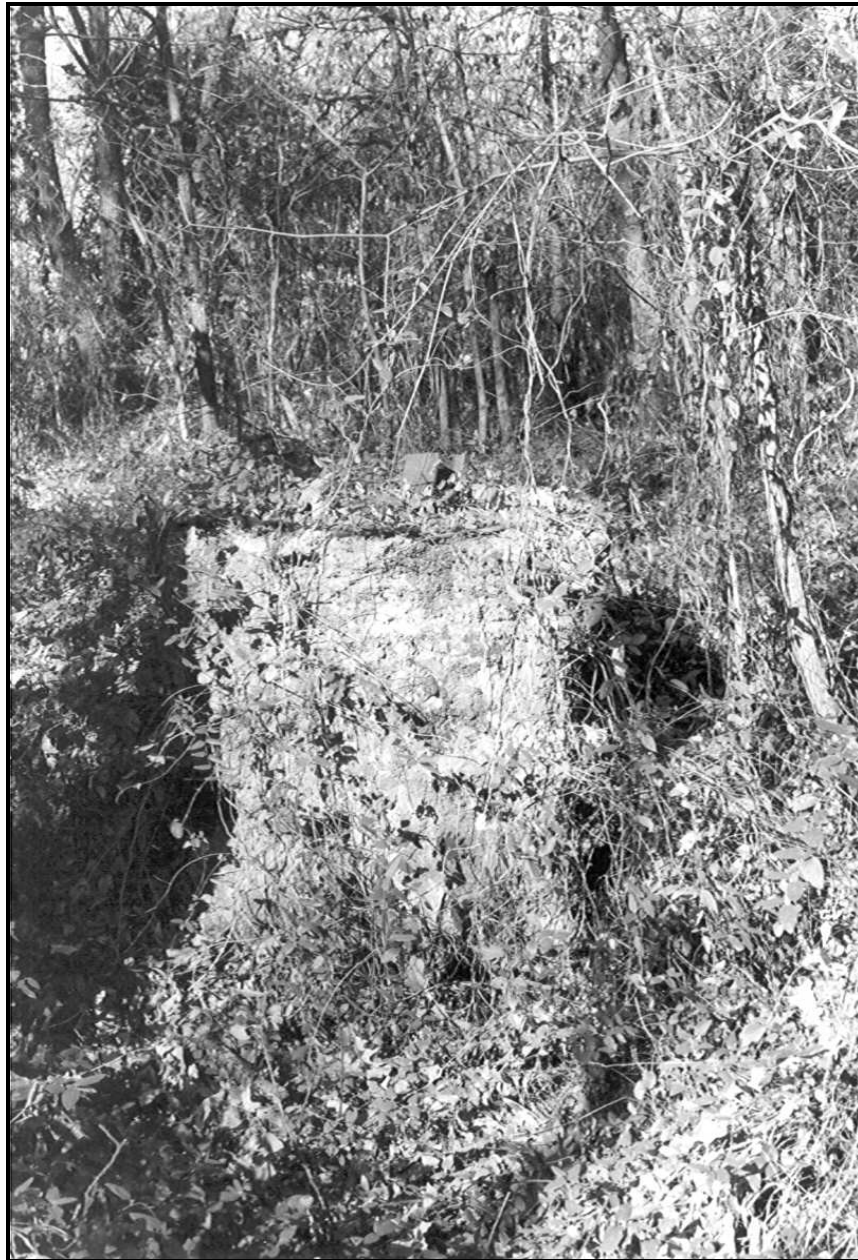
Figure 26. Another footing/pier at the site. This one encased a steel I-beam (now cut off) that may have been part of the tipple structure (FRR November 2001).

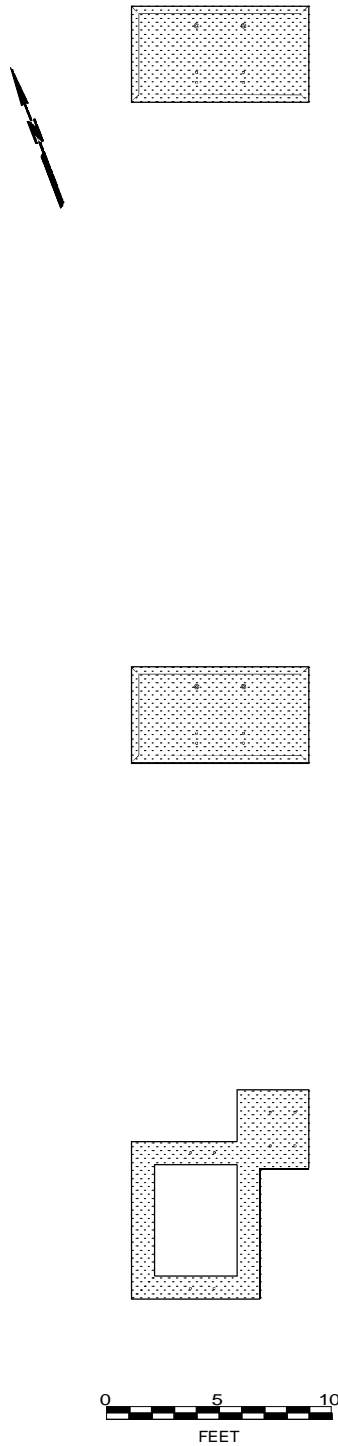
A number of footings and piers also were identified during the survey. Most of these were isolated and provided little evidence as to their original use (see Figures 25 and 26). The only ones drawn to scale in the field were a line of piers located west of the engine house. Kiser (pers. comm. 1 November 2001) suggests that these piers may have been used to pull cable. If so, they may be associated with car-puller house, which was located in the same vicinity (see Figure 27).

Figure 27. Plan view of a line of footings/piers located at the western end of the mine site. These footings possibly are associated with the car-puller house, but this cannot be established with certainty (FRR 2001).
