**ILLINOIS DEPARTMENT OF NATURAL RESOURCES
CULTURAL RESOURCE MANAGEMENT PROGRAM
ABANDONED MINED LANDS RECLAMATION
CULTURAL RESOURCES EVALUATION**

**THE CHERRY MINE
(ST. PAUL COAL COMPANY NO. 2)
CHERRY, ILLINOIS**

prepared by
Fever River Research
Springfield, Illinois

August 2002

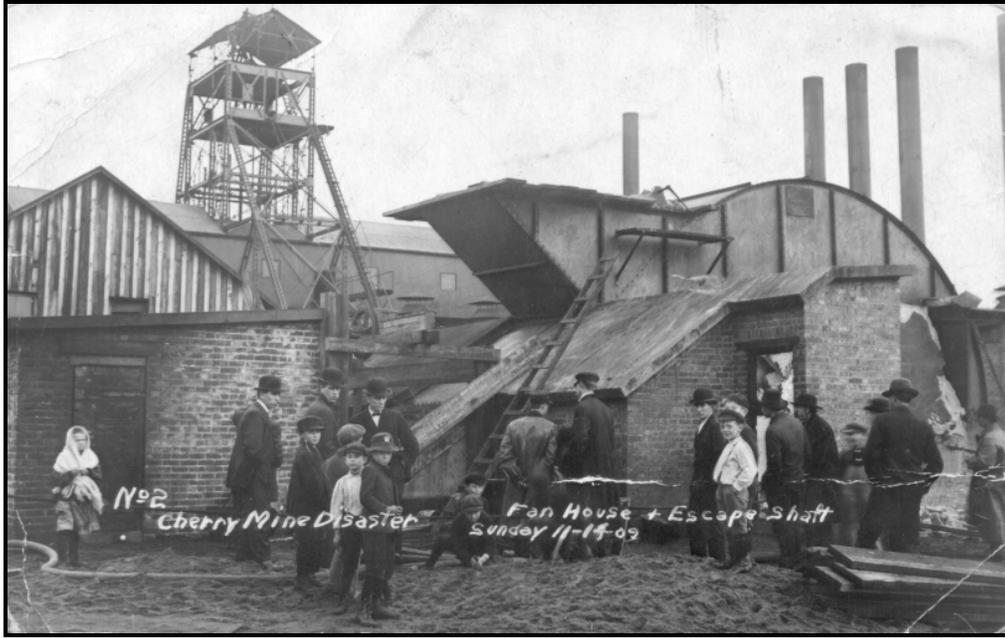
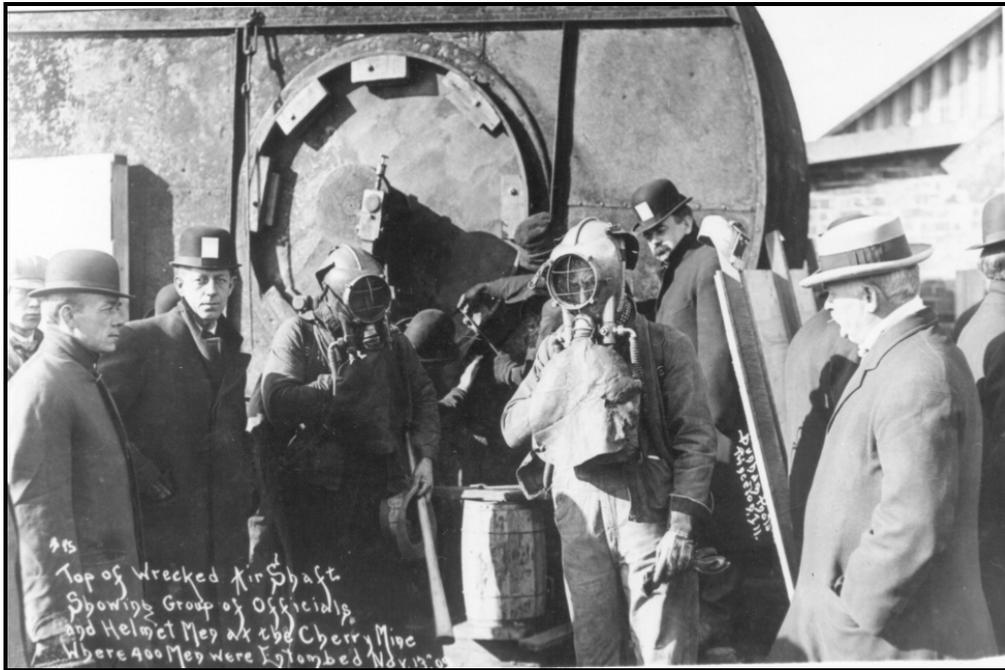
Figure 9. (TOP) Closer view of the damaged fan house (to right) and entrance to the escapement shaft (to left). The tibble and the stacks of the boiler house loom in the background. This photograph was taken the day after the mine fire started. (BOTTOM) Group of officials gathered around the temporary fan installed in the wake of the fire. The helmeted men are preparing to descend into the mine to assess conditions there (Photographs courtesy of Charles Bartoli).

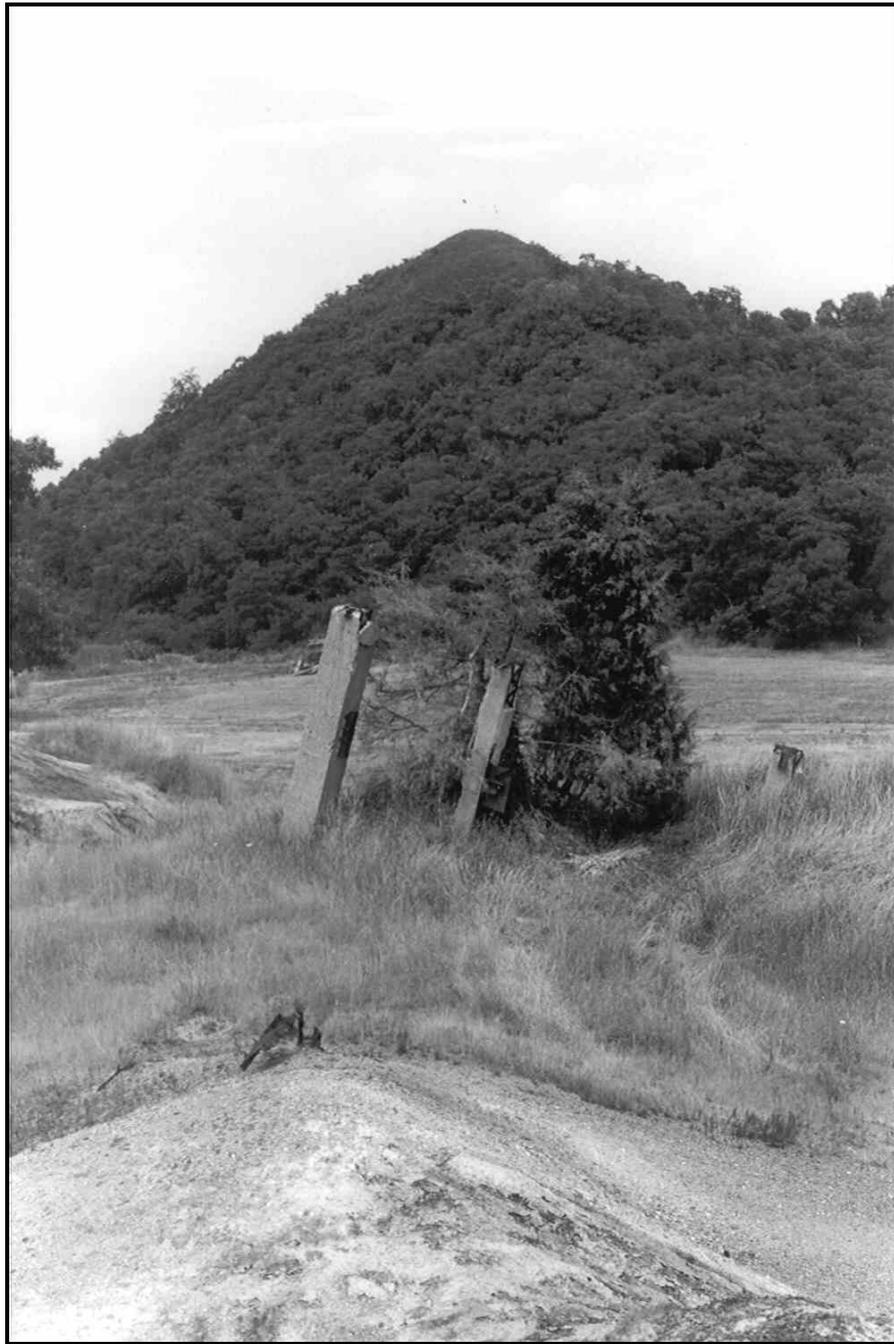
Feature 1 is the remains of the tippel/screener complex at the mine. As discussed in the text above, the tippel was a large steel-frame, raised structure that extended over the main hoisting shaft and rails lines servicing the mine. In 1936, two men employed by the Chicago Bridge and Iron Company cut up the structure for scrap. The last section scrapped out was the hoisting frame over the shaft (the tippel proper), whose legs finally had to be dynamited even after being cut with a torch (Charles Bartoli, pers. comm., 23 July 2002). All that remains of the tippel is the lower part of three vertical posts, or "legs." The posts measure 1' square and are of composite construction, being formed with paired steel beams with lattice bracing in between. At some point, the posts were partially encased in concrete, presumably to strengthen them (see Figure 19).

Figure 18. Present-day view of the tippel site at the Cherry Mine, showing the three upright posts still remaining from the structure (Feature 1). These posts are located adjacent to the main shaft to the mine. One of the tall gob piles appears in the background (FRR July 2002).

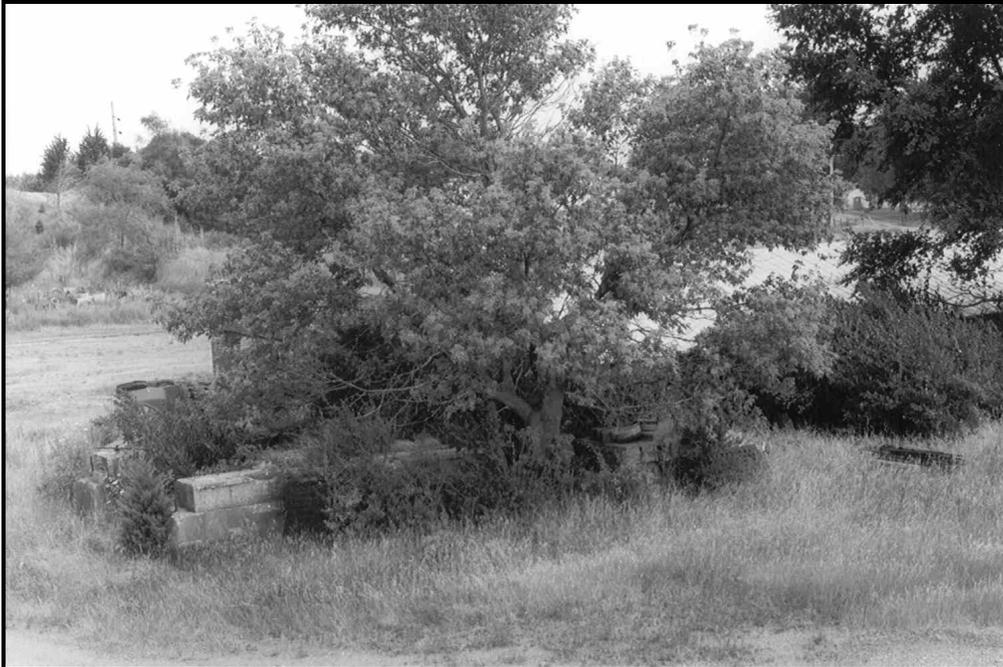
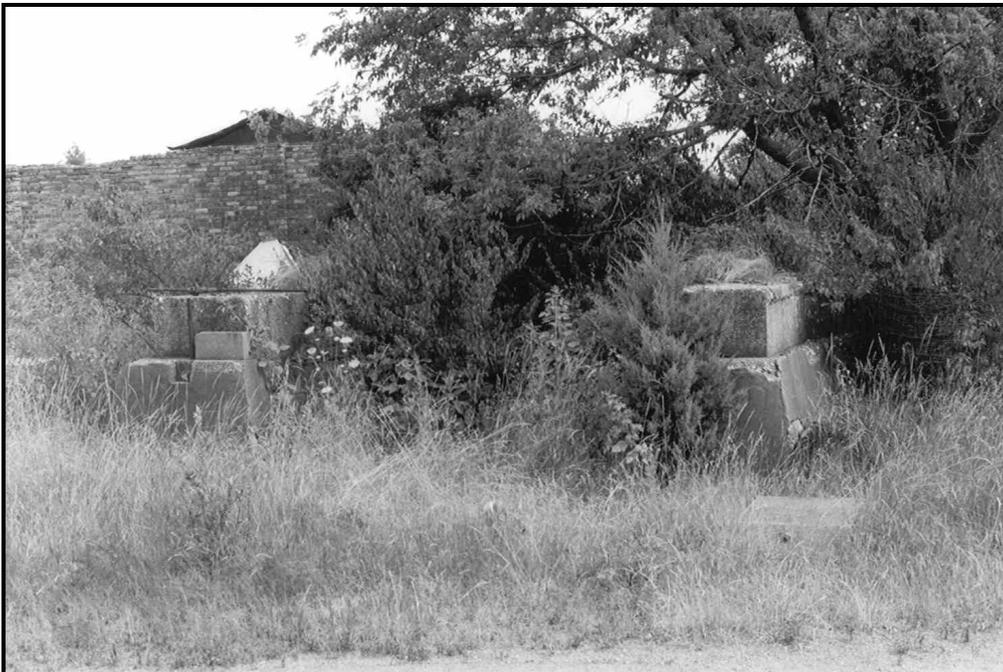
Feature 2 is the remains of the hoist engine house. This structure has been demolished down to its foundations, but it is well illustrated in historic photographs of the mine. It measured approximately 40' (north/south) by 31' (east/west), had 12" thick brick walls with pilasters, and a low-sloped shed roof. The building originally housed a steam-powered hoist engine that was used to raise and lower the cage in the main shaft. Cables extended from the engine to the top of the hoisting frame on the tippel. The steam powering the engine was generated in the adjacent boiler house (Feature 4). The engine itself has been removed, but the concrete footings on which it sat are still in place (see Figures 20).

Figure 20. (TOP) View of the hoist engine house (Feature 2), looking southeast. The walls of the building have been demolished to grade. (BOTTOM) View of the concrete footings that formerly supported the hoist engine (FRR July 2002).

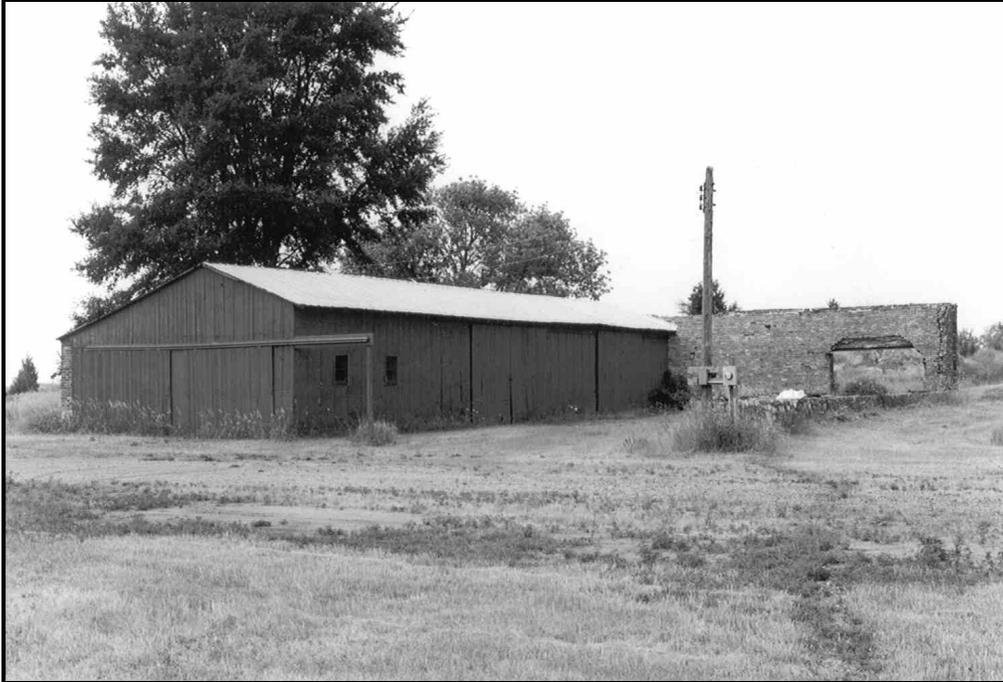
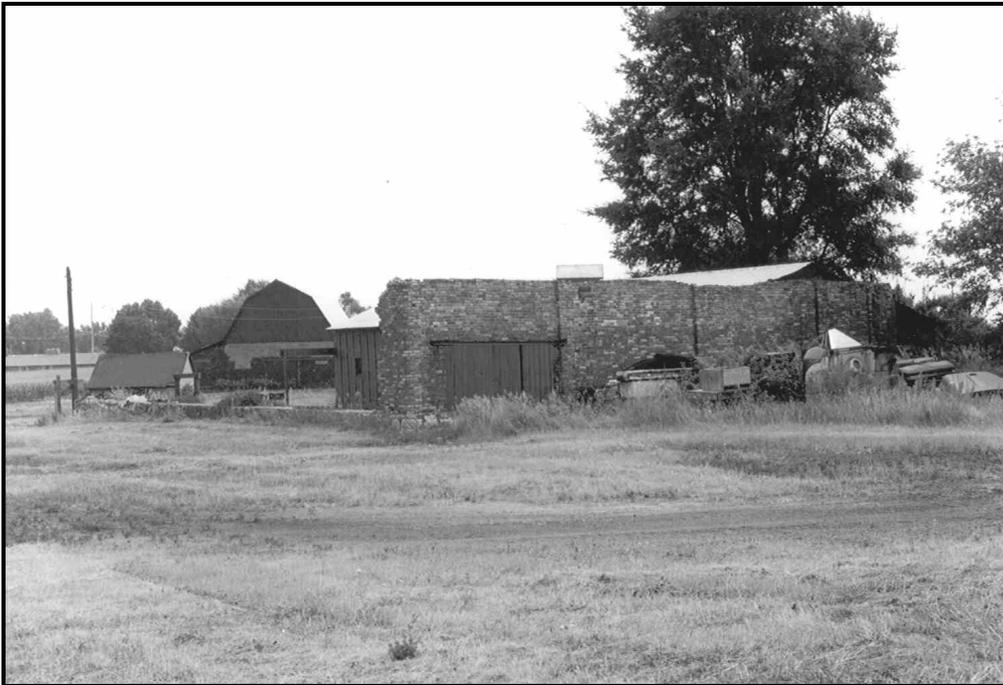
Feature 3 is the remains of the boiler house. This building originally measured 72'-6" (north/south) by 62'-0" (east/west) and housed six boilers. A seventh boiler later was added, necessitating the construction of an 11'-8"-wide addition on the south and increasing the total length of the building to 84'-2". The exterior appearance of the boiler

house matched that of the adjacent hoist engine house, having stone foundations, 12"-thick brick curtain walls separated by pilasters, and a low-sloped shed roof. On the interior, roughly two-thirds of the floor space was occupied by the boilers, which were arranged in a row along the west wall. Coal was piled along the east wall and shoveled by hand into the boilers. A stairway in the northwest corner of the building allowed access into the hoist engine house. Arched doorways were present on the north and south ends of the boiler house. Charles Bartoli stated that the original floor level inside the building was located approximately four feet below the existing grade. After the mine was closed, his father dumped fill inside the building to bring the level up to grade. The Bartolis subsequently demolished the east and south walls of the boiler house, but retained the other two exterior walls and incorporated them into a machine shed built within the perimeter of the boiler house (Charles Bartoli, pers. comm. 23 July 2002). The machine shed is still in use (see Figures 21 and 22).

Figure 21. (TOP) View the boiler house remains, looking northwest. The machine shed built within the building perimeter represents a later addition. Note the intact wall at the far end of the building. (BOTTOM) Another view of the boiler house, looking southwest (FRR July 2002).

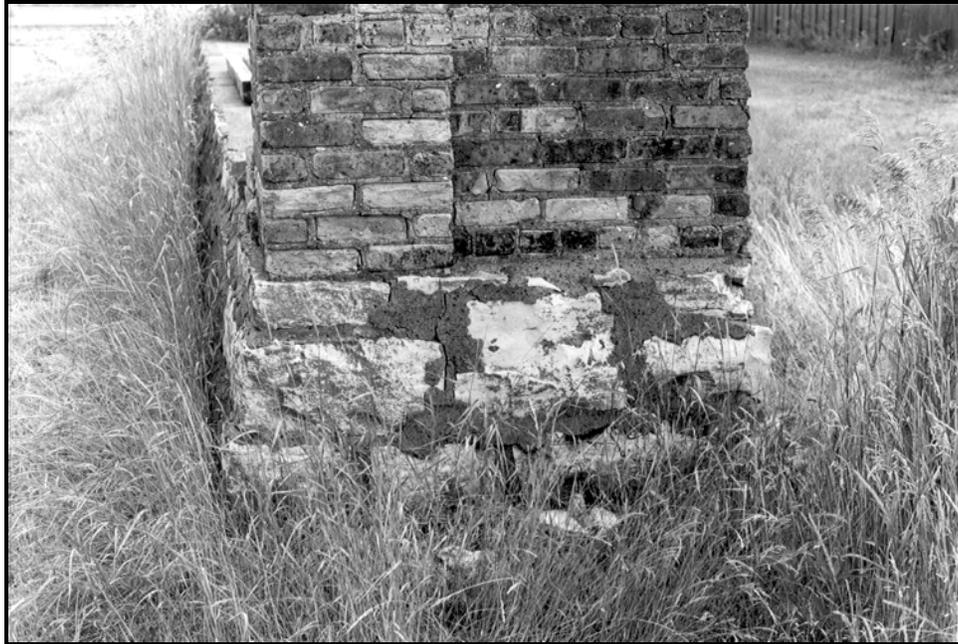
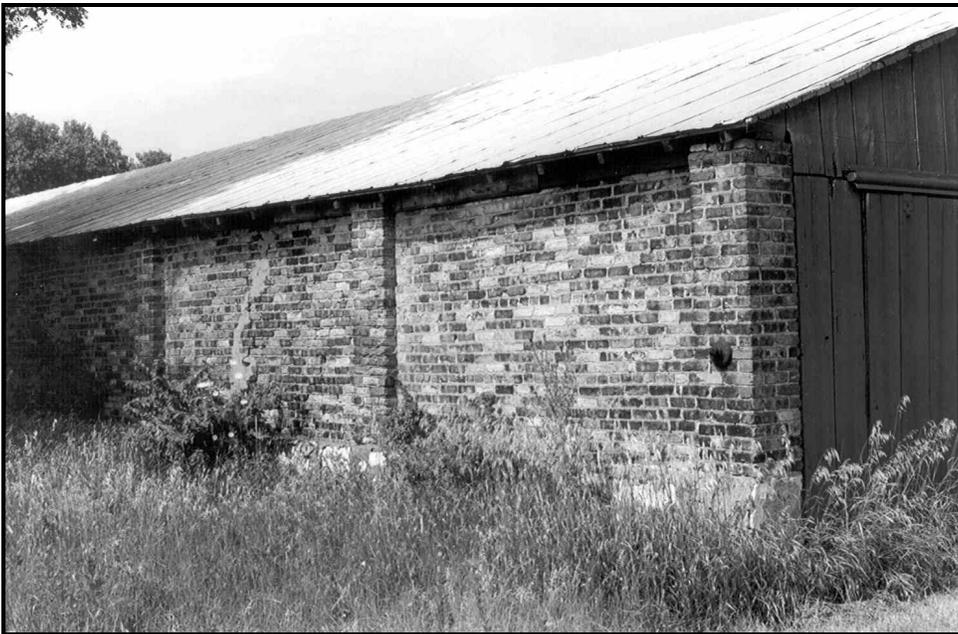
Figure 22. Photographs illustrating the methods and materials of construction used for the boiler house. (TOP) Detail of the northeast corner of the building, showing the juncture between the raised stone foundations and the brick wall. The use of stone for the foundations is of interest, considering the widespread use of concrete at contemporary mine sites and its use on other buildings at the Cherry Mine. (BOTTOM) Photograph of the rear (west) wall of the boiler house, showing the pilasters that were interspersed along the exterior walls. Although supporting overhead roof trusses, the pilasters provided a subdued decorative element to an otherwise purely functional industrial building (FRR July 2002).

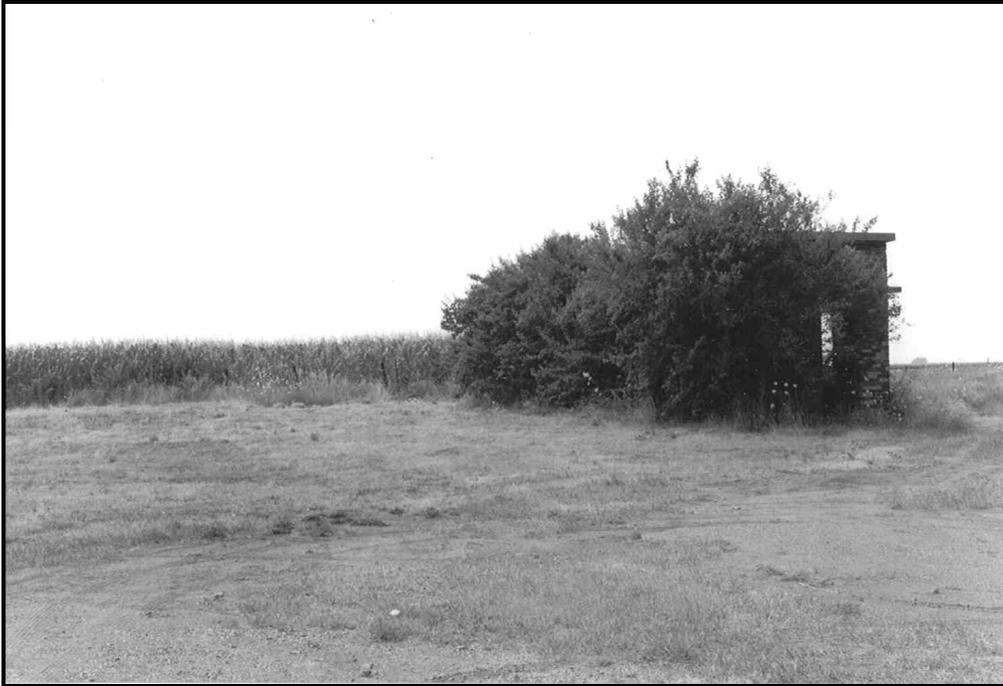
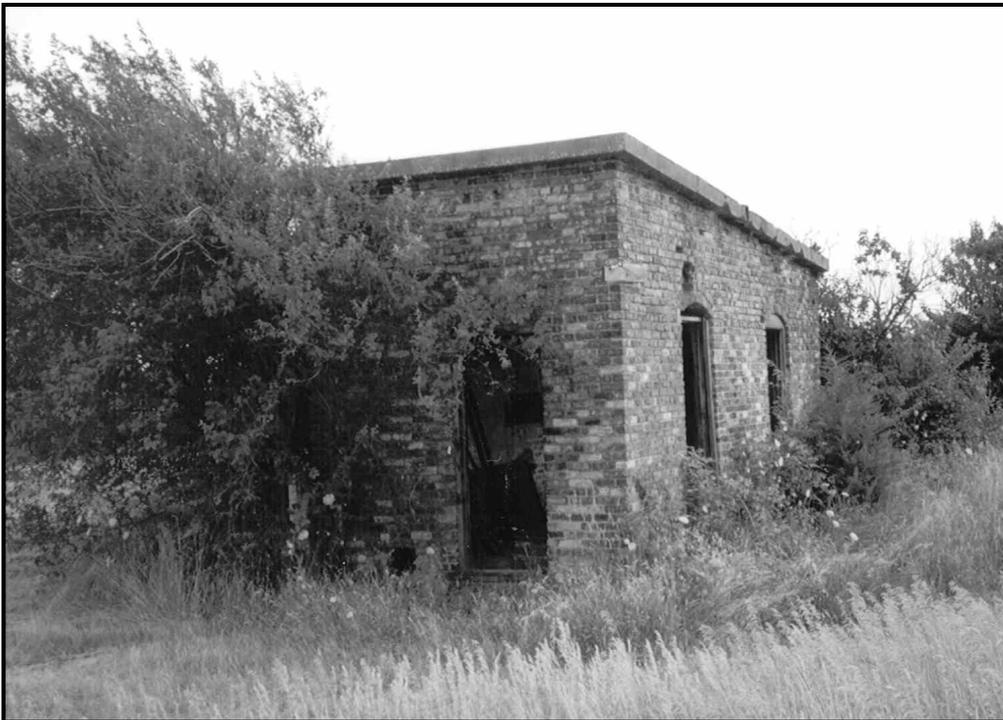
Feature 6 is the remains of the brick fan house. As originally constructed, this building was divided into two main sections: an engine room on the north and a fan room on the south. At the time of the 1909 fire, a Clifford Capell fan was in use, and this was operated as a blower to force air into the mine via the air/escape shaft, which was positioned directly to the rear of the fan house. The main hoisting shaft, in turn, functioned as the uptake, creating a continuous current through the mine. Typical of structures of this kind, the fan was positioned over a pit and had an arched housing over the top it. Service aisles, accessible through separate doors on the west side of the building, extended along the north and south sides of the fan. The fan was driven by a steam engine located in the north room of the building. In 1936, the fan and its steel housing were scrapped out, and the walls surrounding it were demolished. The only sections of the building that remain visible above grade are the engine room, whose walls are fully intact, and the top of the air shaft, which is capped with a concrete slab. The

engine room has 8"-thick brick walls and is covered with a shed roof formed with poured concrete and railroad rails. It has a single doorway on its east side and two windows on the north. On its interior, the engine room measures 9'-0" (north/south) and 21'-4" (east/west). The fan engine was removed long ago, but its former location is evident on the concrete floor. There is a hole in the south wall of the room through which the drive shaft to the fan passed. Located next to this hole is a wooden cabinet where oil and other maintenance equipment for the engine were kept. There is a small chamber located to the rear of the engine room, which was positioned over a shaft leading down into the mine. This chamber, which measures 4'-3"x3'-8," originally was accessible through an exterior doorway on the west and an interior door on the south (leading from the fan room). It is possible that the shaft served an alternate escape route from the mine. After the mine closed the Bartolis converted the chamber into a privy, flooring over the partially filled shaft and installing a two-seat toilet (Charles Bartoli, pers. comm., 23 July 2002) (see Figures 24 through 27).

Figure 24. (TOP) View of the fan house, looking west. Only the northern third of the building—the fan engine room—remains standing. The remainder of the building has been demolished to below grade. (BOTTOM) Exterior view of the engine room of the fan house, looking west. Note the brick walls and concrete roof (FRR July 2002).

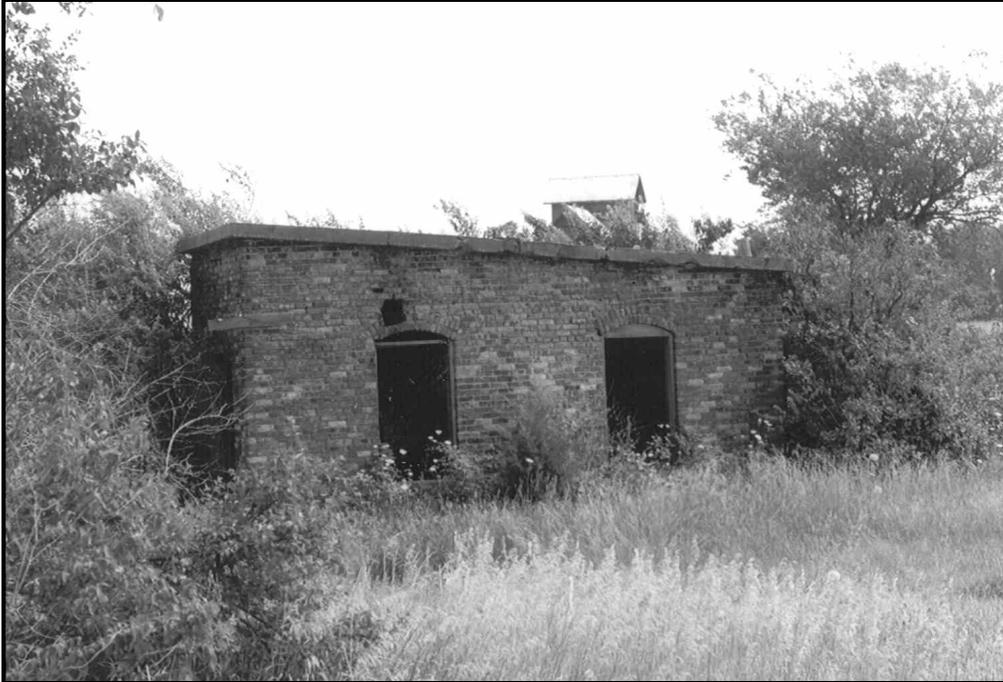
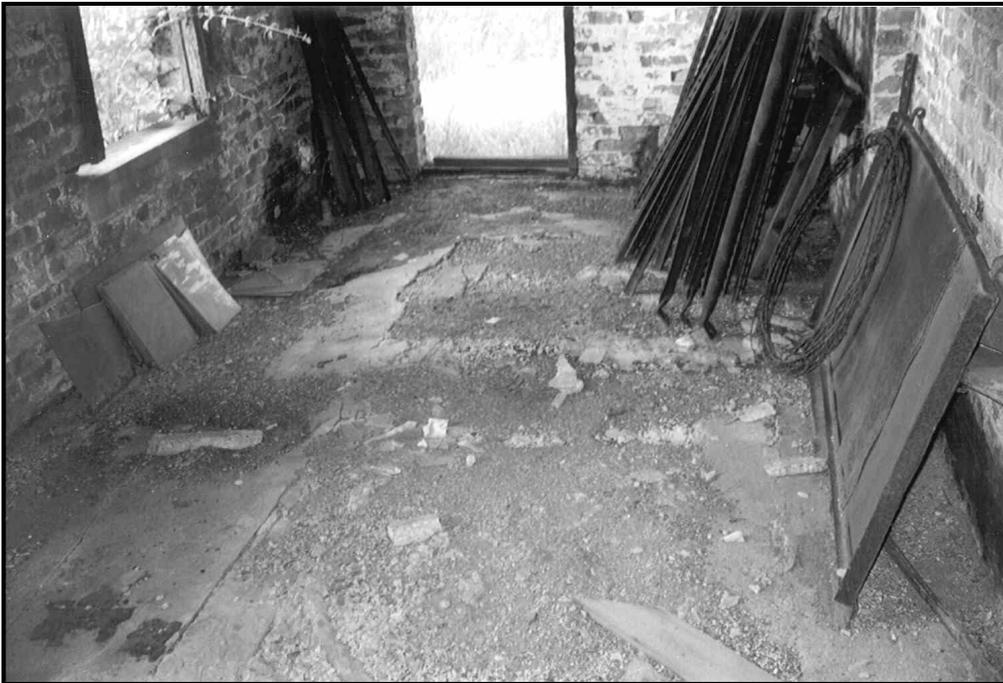
Figure 25. (TOP) Exterior view of the fan engine room, looking south. (BOTTOM) Interior view of the fan engine room, looking east towards the exterior doorway. The broken-up area on the concrete floor delineates the location of the engine (FRR July 2002).

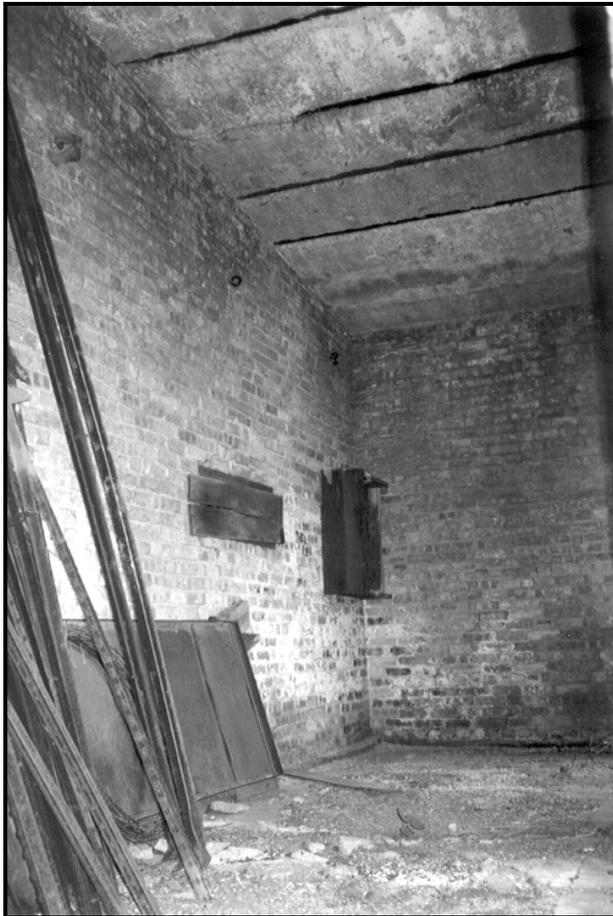
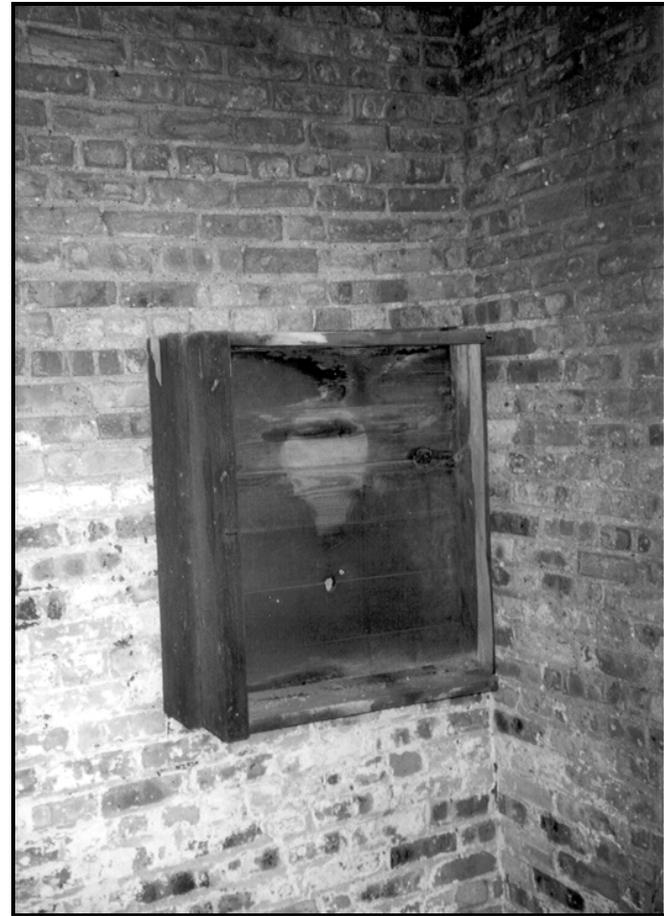
Figure 26. (LEFT) Interior view of the fan engine room, looking west from the doorway. The boarded-up opening on the left is where the drive shaft passed through to the fan. Note the steel rails showing through the ceiling, around which the concrete roof was poured. (RIGHT) View of the frame cabinet in which oil and other maintenance equipment for the fan engine were stored (FRR July 2002).

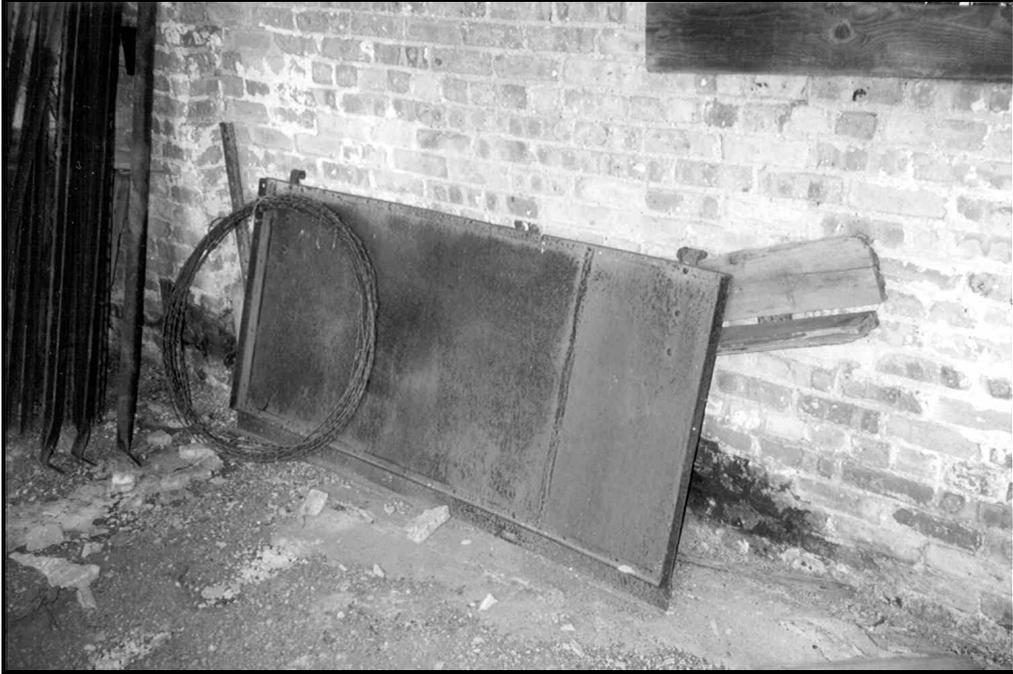
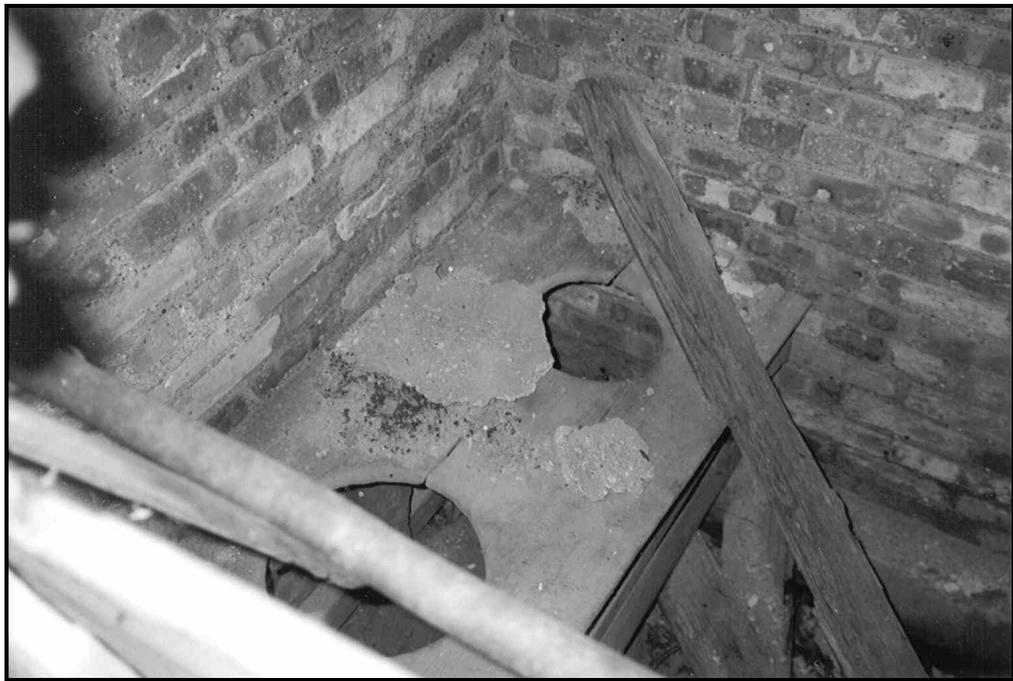
Figure 27. (TOP) View of the steel door that formerly hung in the exterior doorway leading into the fan engine room. Steel doors were more fireproof and durable longer than ones made of wood and were commonly used in mine buildings. (BOTTOM) View of the small chamber located to the rear of the fan engine room. This chamber was positioned over a shaft leading into the mine and later was converted for use as a privy. Note the two-seat toilet (FRR July 2002).

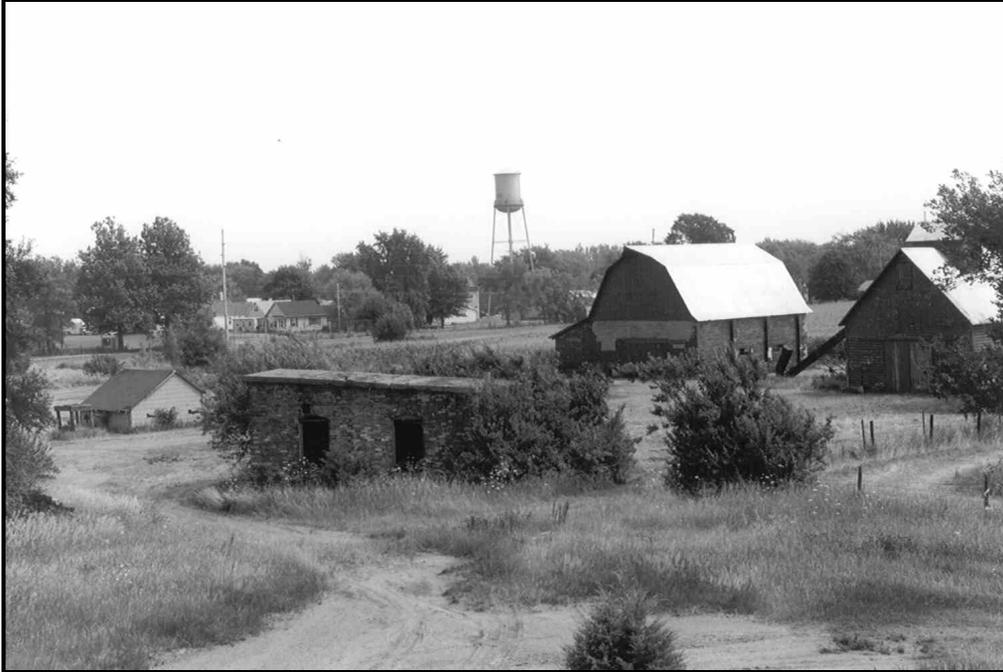
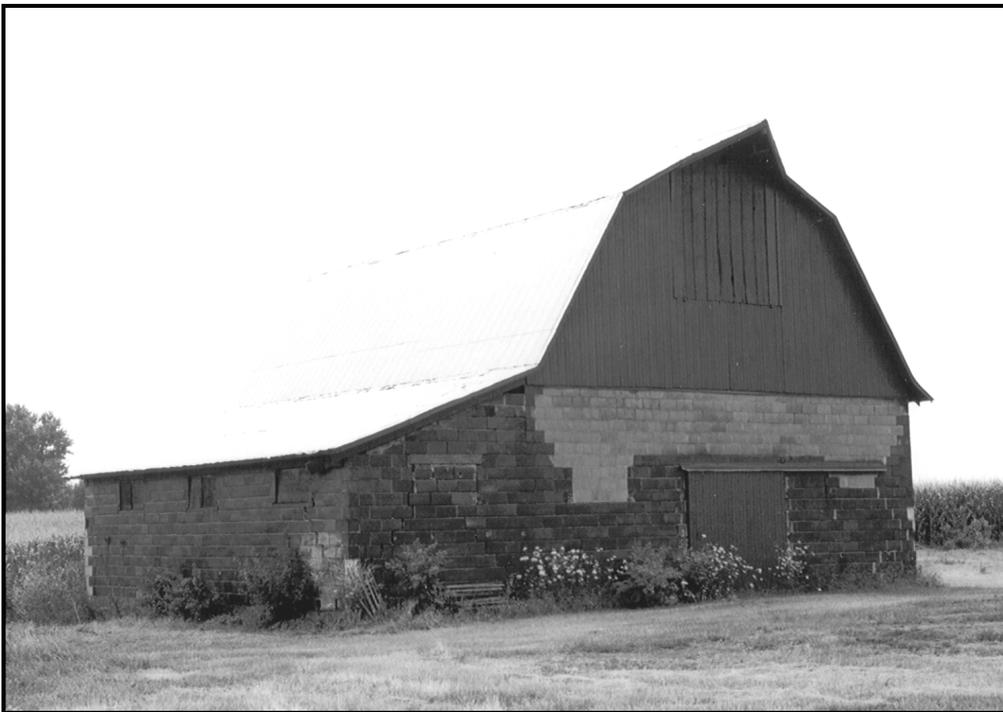
Feature 7 is the wash house for the mine. One of the last buildings added to the surface complex, the wash house was constructed at some point between 1915 and 1928. Its walls are built with 8"x16" hollow tile block manufactured by NATCO (National Fire Proofing Company), and thus contrasts to the earlier brick and frame buildings erected at the site.² On its interior, the wash house originally was divided into two rooms: a large changing room on the west, which measured 38'-2"x31'-2"; and a 38'-2" x11'-0" shower room on the east. The changing room had an overhead system of hooks and chains for the miners to hang their clothes and equipment upon. There also was a large water tank in the changing room. After the Bartoli Family went into farming, they converted the wash house into a dairy barn. In 1948, they replaced the original roof on the building with a gambrel roof in order to provide increased hay storage. The Bartolis also tore out the original entrance vestibule to the changing room and added several doors on the north side of the building (Charles Bartoli, pers. comm., 23 July 2002) (see Figures 28 and 29).

Figure 28. (TOP) View of the southern end of the mine site, looking southeast toward Cherry. The fan engine room appears in the foreground and the wash house (the gambrel-roofed building) lies in the background. The two gable-roofed buildings are agricultural outbuildings post-dating the mine. (BOTTOM) View of the wash house, looking southwest. This building is the last mine-related building known to have been constructed at the site. The gambrel roof represents a later addition, constructed when the building was converted into a barn (FRR July 2002).

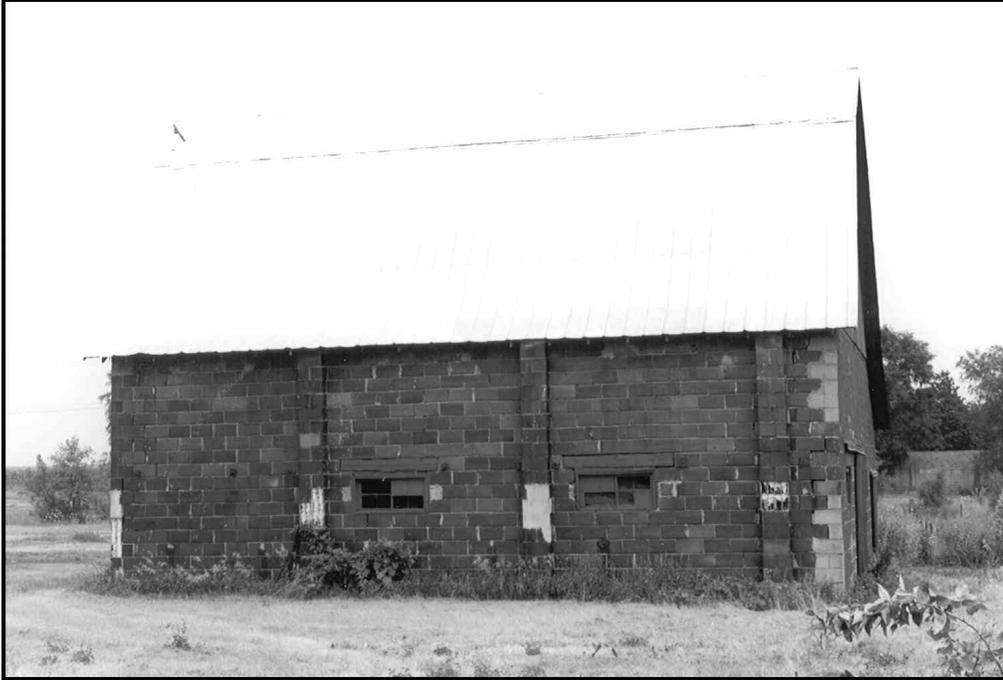
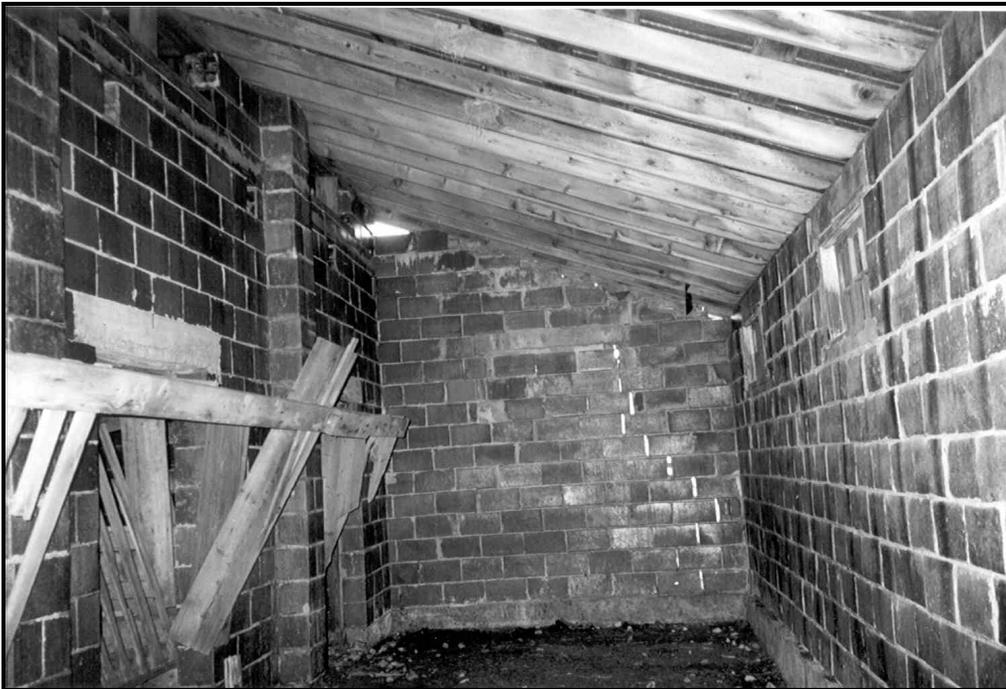
Figure 30. (TOP) Exterior view of the wash house, looking east. (BOTTOM) Interior view of the shower room in the wash house. The doorways on the left lead into the changing room (FRR July 2002).

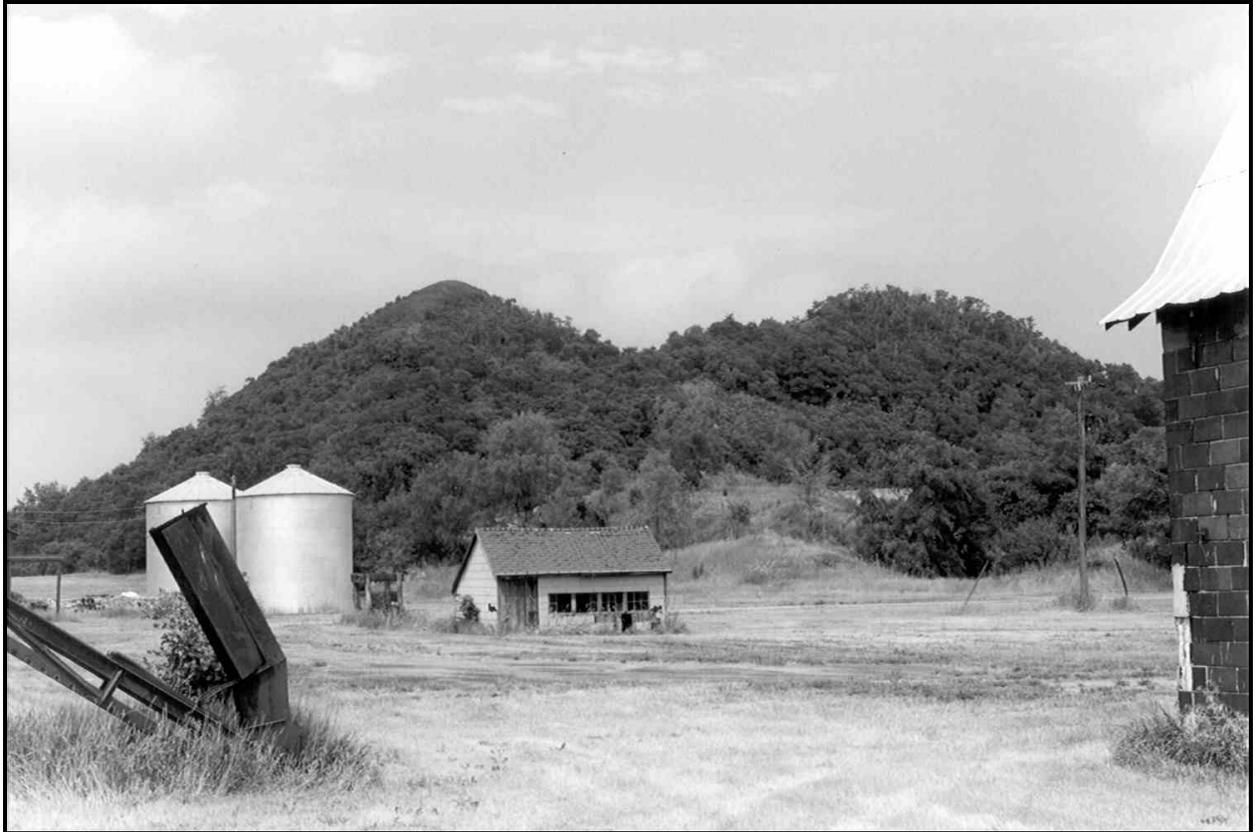
Landscape Features: The principal landscape features associated with the Cherry Mine are the two large gob piles that dominate the east side of the site (see Figure 30). The

piles cover roughly 16 acres at their base and rise approximately 170 feet above the surrounding landscape (AML 2002a). Waste material stopped being dumped on them after the Cherry Coal Company took over operation of the mine in 1928. By that date, the sides of the gob piles were so steep that it was becoming increasingly difficult to keep the cars on the incline railways running up them. Gob removed during the final years of the mine's operation was deposited west of the tippie. Railroad ties and other equipment still litter the paths of the incline railways. The abandoned railroad grade of the Chicago, Milwaukee, and St. Railroad also is visible on the southeastern corner of the site, in the area where the mine office was located.

Figure 31. View of the gob piles that dominate the east side of the mine site. The frame chicken house and silos are not associated with the mine (FRR July 2002).
