ILLINOIS DEPARTMENT OF NATURAL RESOURCES CULTURAL RESOURCE MANAGEMENT PROGRAM ABANDONED MINED LANDS RECLAMATION CULTURAL RESOURCES EVALUATION

WORDEN COAL COMPANY MINE NO. 1 WORDEN, MADISON COUNTY, ILLINOIS

prepared by Fever River Research Springfield, Illinois

January 2003

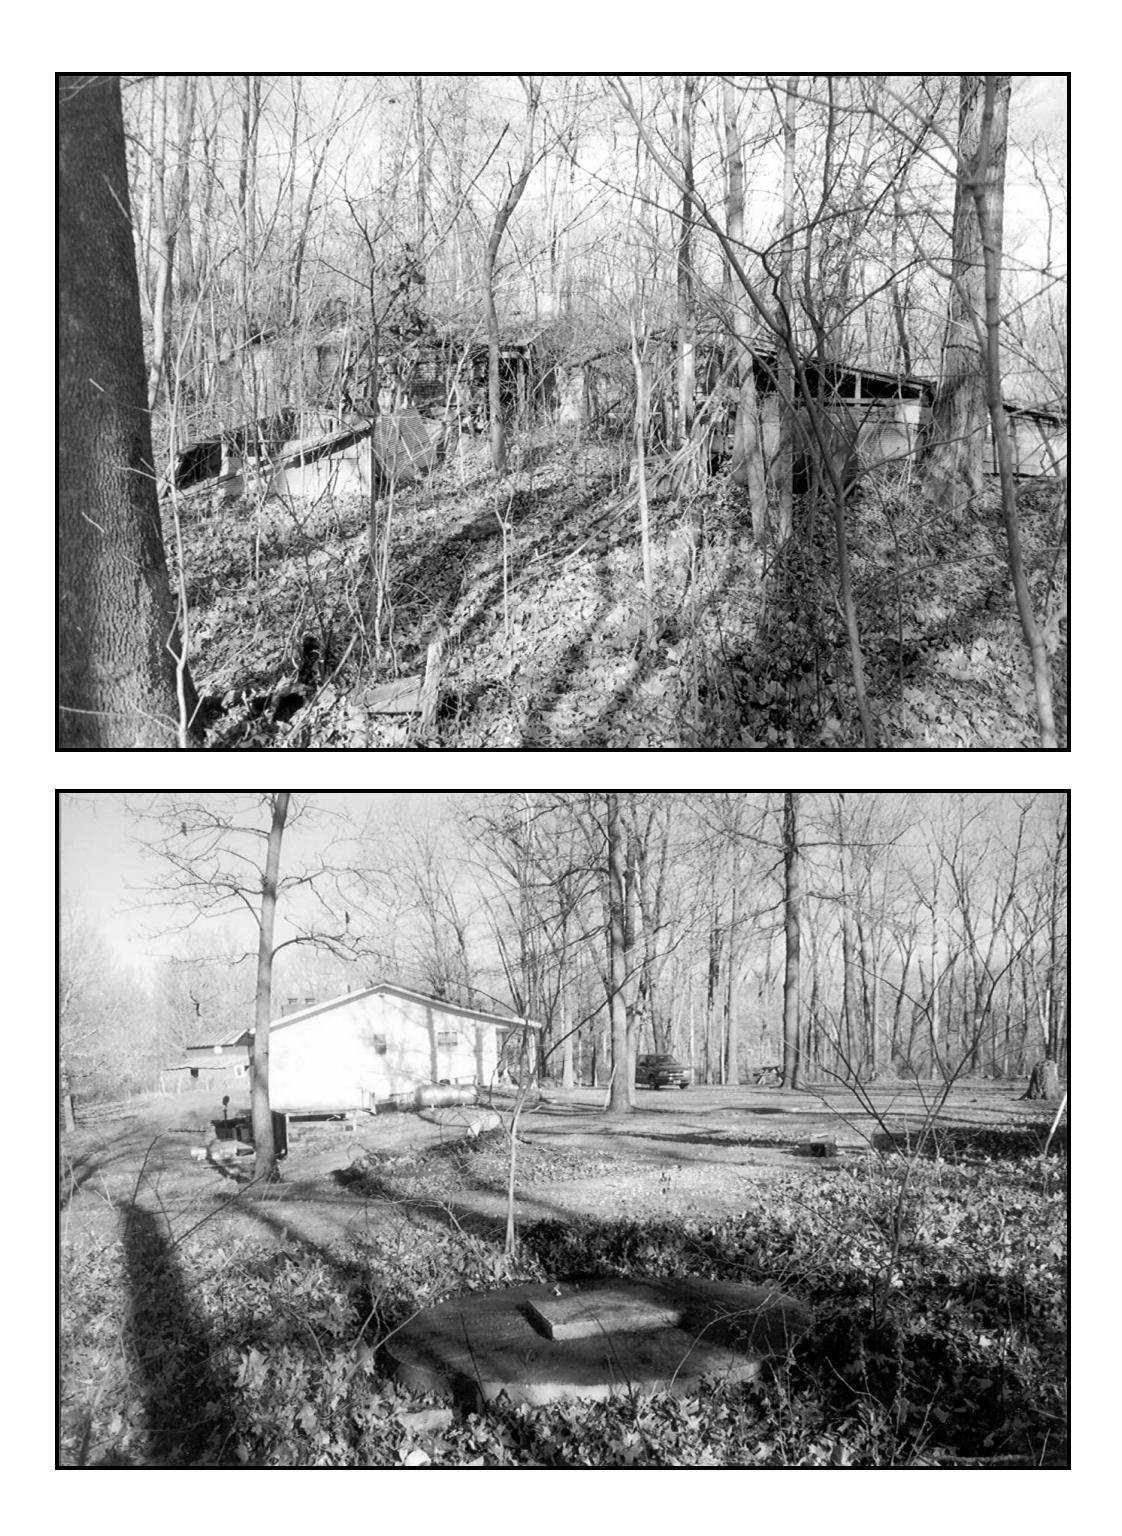
Figure 3. The main part of the site is located in a wooded area at the base of the bluff bordering the west side of an unnamed tributary of Cahokia Creek. After the mine's abandonment, the site was utilized for agricultural purposes and a number of livestock sheds were built amongst the ruins of the mine buildings. (BOTTOM) A portion of the site extends onto the bluff crest, which presently is occupied by a residence and associated yard (FRR December 2002).

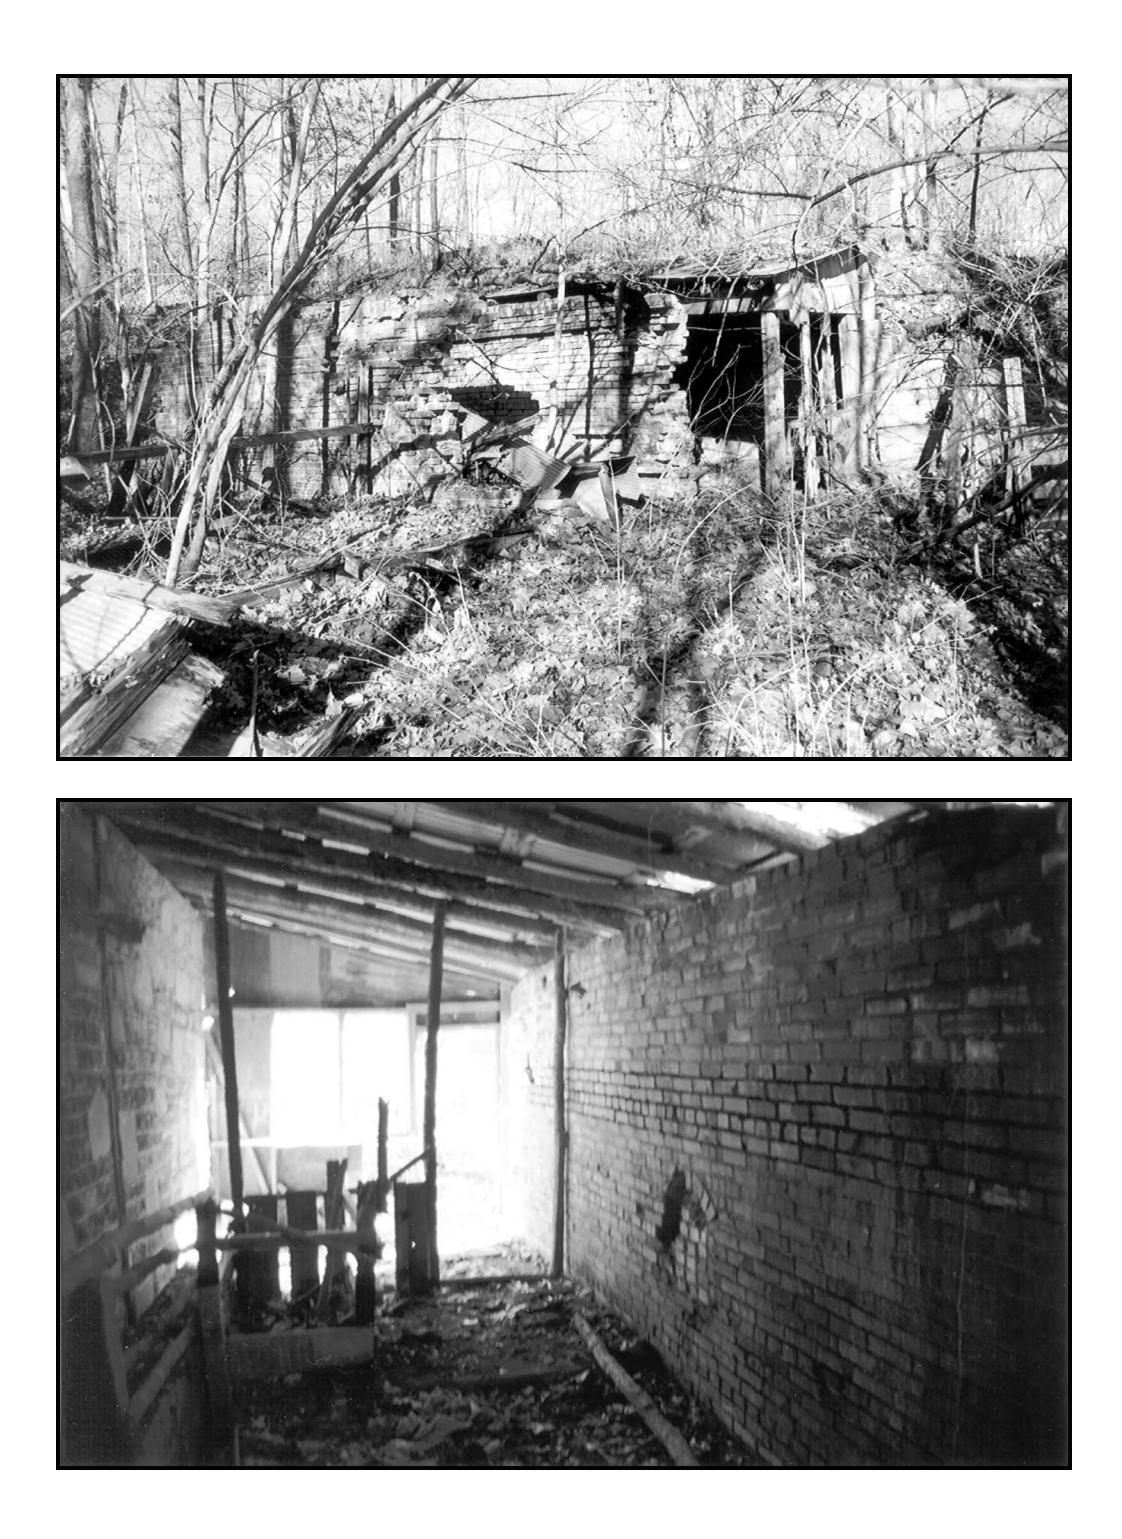
<u>Feature 1</u> represents the ruins of a boiler house that was built back against the bluff slope. This building formerly housed one or more coal-fired boilers that generated the steam used to power a hoist engine and other equipment and possibly used to heat the other buildings at the site. We do not know what the boiler house looked like originally. The only historic image that shows the building only provides a glimpse of a tall smokestack to the rear of the tipple (reference Figure 5). Two sections of the boiler house are still standing. One of these is a brick boiler chamber measuring 9'x25' on the exterior and 6'x22' on the interior. The chamber has 1'-6"-thick walls laid with four-courses of hard-pressed brick. The boiler machinery itself has been removed, possibly as scrap after the abandonment of the site. Running along the north side of the boiler chamber is an aisle that measures 9'-0"x32'-6" on the interior. The retaining wall of this aisle serves as a retaining wall for the cut bank behind it. The retaining wall is constructed with an odd assortment of irregularly sized and finished concrete blocks. The west end of the aisle extends past the west end of the boiler chamber and can be accessed through a doorway on this end (see Figures 9 through 11, 13).

Figure 9. (TOP) View of the boiler house remains (Feature 1), looking north. The building is constructed against the bank of bluff. (BOTTOM) Interior view of the boiler house, showing the aisle that runs along the north side of the boiler chamber, the brick wall of which appears on the right (FRR December 2002).

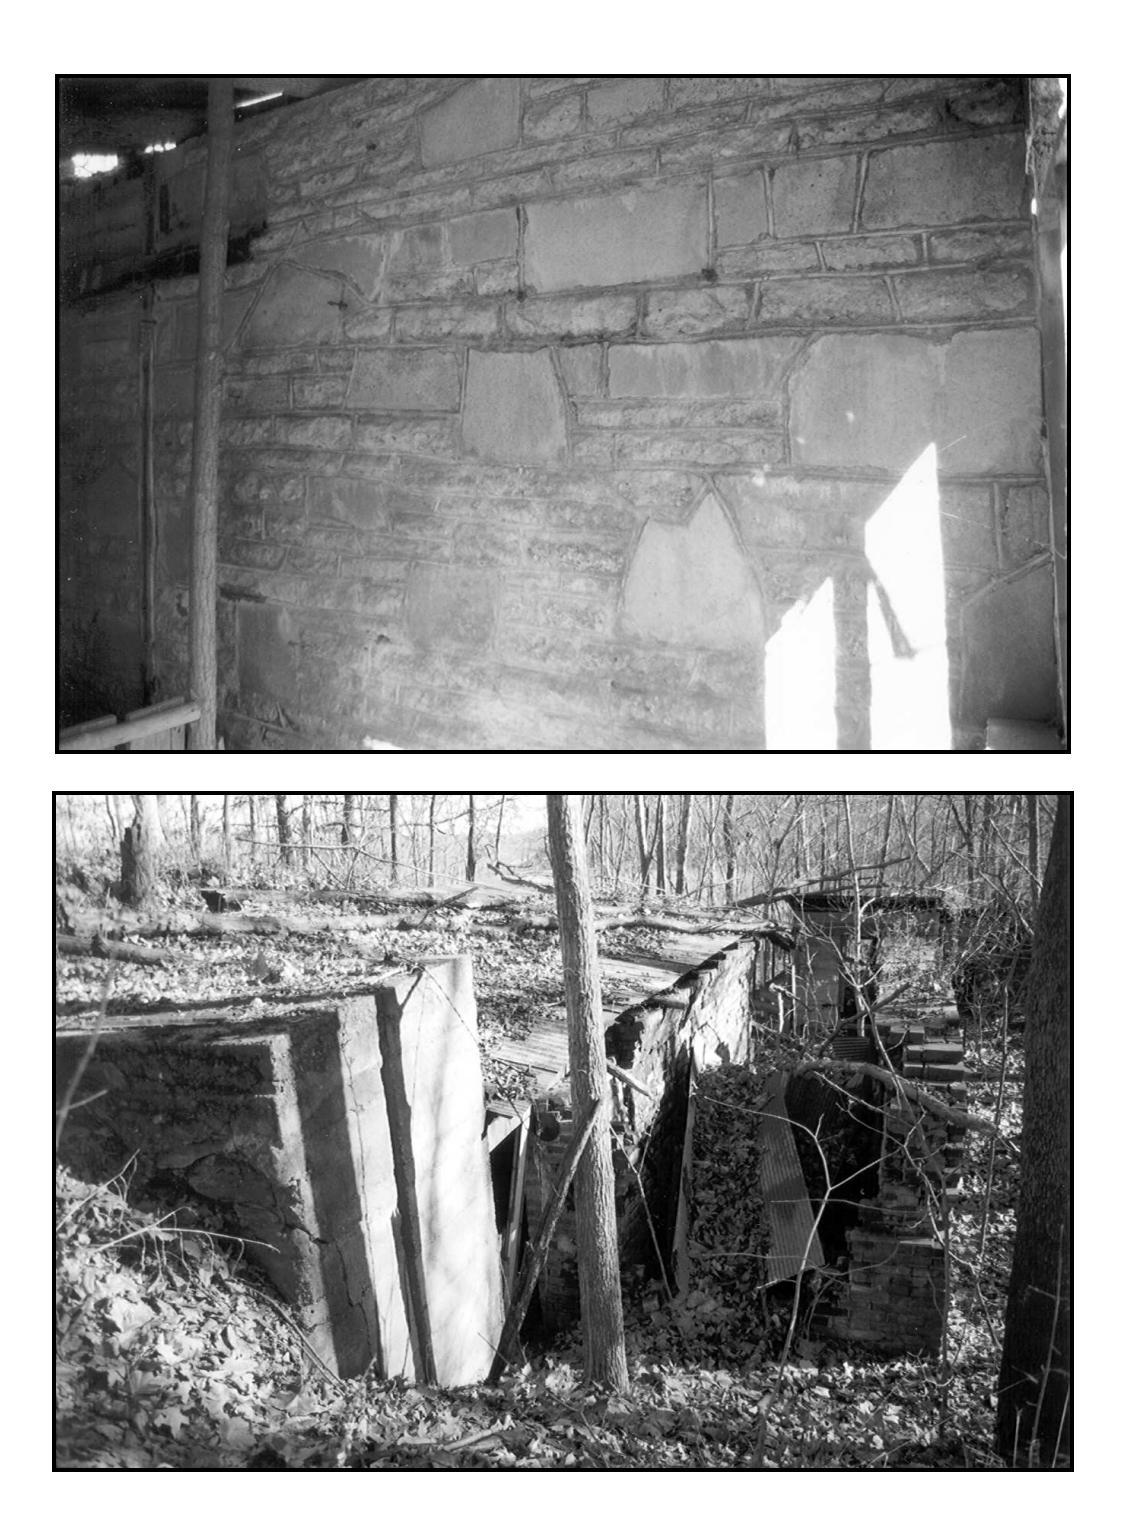
Figure 10. (TOP) The north of the boiler house serves as retaining wall and is laid with an odd assortment of chipped and smooth concrete block fragments. It is unclear whether this was done out of economy or for esthetics (or a mixture of both). (BOTTOM) View looking down the length of the boiler chamber. The boiler has been removed (FRR December 2002).

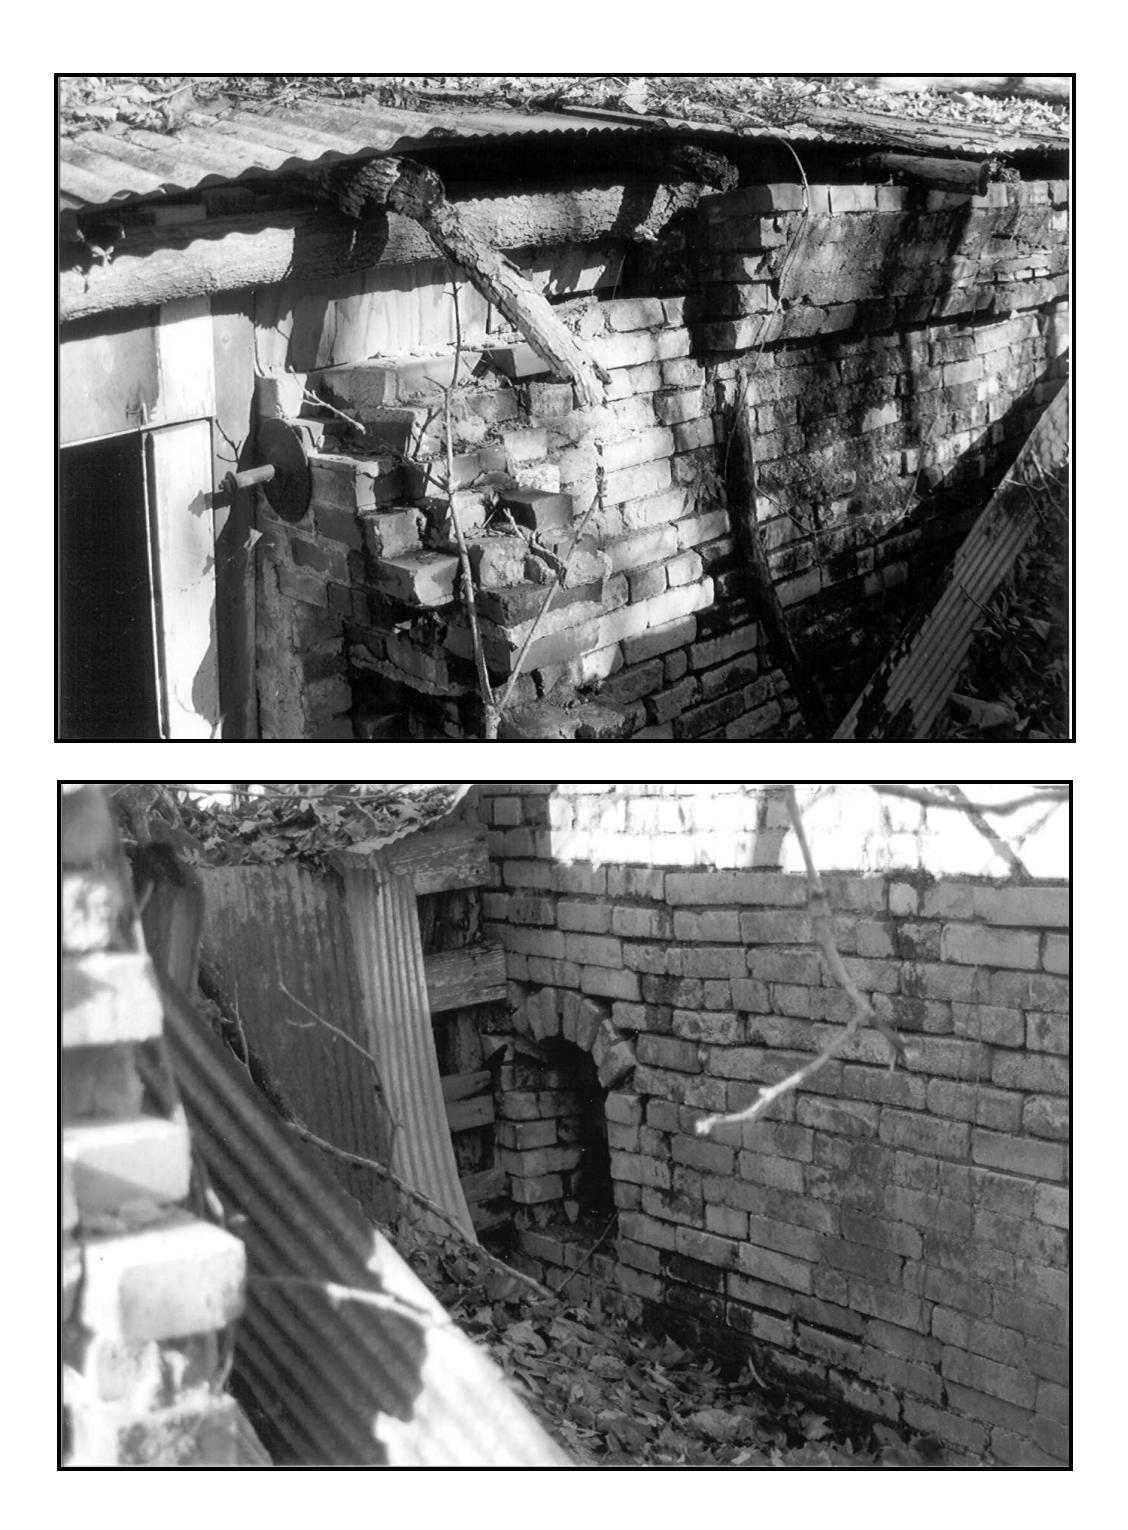
Figure 11. (TOP) Detail of the brickwork on the boiler chamber walls. The walls are four courses thick. (BOTTOM) View of the vent, or clean-out portal, on the north side of the boiler chamber (FRR December 2002).

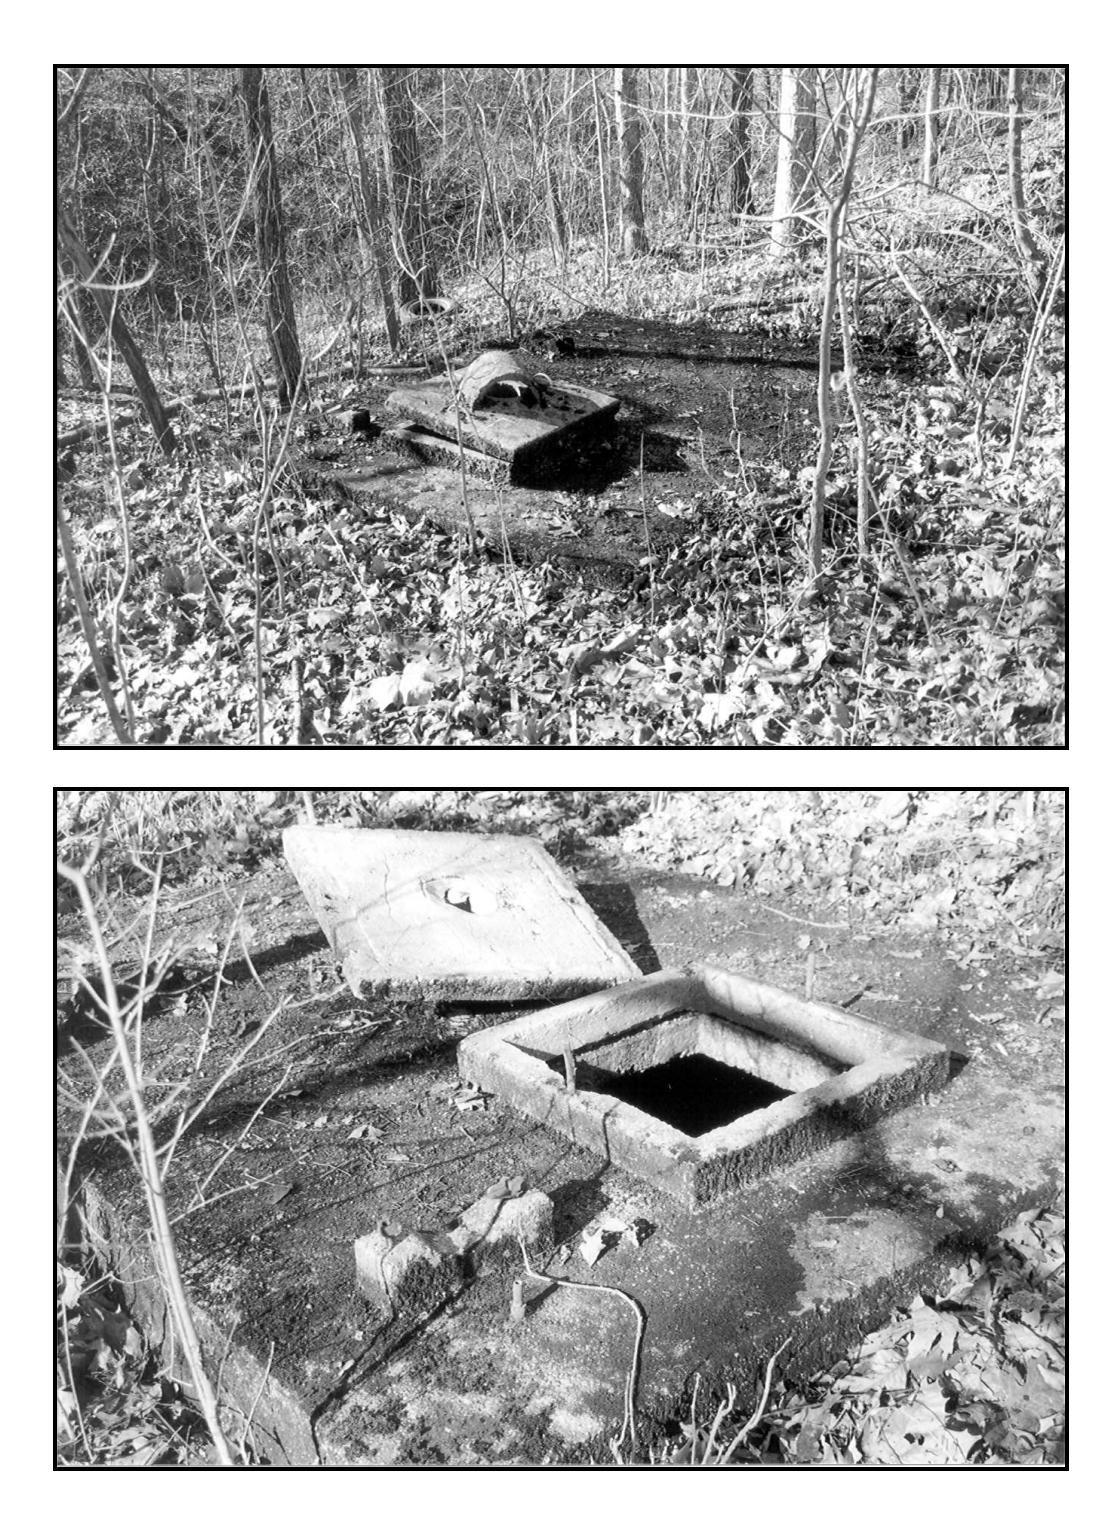
<u>Feature 2</u> represents the remains of a large concrete cistern located on the rise above the boiler house. This structure was used to hold water, large amounts of which were required by the boiler in the adjoining building. The cistern measures 6'-10"x8'-10" on the surface and has a roof that is set nearly flush with the ground. The walls, floor, and roof of the structure are all poured concrete. On the interior, the cistern measures 6'-0"x8'-8" and has a 7'-0" depth. A 1'-10"-square scuttle on the roof, which can be covered with a vented cap, provides access to the interior. There are two small concrete cradles, or footings, with threaded bolts (serving as tie-downs) on top of the cistern that may have formerly held a pump or some other mechanism. A 2" pipe extends out of the south side of the cistern; it is unclear whether this pipe was the means by which water was drawn from, or into, the cistern (see Figures 12 and 13).

Figure 12. (TOP) View of the large concrete cistern (Feature 2) located directly adjacent to the boiler house, looking west. (BOTTOM) An opening in the roof of the cistern allows access to the interior. Note the footing, or pipe cradle (?), to the left of the opening (FRR December 2002).

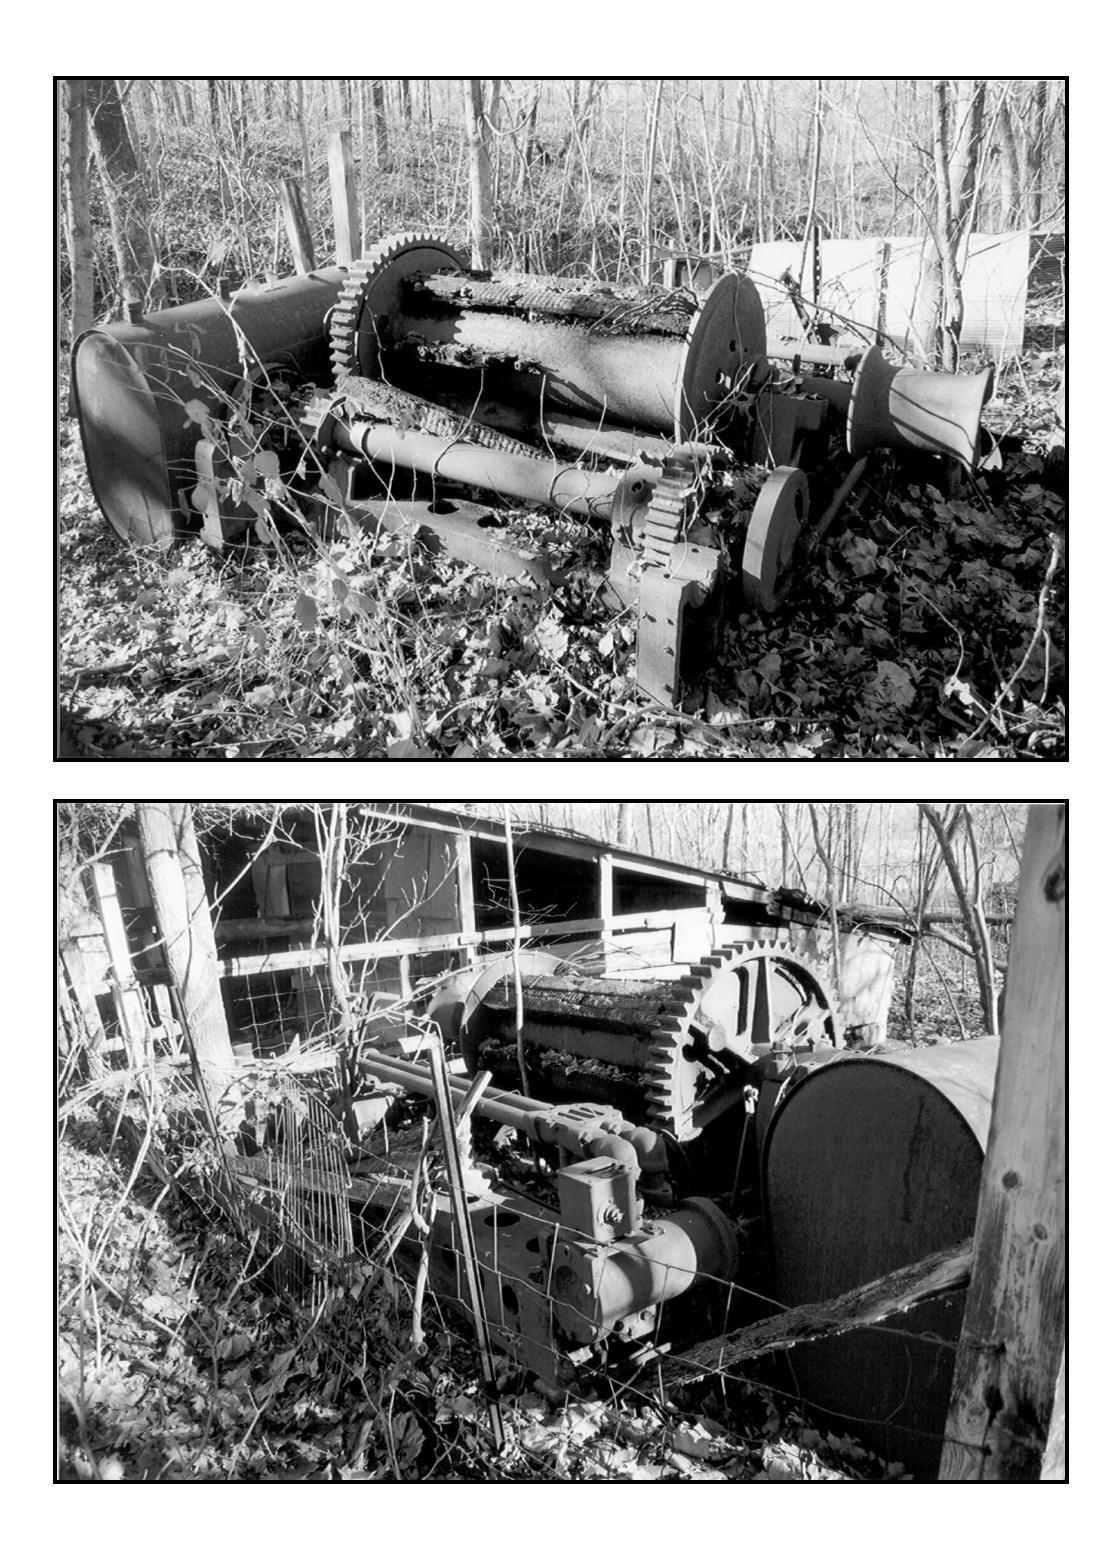
<u>Feature 3</u> is the hoist engine house. The only remains of this building that are visible above ground are two adjoining concrete pads. Both pads measure approximately 8'-square. Sitting on one of the slabs, however, is the actual hoist engine that was used to raise/lower men and material into/out of the mine. The engine was manufactured by the American Hoist and Derrick Company of St. Paul Minnesota and was steam-powered (the steam being supplied from the boiler house). A standard feature at any shaft mine, the hoist engine is equipped with a large spool on which the cable connected to the mine cage was reeled in and out. The cable would have run from to the engine house to a pulley mechanism at the top of the tipple and from there to the cage. One of the historic photographs taken of the mine when it was in operation shows a front-gabled (frame?) building located directly west of the tipple that may represent the hoist engine house. A large fuel-oil tank is leaning against hoist engine. The tank is stamped with a label that says: "Underwriter's Laboratories, Inc. / INSPECTED / INSIDE STORAGE TANK / FOR OIL BURNERS / METAL NO. 14 U.S. GUAGE" (see Figure 14).

Figure 14. Two views of the steam-powered hoist engine that remains at its original location at the mine. The American Hoist and Derrick Company was the manufacturer. The engine originally was sheltered within a building (Feature 3, the hoist engine house), which has been torn down to its foundations (FRR December 2002).

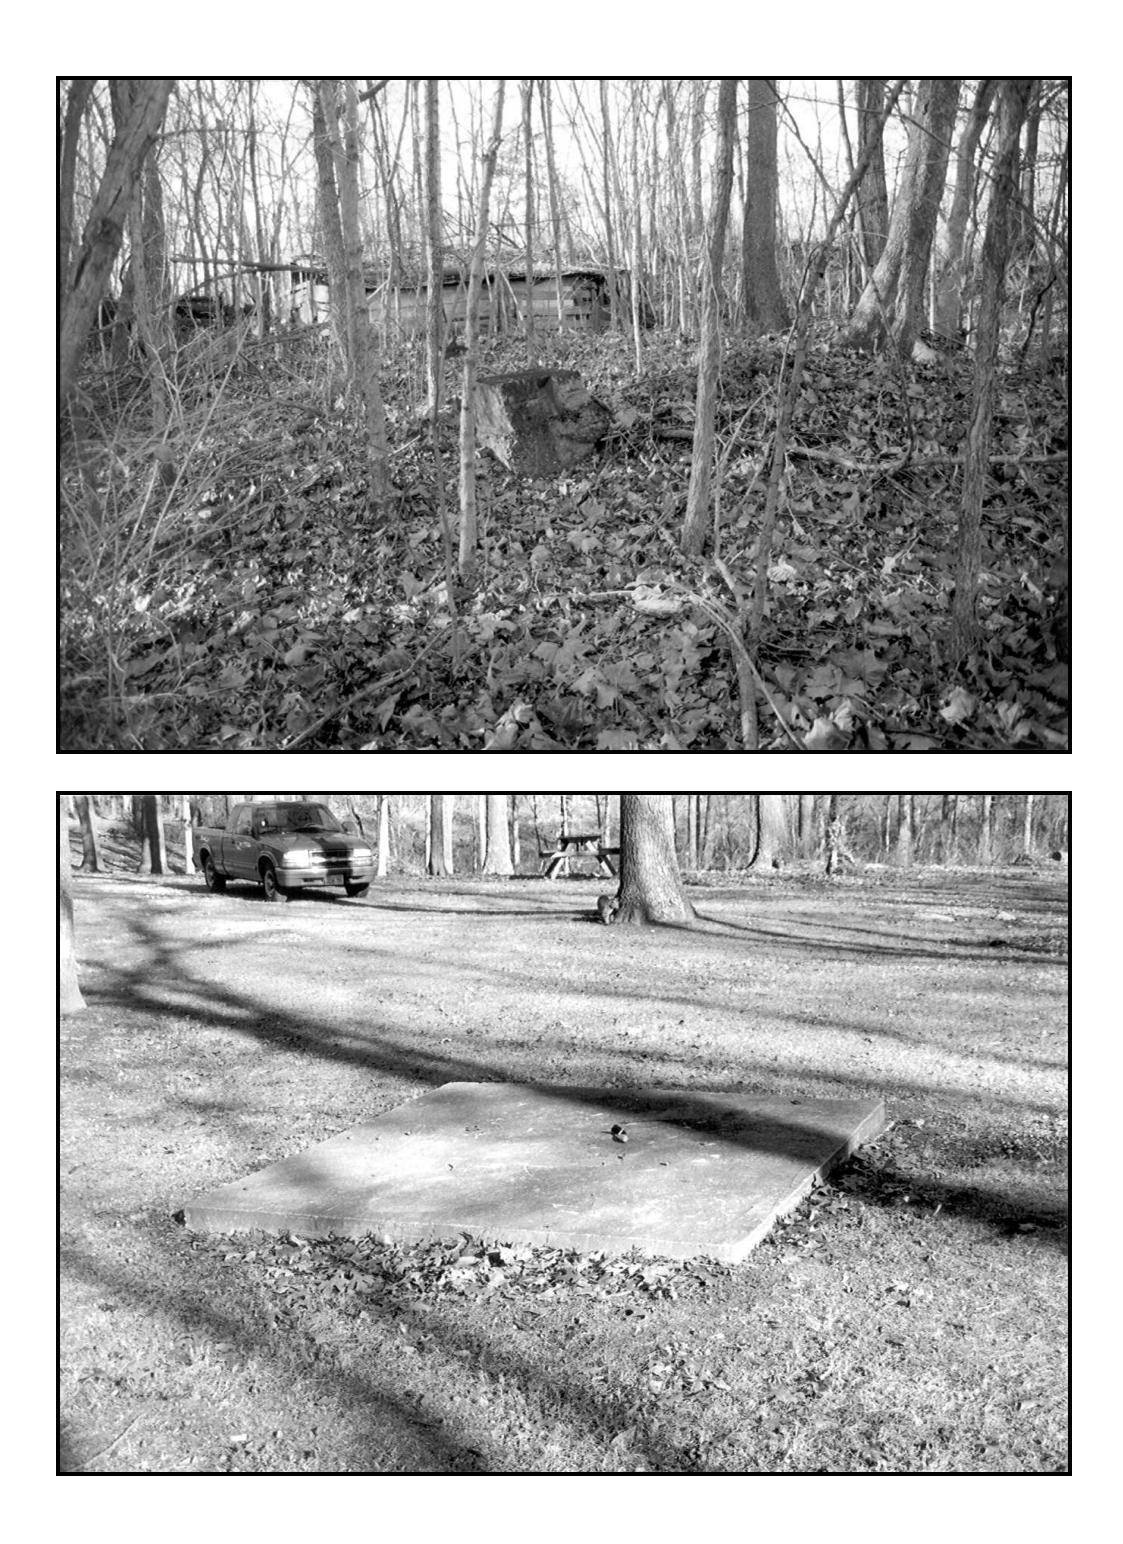
horizontal planking) and covered with a roof. Although difficult to tell from the photograph, the base of the structure appears to have been built like a hopper, so trucks could pull beneath it and be filled. At larger shipping mines, the tipple and coal bins would have been integrated within a single structure, rather than being detached from one another. Nothing structural remains from the tipple and coal bin other than a lone concrete footing and post holes left behind after the demolition of the superstructures (see Figure 15).

<u>Feature 6</u> is a concrete pad on the bluff crest that is believed to cover the airshaft for the mine. The pad is 4" thick and measures 7'-6" square. A lone concrete footing, whose function is unknown, is located approximately 30' southeast of the airshaft. The footing measures $2'-4"x3'-\frac{1}{2}"$ and had two threaded bolts on its top surface that presumably served as tie-downs originally (see Figure 15).

Figure 15. (TOP) Photograph of the tipple (Feature 4) location at the mine site. Other than the concrete footing shown here and post holes, nothing remains of the tipple structure. (BOTTOM) View of the concrete pad (Feature 5) that is suspected to cover the airshaft for the mine. The pad is located on top of the bluff, above the main building complex (FRR December 2002).

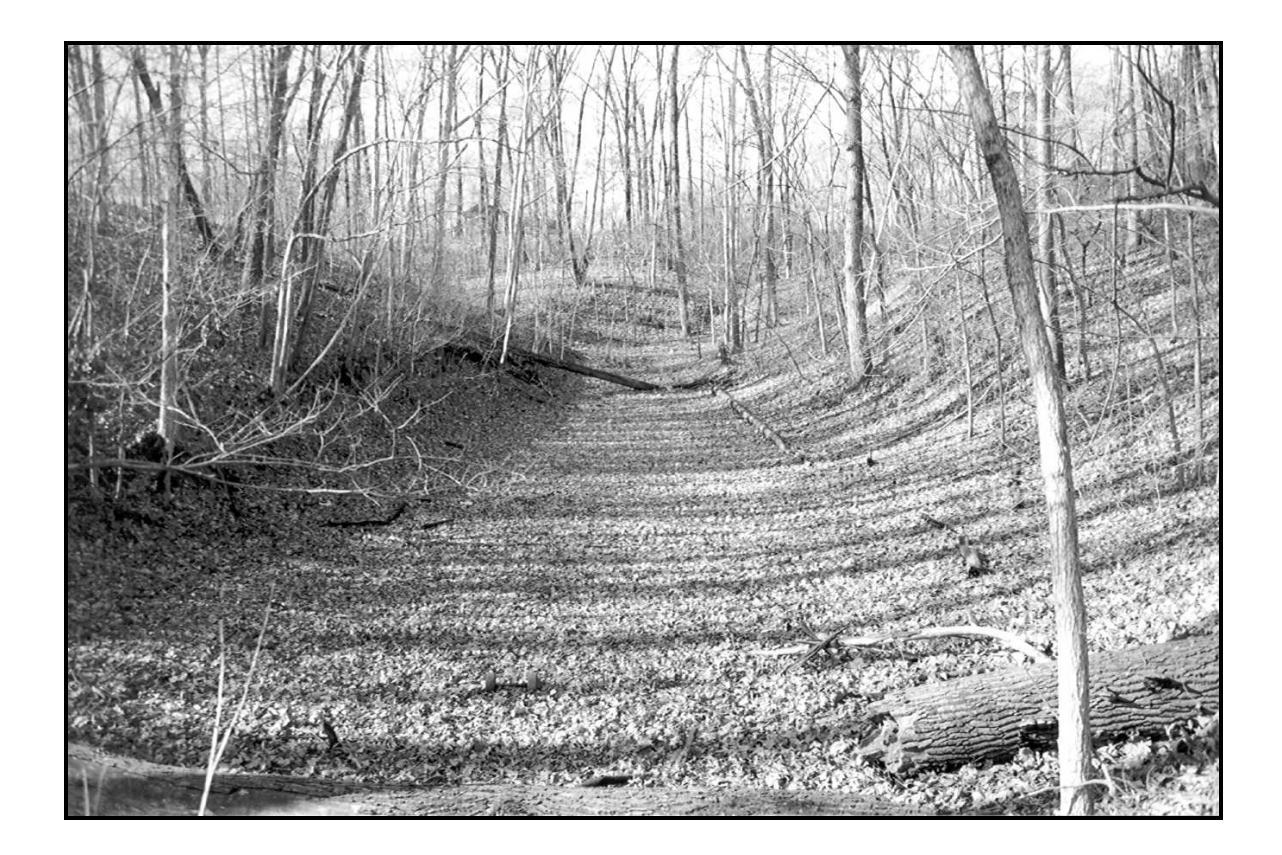
<u>Landscape Features</u>: There are several landscape features associated with the mine. One of these is a retaining pond, which was used to store water pumped out of the mine. The pond is located due south of the mine building complex and occupies a surface area approximately one-half acre in size (80'x250'). It was created by building an earthen dam across the mouth of a ravine (see Figure 16).

Figure 16. View of the dry retaining pond at the mine site. The pond, now empty, was formed by building an earthen dam across the head of a ravine (FRR December 2002).
