**ILLINOIS DEPARTMENT OF NATURAL RESOURCES
CULTURAL RESOURCE MANAGEMENT PROGRAM
ABANDONED MINED LANDS RECLAMATION
CULTURAL RESOURCES EVALUATION:**

**YOUNG SHAFT SITE (11MS2183)
RURAL MADISON COUNTY, ILLINOIS**

prepared by
Fever River Research, Inc.
Springfield, Illinois

October 2005

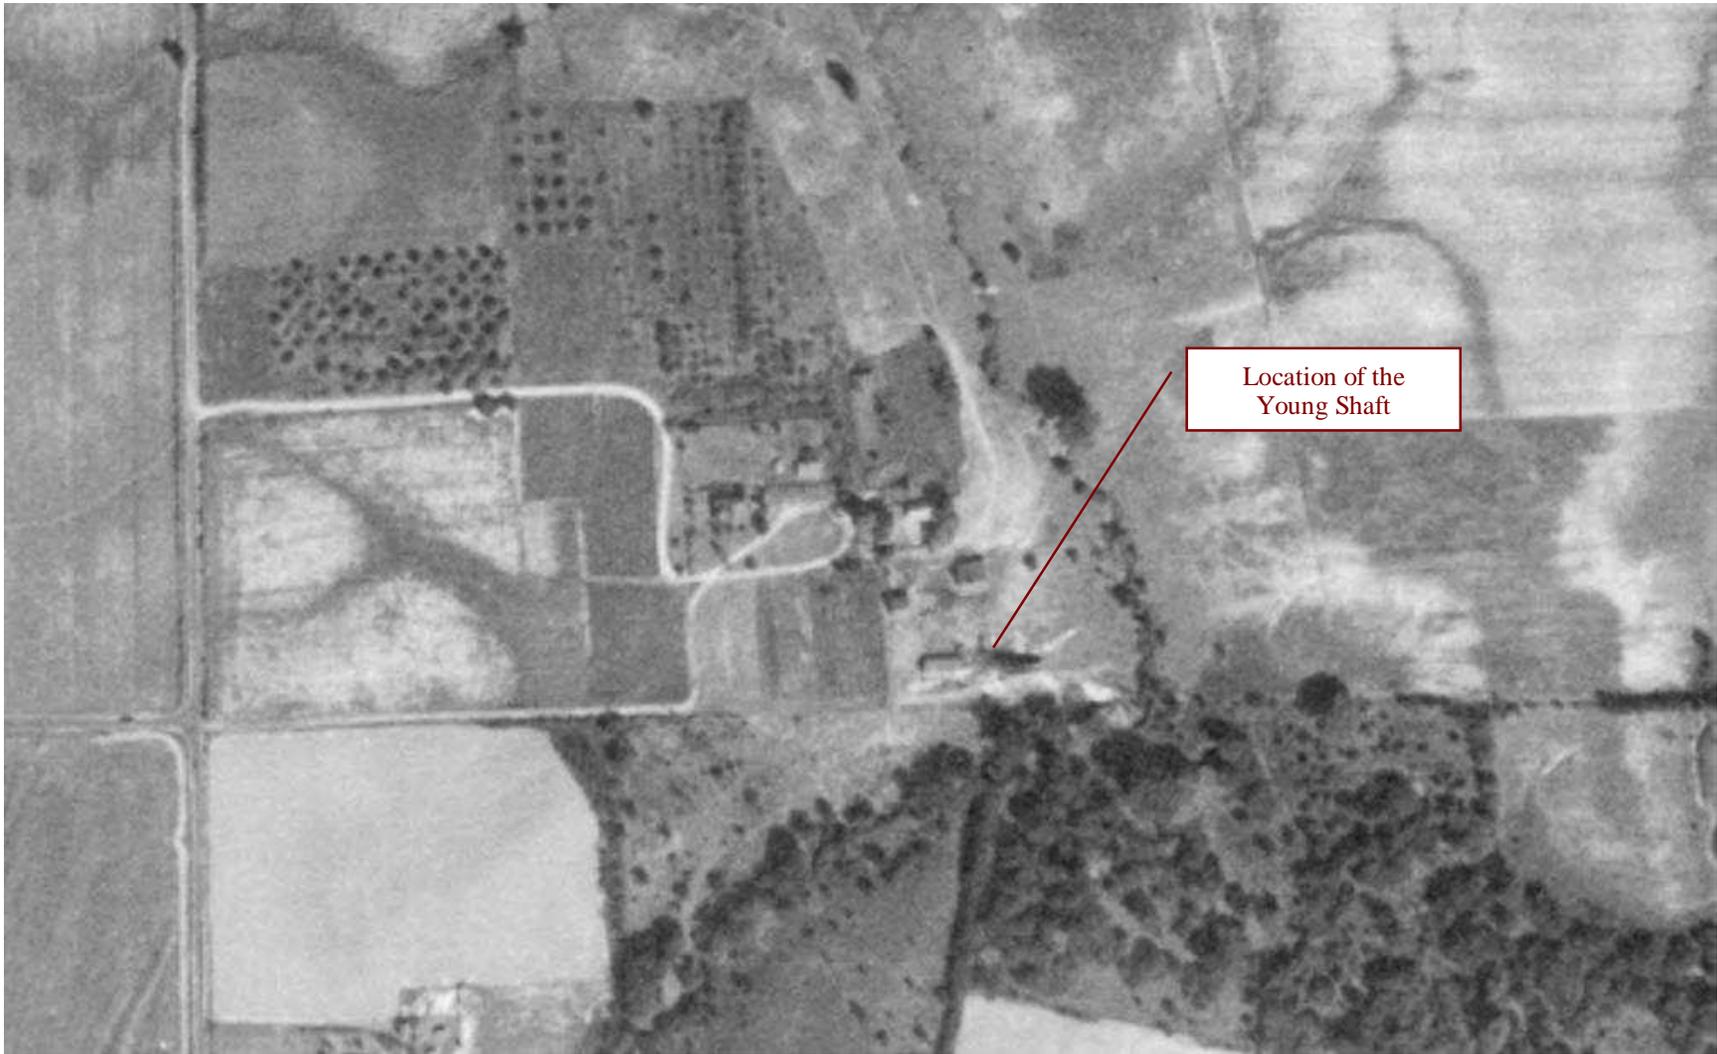
Figure 3. A 1941 aerial photograph showing the location of the Young Shaft and immediate environs (United States Department of Agriculture 1941).

A 1941 aerial photograph of the mine area shows the tipple complex and hoist engine house as well as a number of other buildings a short distance to the north (see Figures 3 and 4). Some of these structures are undoubtedly mine-related, but others appear to be

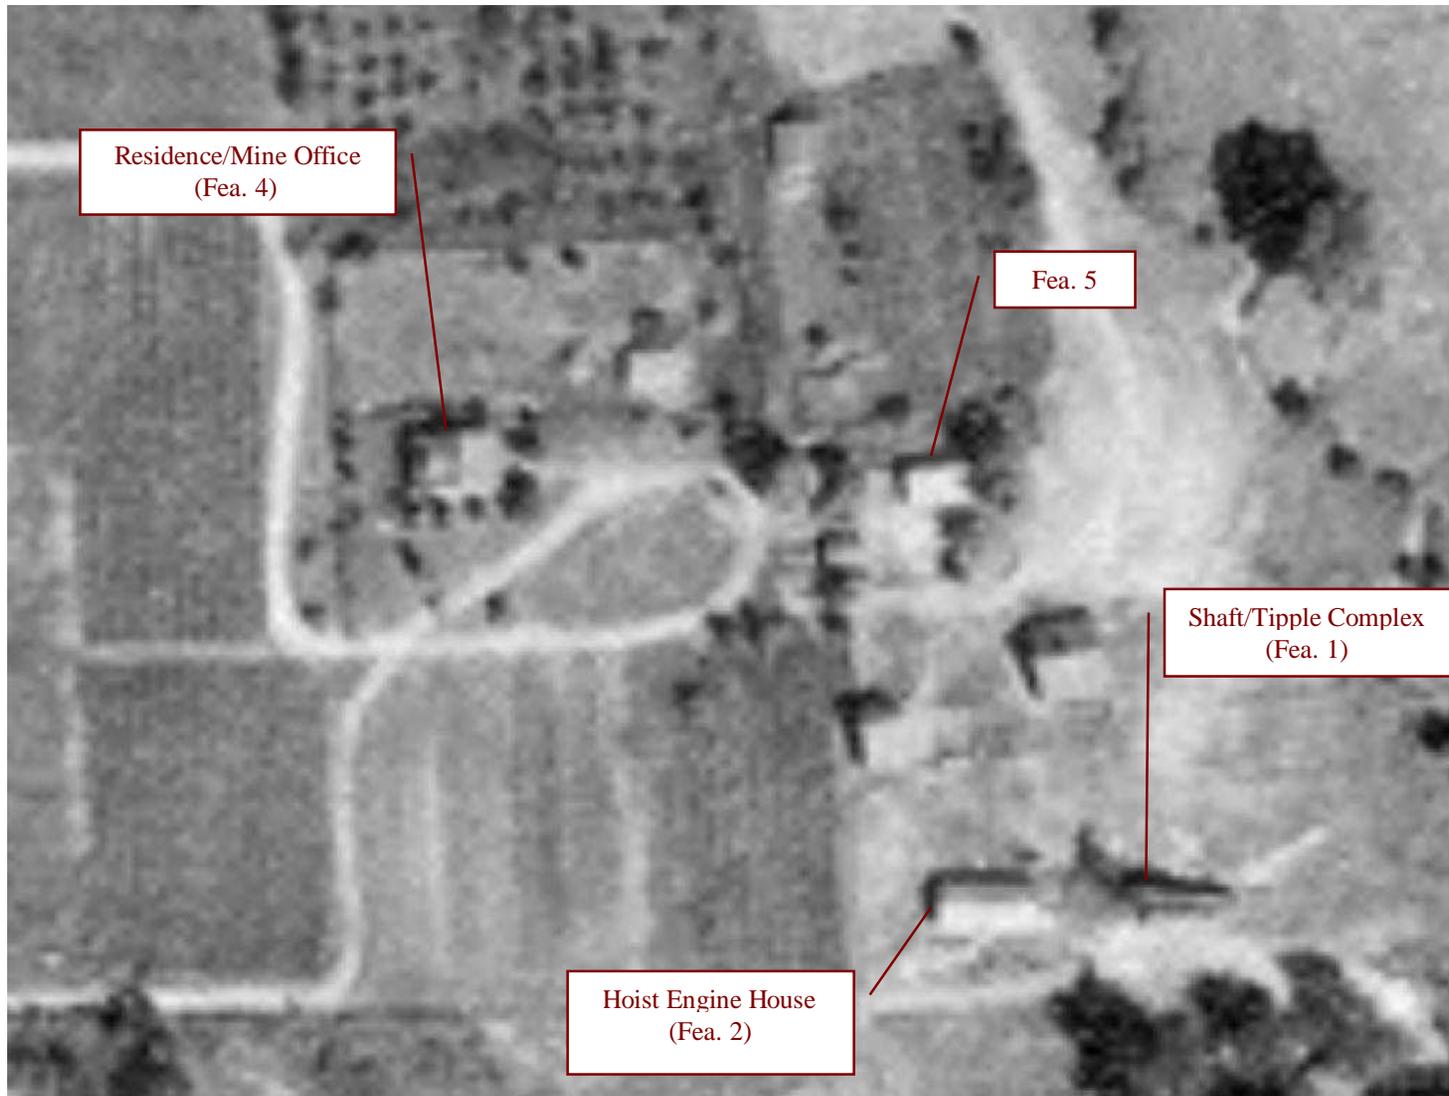
Figure 4. Detail of a 1941 aerial photograph showing the Young Shaft Site. A number of key features identified during the survey have been labeled. Features 3 and 6, which are not clearly illustrated here, are not labeled (United States Department of Agriculture 1941).

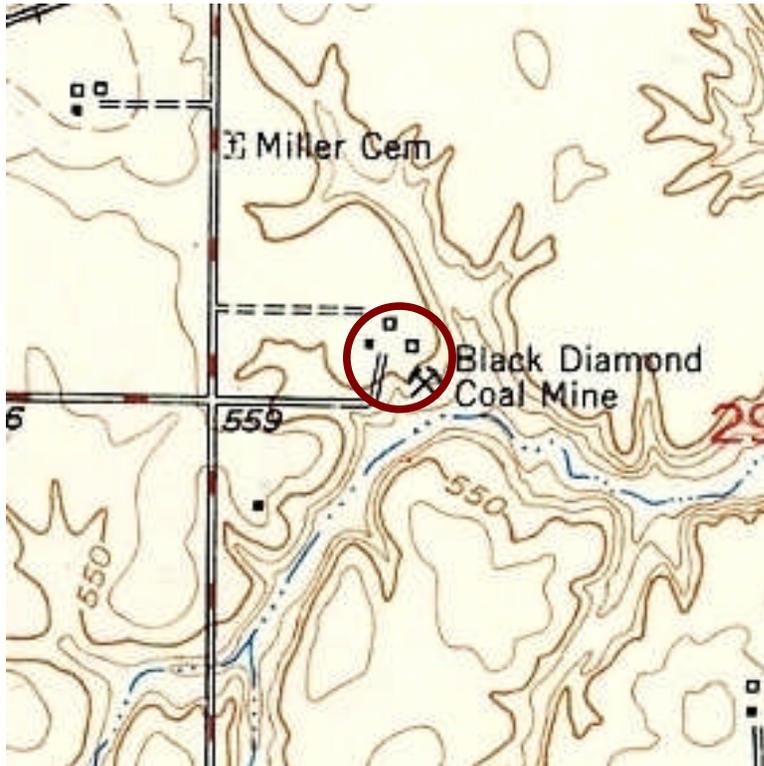
Figure 6. Comparison of two USGS 7.5-minute topographic maps illustrating the location of the Young Shaft Site (circled in red). The map at LEFT was based on a 1948 survey and was published in 1950. It clearly indicates the location of the mine shaft, which is labeled as the “Black Diamond Coal Mine.” The image at RIGHT was surveyed and published in 1954 and marks the shaft with a large cross-hatched square. The hoist engine house also is indicated on this map, to the left of the shaft.

The 1950 Edwardsville USGS 7.5-minute topographic quadrangle map has the mine symbol at the location of the Young Shaft labeled as Black Diamond Coal Mine (see Figure 6). One would assume that this appellation was based on fairly current and/or accurate information at the time the data for this map was compiled (USGS, Edwardsville Quadrangle 1950). Another topographic map, published in 1954, also designates a mine shaft at the site, though no name is assigned to it (see Figure 6). In addition, this map illustrates the hoist engine house located west of the shaft (USGS, Edwardsville Quadrangle 1954).

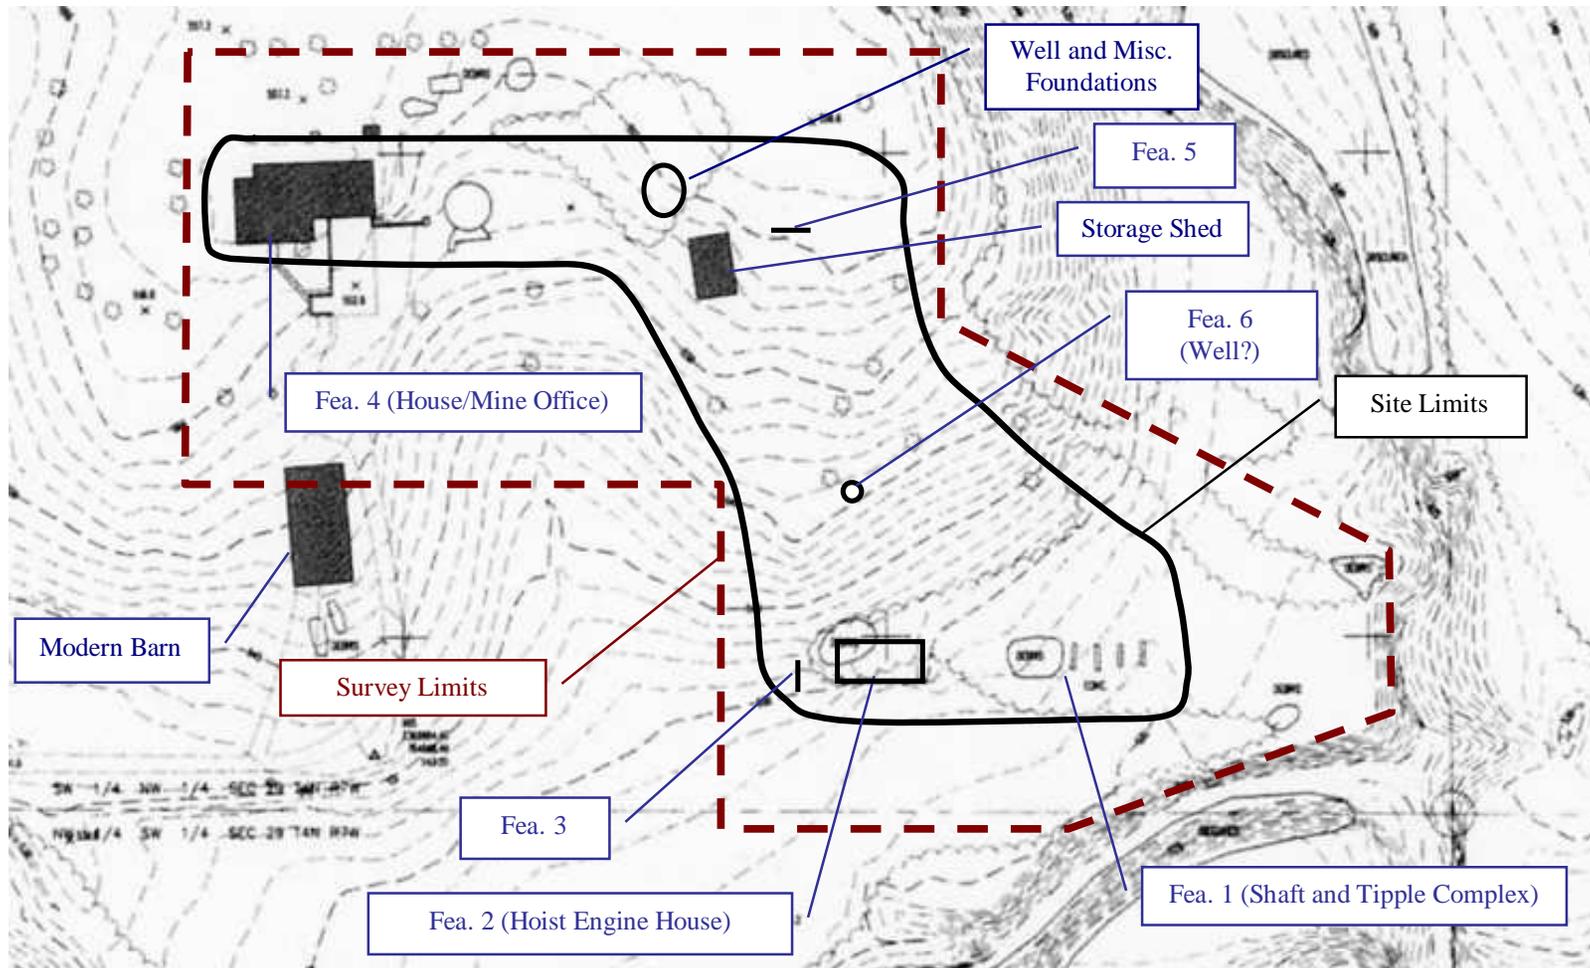
Figure 9. Enlargement of previous figure, showing the area surveyed, site limits, and features identified. Feature numbers have been assigned to buildings and structural remains known to be, or potentially, associated with the mine (Illinois Department of Natural Resources 2005).

Sites/Features Found: The survey resulted in the documentation of a tipple complex (including intact headframe), the ruins of a hoist engine house, and several other features potentially associated with the Young Shaft coal mine. Digital images of these features are attached below; figure captions contain additional commentary to supplement the following feature descriptions. See Figure 9 for feature locations.

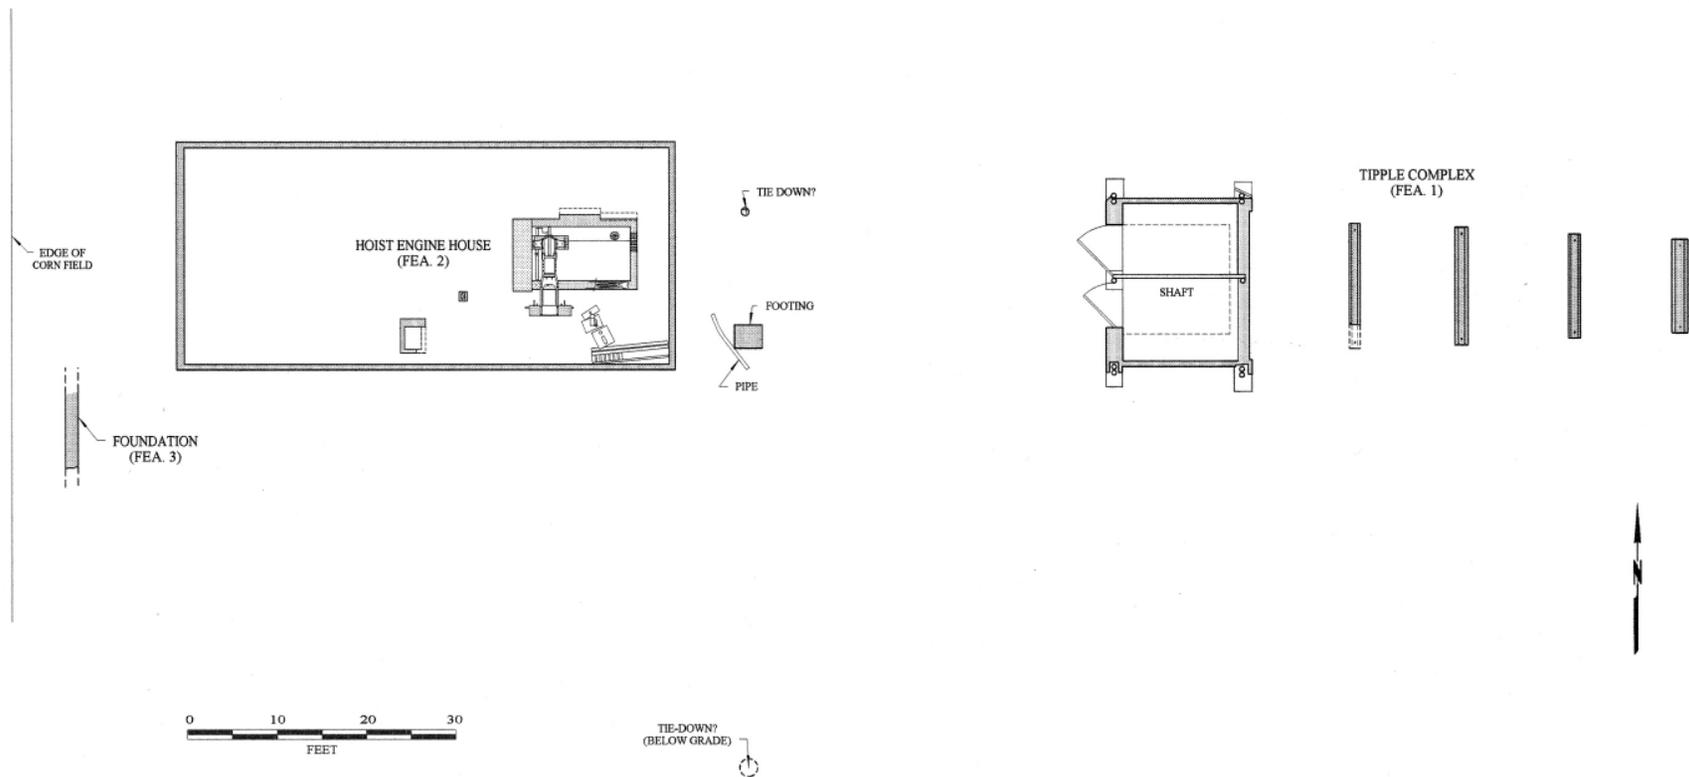
Figure 10. Plan of the tippel complex (Feature 1) and hoist engine house (Feature 2) at the Young Mine Site (FRR 2005).

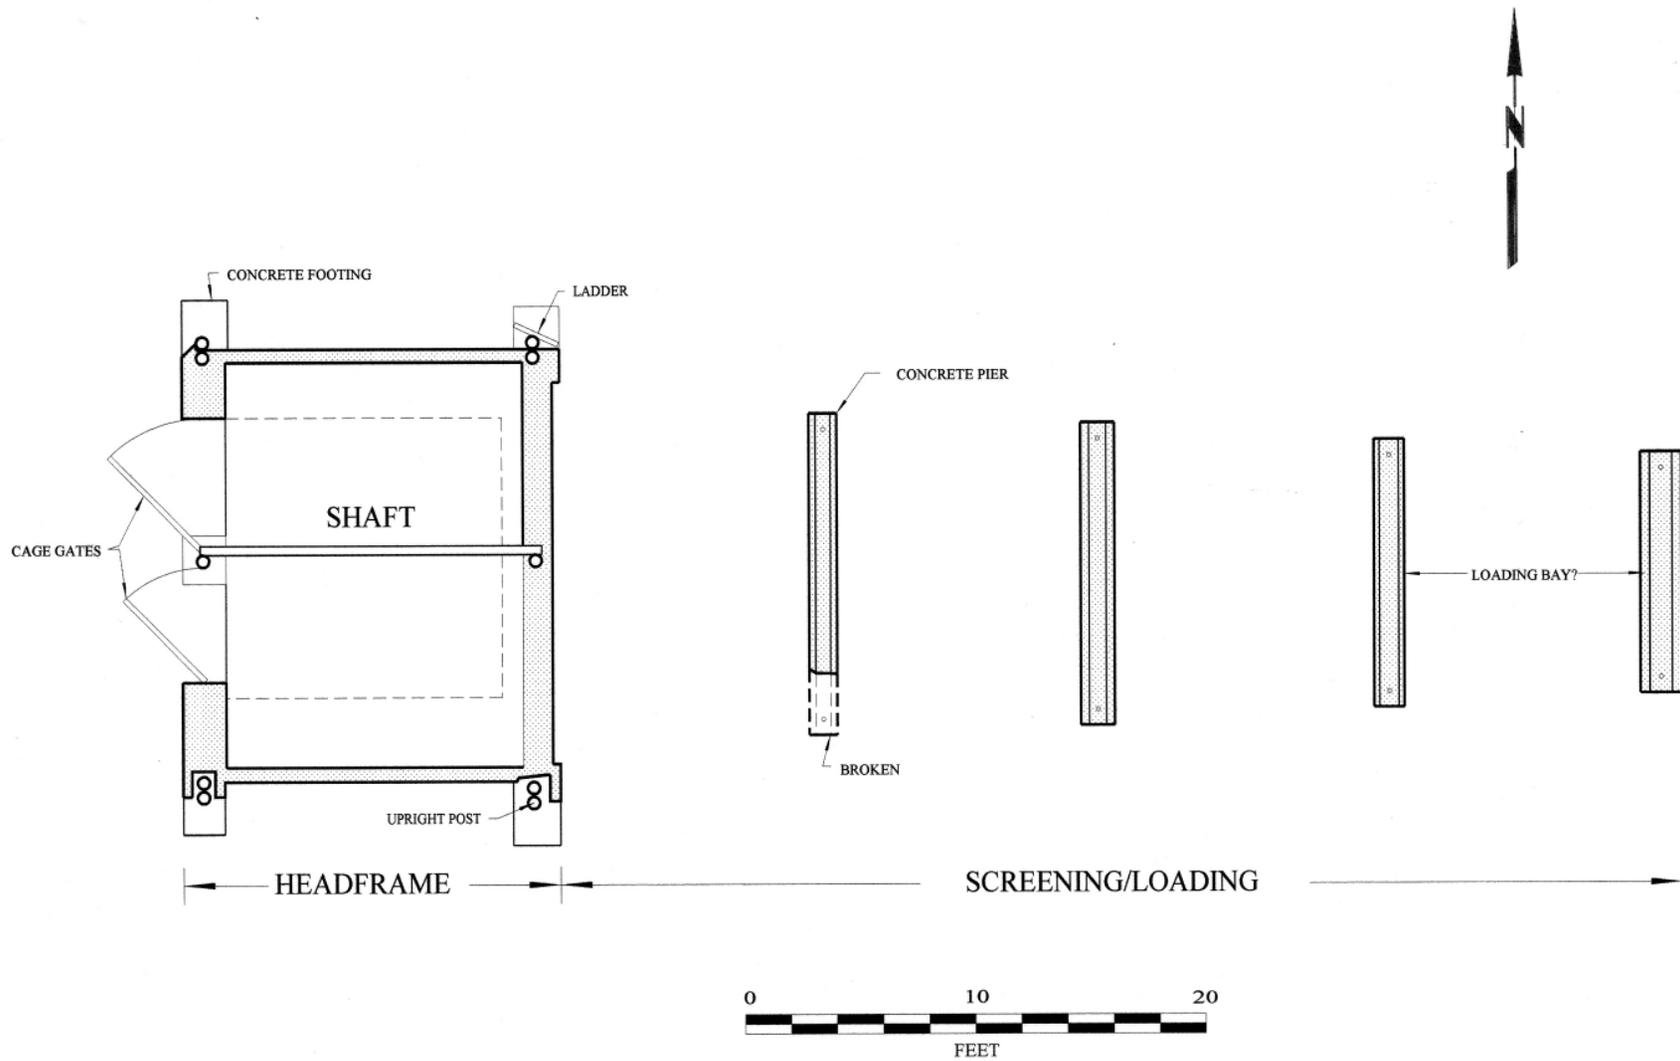
Feature 1 is the tipple complex of the Young Shaft mine. The tipple is aligned on an east/west axis and is comprised of three distinct sections, including 1) a hoisting shaft, a 2) steel-frame headframe located over the shaft, and 3) a series of concrete footings that formerly a superstructure in which coal was screened and sorted. See Figures 10 through 28 for plans and photographs of the tipple. The hoisting shaft is concrete lined and measures approximately 12’ square. It is filled with water to within less than 10’ of the ground surface. After the mine was abandoned, the shaft was rudely covered with tree limbs and steel sheeting. The headframe is of steel construction and has battered (or canted) sides for stability. It measures 21’-0”x14’-10” at the base and tapers up to a platform measuring 11’-6” square. The structure stands approximately 43’ tall at the height of the sheave platform and 50’ to its peak. The structure appears to have been designed to allow a dual hoisting system, in which one cage was lowered into the mine as the other was raised. Such a system usually utilized two sheaves (one per cage), but only one has been documented at the site; this now lies at the base of the tipple. The sheaves sat on a wood deck framed with 1-½ “x11” joists and 12-½”-square beams. They protected from the elements by a gable roof, of which only the steel frame remains. Each of the cages could be accessed through steel gates located at grade along the west side of the tipple.

Figure 11. Plan view of the tippel complex (Feature 1) (FRR 2005).

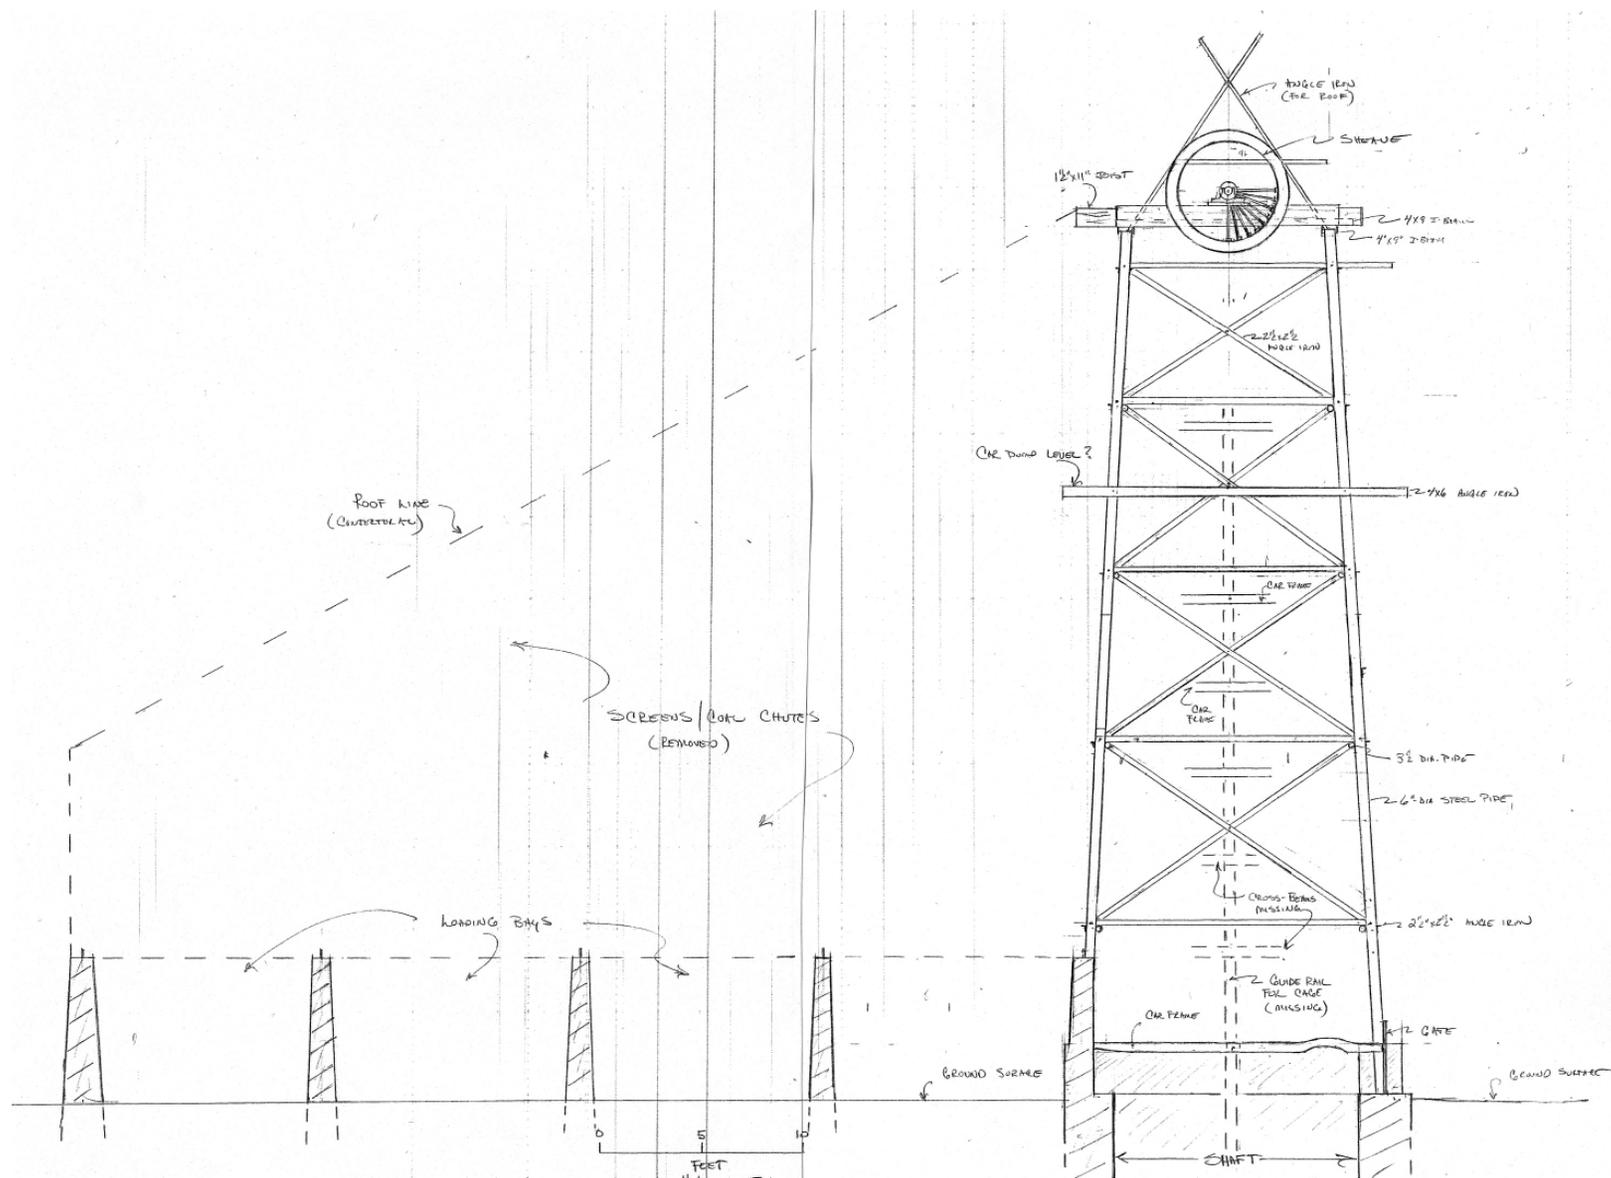
Figure 12. Longitudinal view of the tippel complex, looking south (FRR 2005).

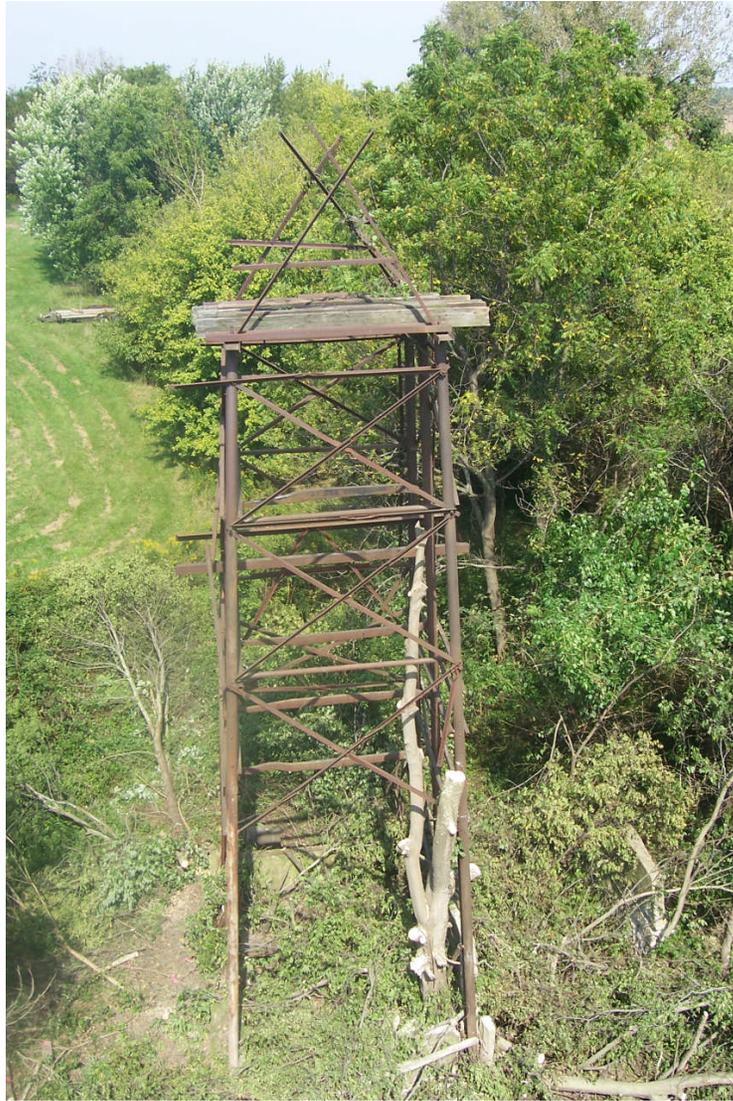
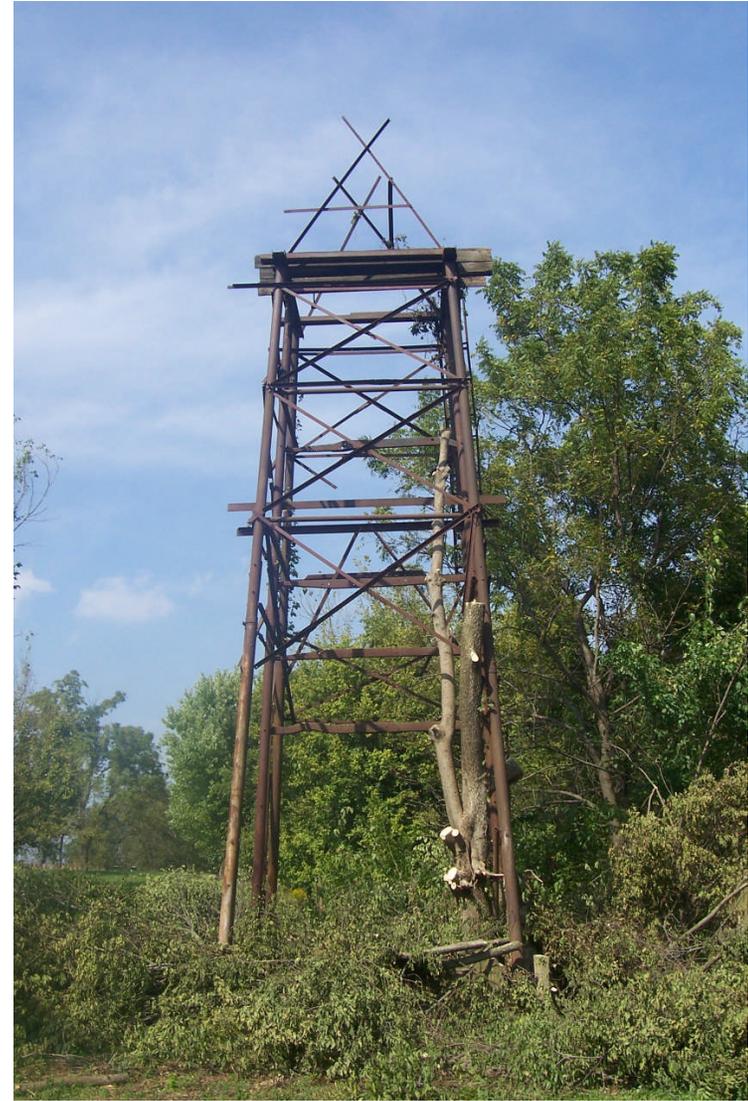
A variety of steel stock was used in the construction of the headframe, including 6” diameter piping for the main uprights and 3-½” piping and 2-½” angle iron for horizontal and diagonal bracing. The upper ends of the uprights are tied together with 9”x12” I-beams. Salvaged car frames were used for the cross-beams on which the cage guide-rail was mounted. One these car frame sections had a serial number plate attached to it, whose placement indicates that it belonged to a Buick manufactured between 1926 and 1937.¹ The uprights rest on concrete footings. A raised concrete foundation wall (standing about 2’-6” tall) runs around the base of the headframe, providing a barrier from the shaft.

Figure 13. Two views of the intact headframe of the tippel complex at the Young Mine Site, showing the southern elevation of the steel-frame structure (FRR September 2005).

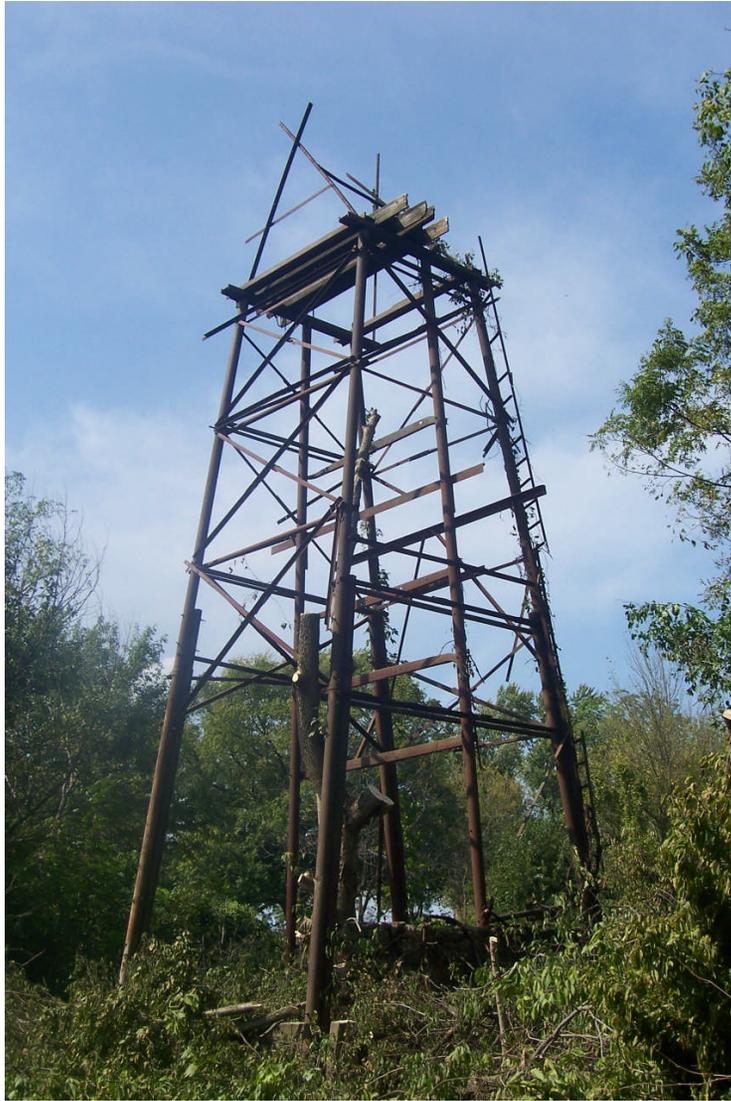
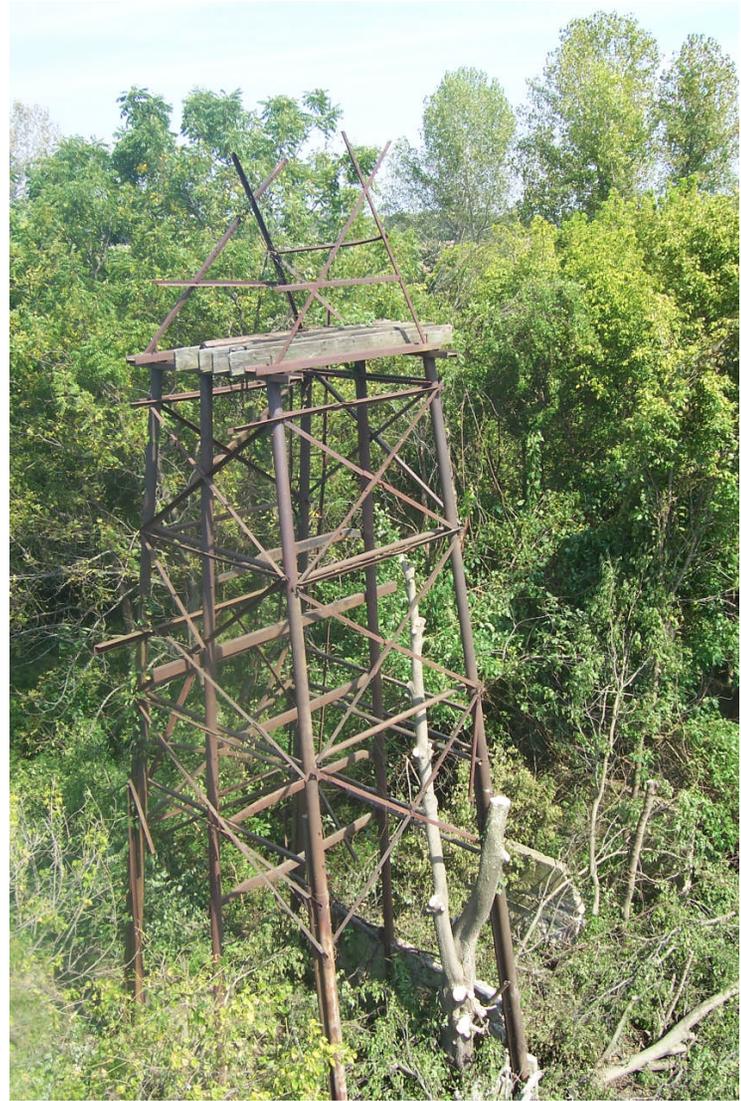
Figure 14. Views of the southeast (LEFT) and southwest (RIGHT) corners of the tippel headframe (FRR September 2005).

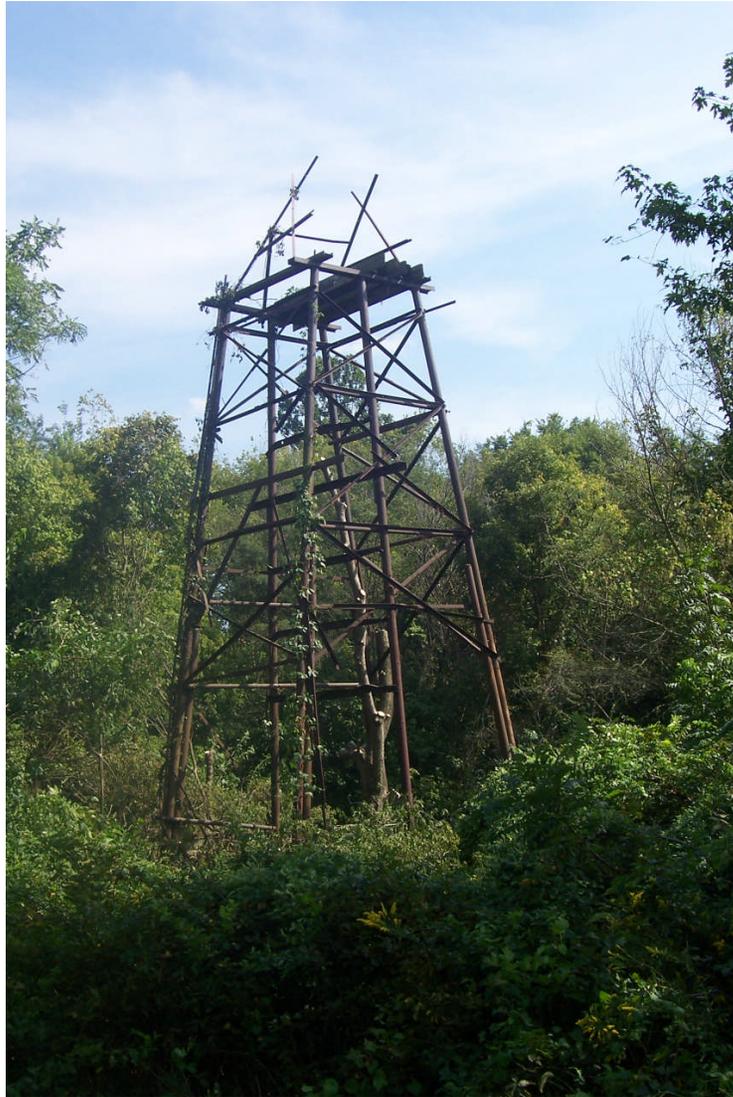
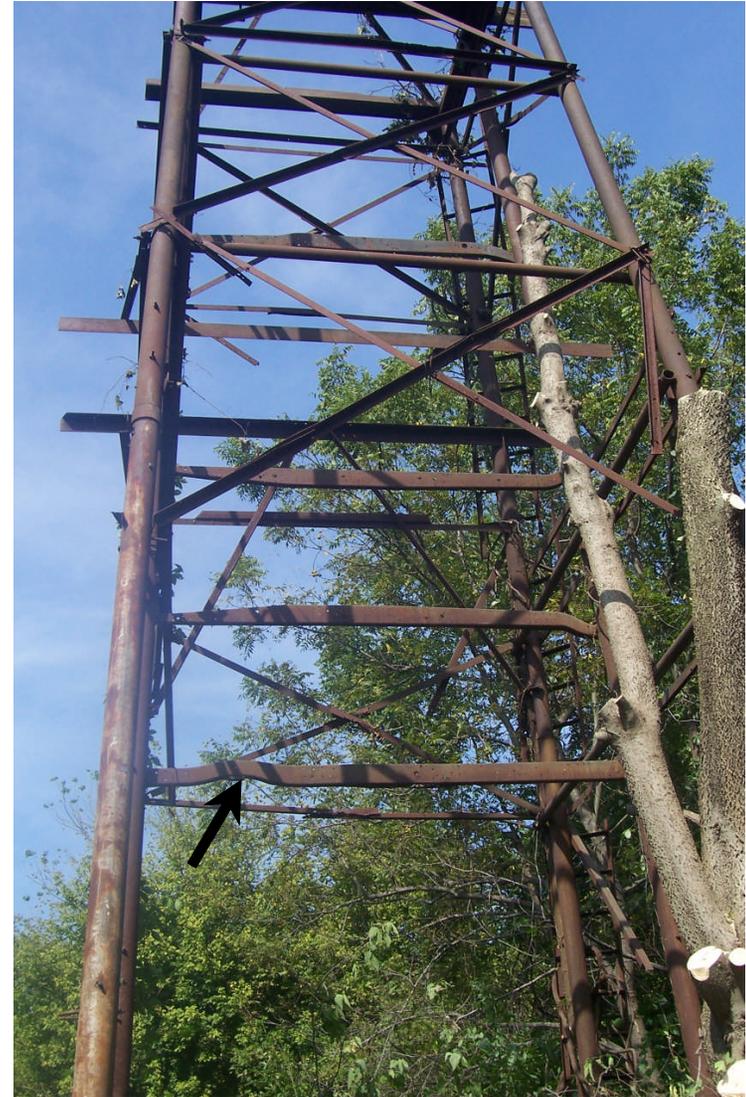
¹ The plate is stamped “Buick / 1515572.”

Figure 15. (LEFT) View of the headframe, looking southeast and showing the west and north elevations. (RIGHT) View of the steel beams used to support the cage guide rail. Some of these beams (note arrow) were salvaged from a Buick automobile (FRR September 2005).

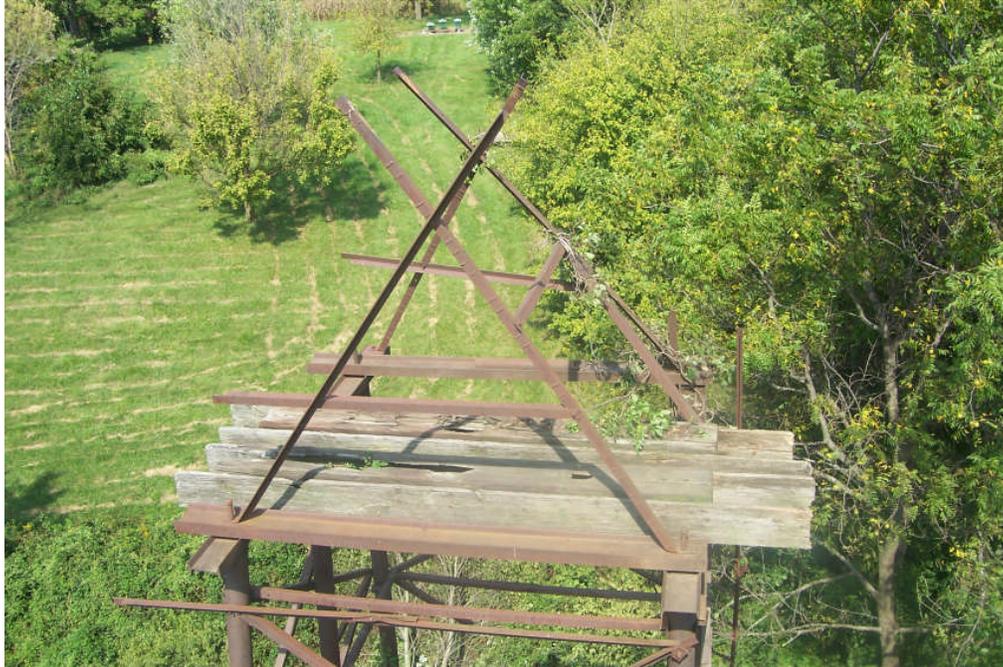
Figure 16. View of the platform at the top of the headframe, on which the sheave(s) rested. The platform appears to have been roofed over originally (FRR September 2005).

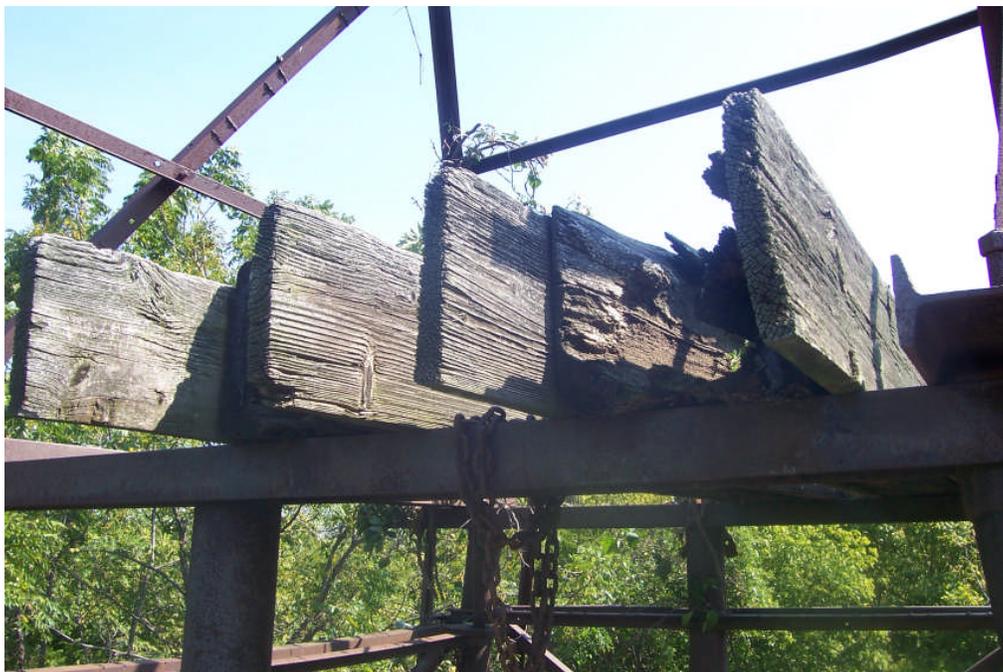
Figure 17. Detail of the sheave platform. The deck is framed with 1-1/2"x11" floor joists, in between which 12-1/2"x12-1/2" beams are laid (FRR September 2005).

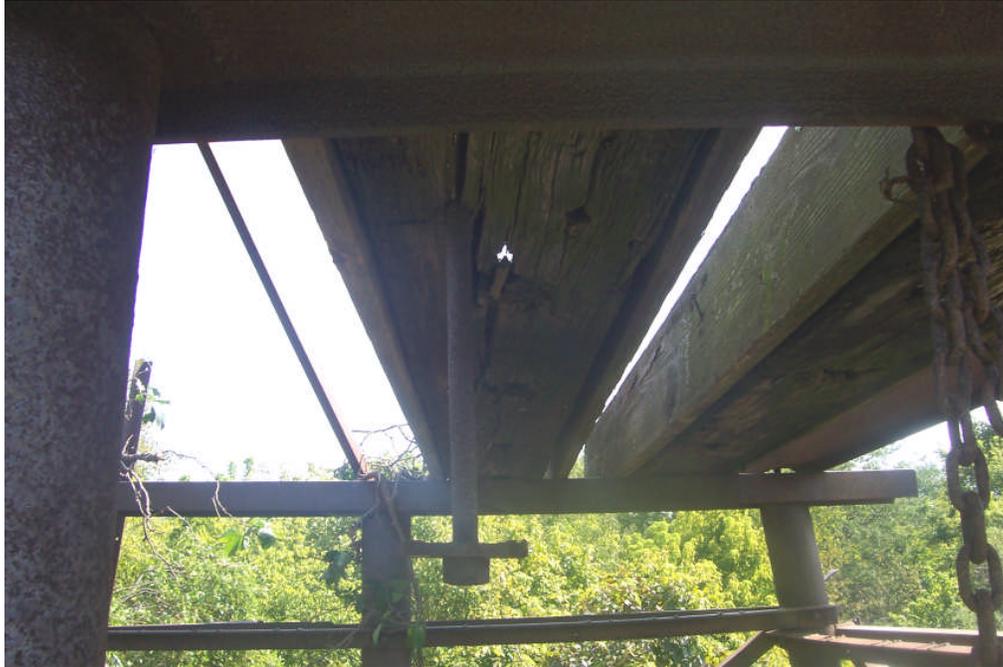
Figure 18. Another detail of the sheave platform, showing one of the bolts by which the sheave was attached to the deck (FRR September 2005).

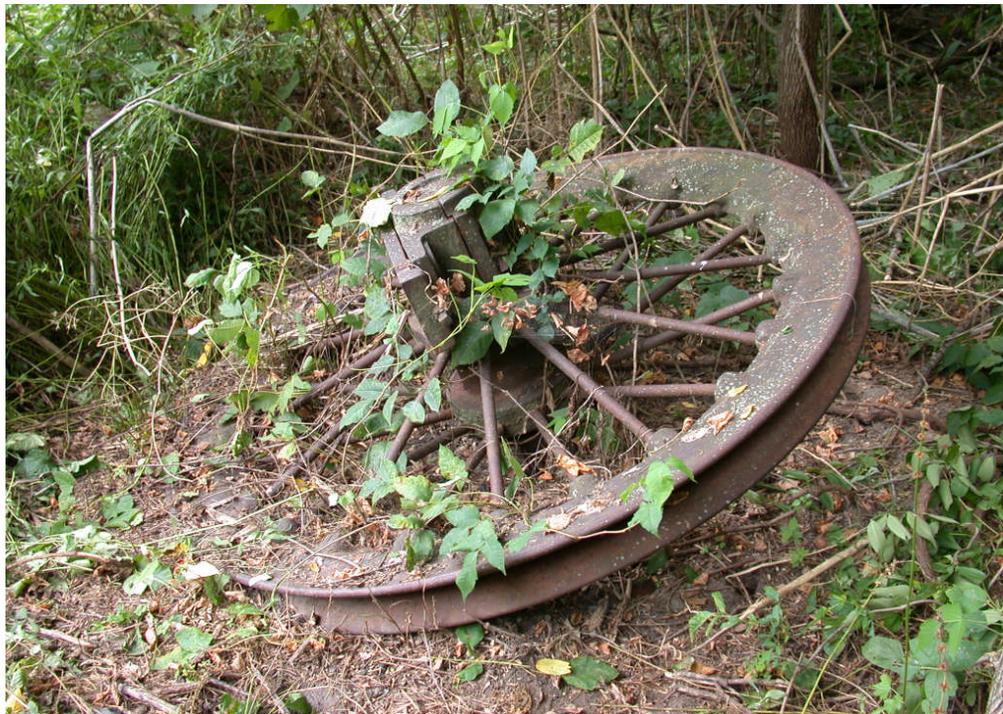
Figure 19. Photograph of a sheave associated with the headframe. This now lies on the ground at the bottom of the structure (FRR September 2005).

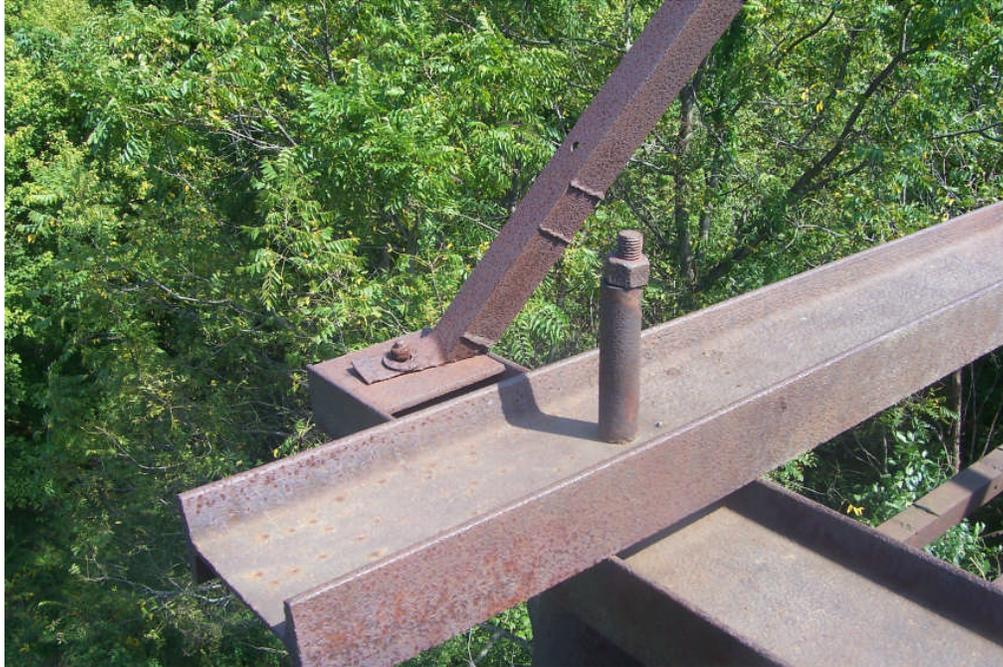
Figure 20. Framing detail showing the northwest corner of the sheave platform. Steel I-beams were used tie the upper ends of the corner posts together, as well to support the sheave platform (FRR September 2005).

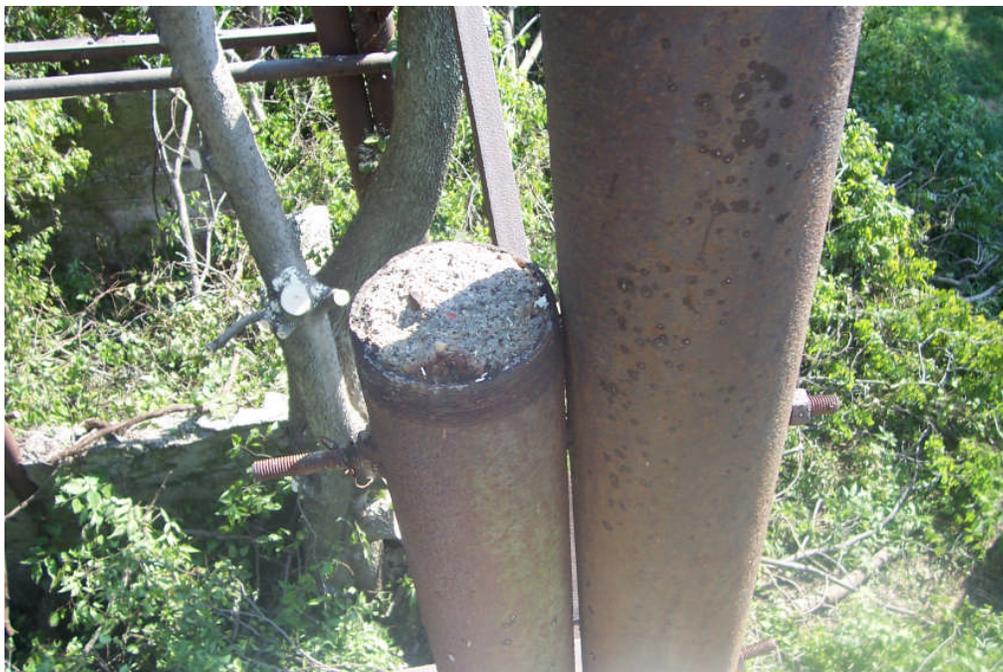
Figure 21. The corner posts of the headframe consist of 6'-diameter steel piping, which is doubled up on the lower half of the structure, as seen above (FRR September 2005).

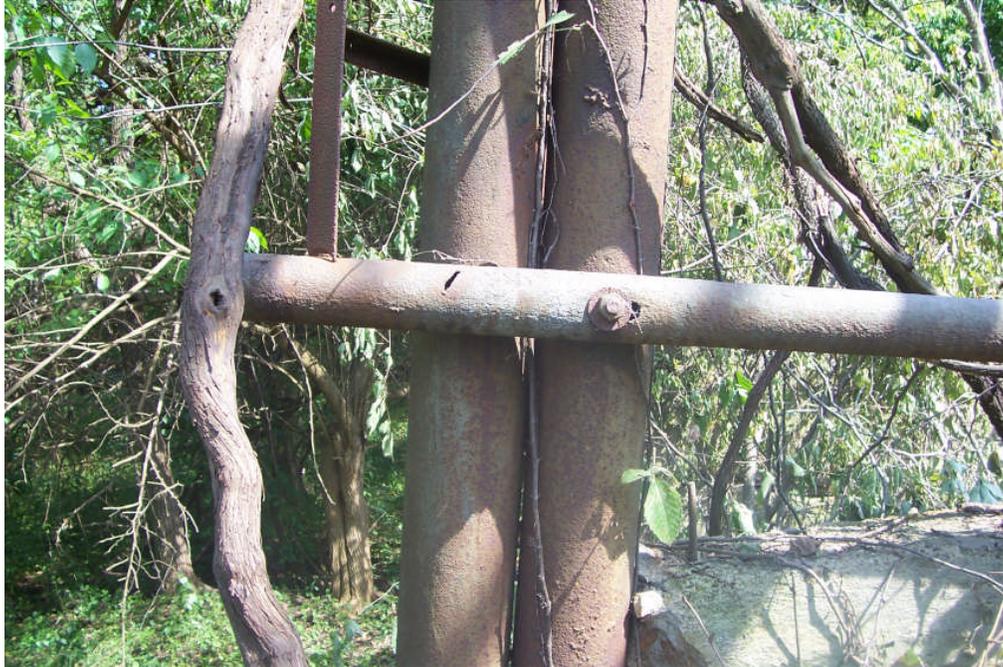
Figure 22. The corner posts are ties together, in part, with 3-1/2" diameter piping such as that shown above. Such piping was used for horizontal bracing on the structure. The base of a ladder ascending the northeast corner post also is shown (FRR September 2005).

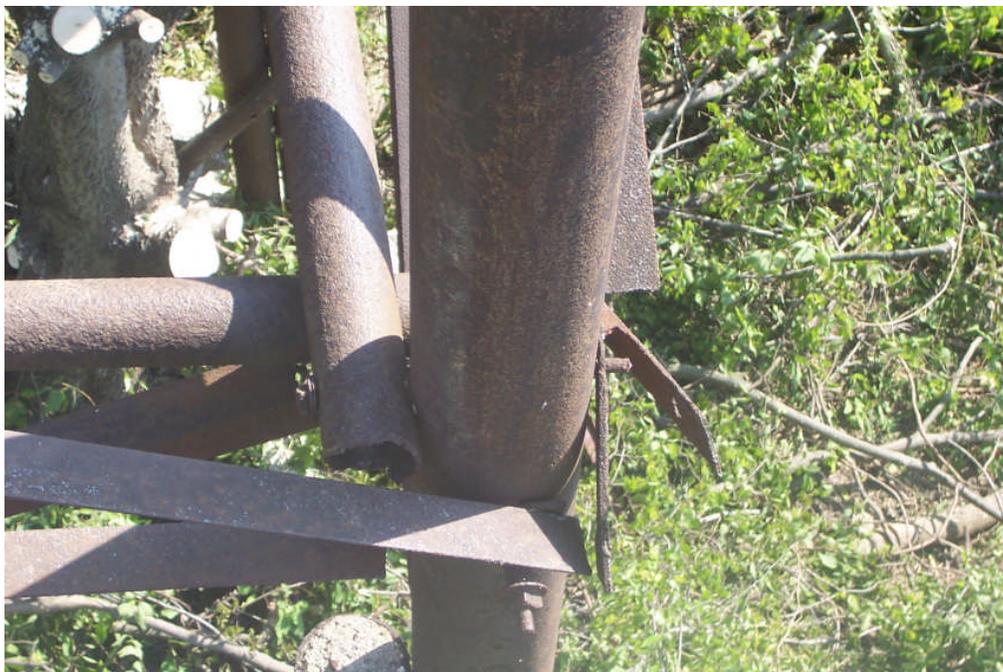
Figure 23. Framing detail showing juncture of horizontal and diagonal bracing with southwest corner post (FRR September 2005).
