**ILLINOIS DEPARTMENT OF NATURAL RESOURCES
CULTURAL RESOURCE MANAGEMENT PROGRAM
ABANDONED MINED LANDS RECLAMATION
CULTURAL RESOURCES EVALUATION:**

**YOUNG SHAFT SITE (11MS2183)
RURAL MADISON COUNTY, ILLINOIS**

prepared by
Fever River Research, Inc.
Springfield, Illinois

October 2005

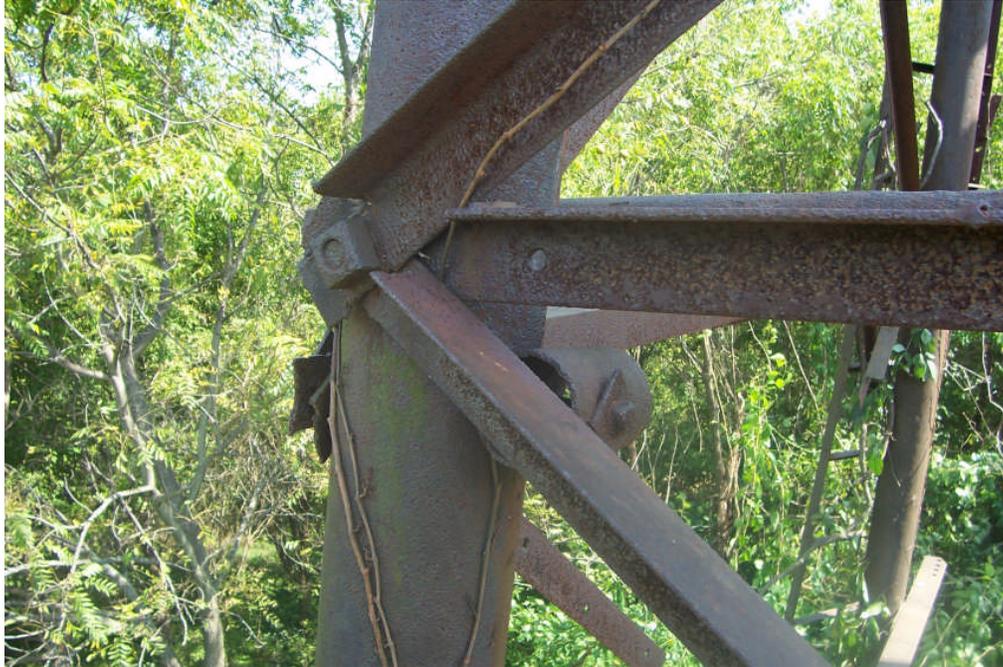
Figure 24. Detail of the northwest corner post, showing 2-1/2" angle iron used for diagonal and horizontal bracing (FRR September 2005).

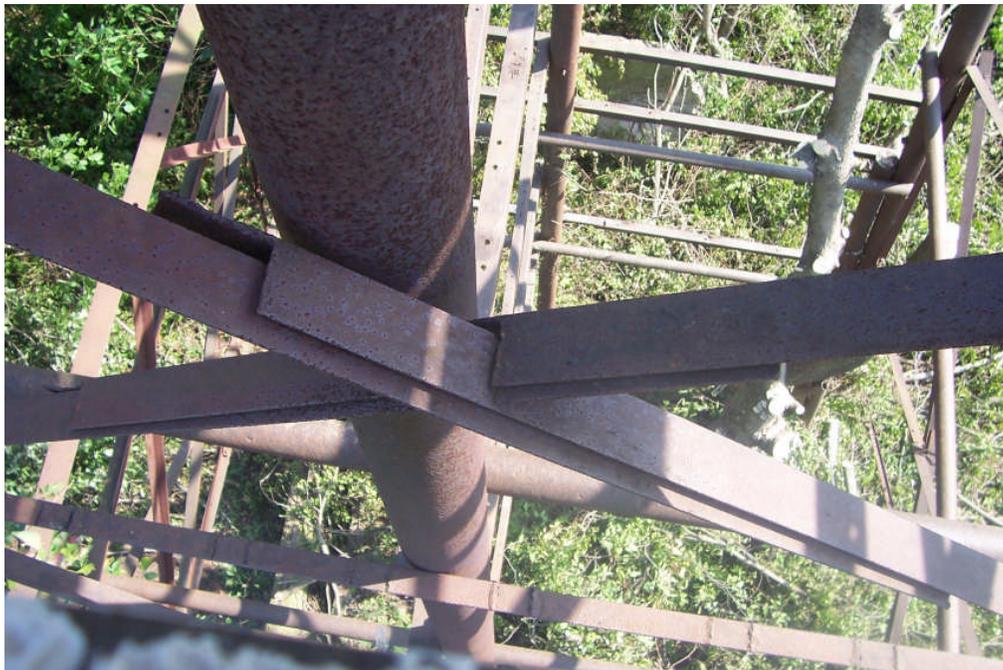
Figure 25. View of center post on west elevation, showing bracing (FRR September 2005).

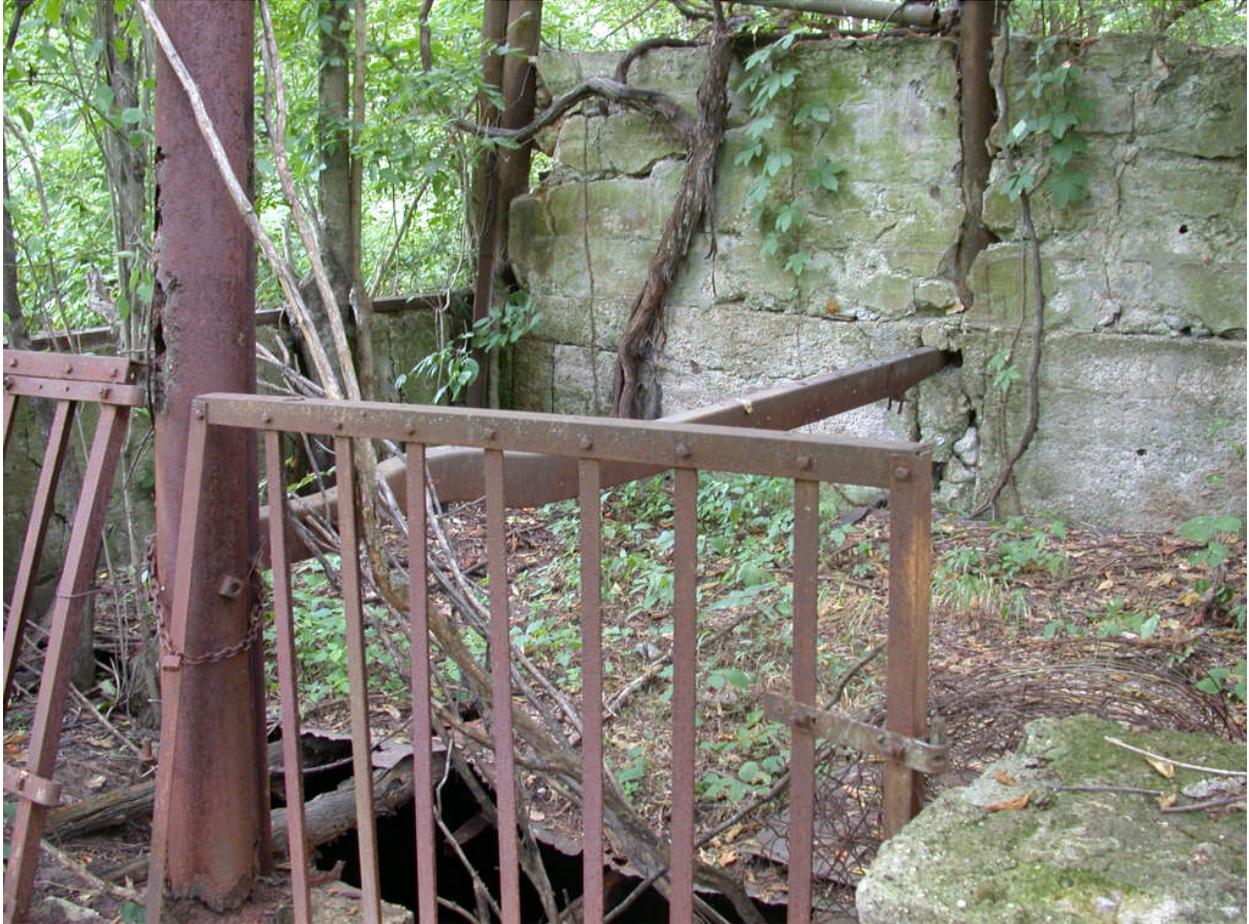
Figure 26. View of the gates at the base of the headframe, on its west side. These gates allowed access to two paired cages, by which men, material, and coal were hoisted. This photograph also one of the beams (in this a case part of a salvaged car frame) to which the guide rails for the cages were attached (FRR August 2005).

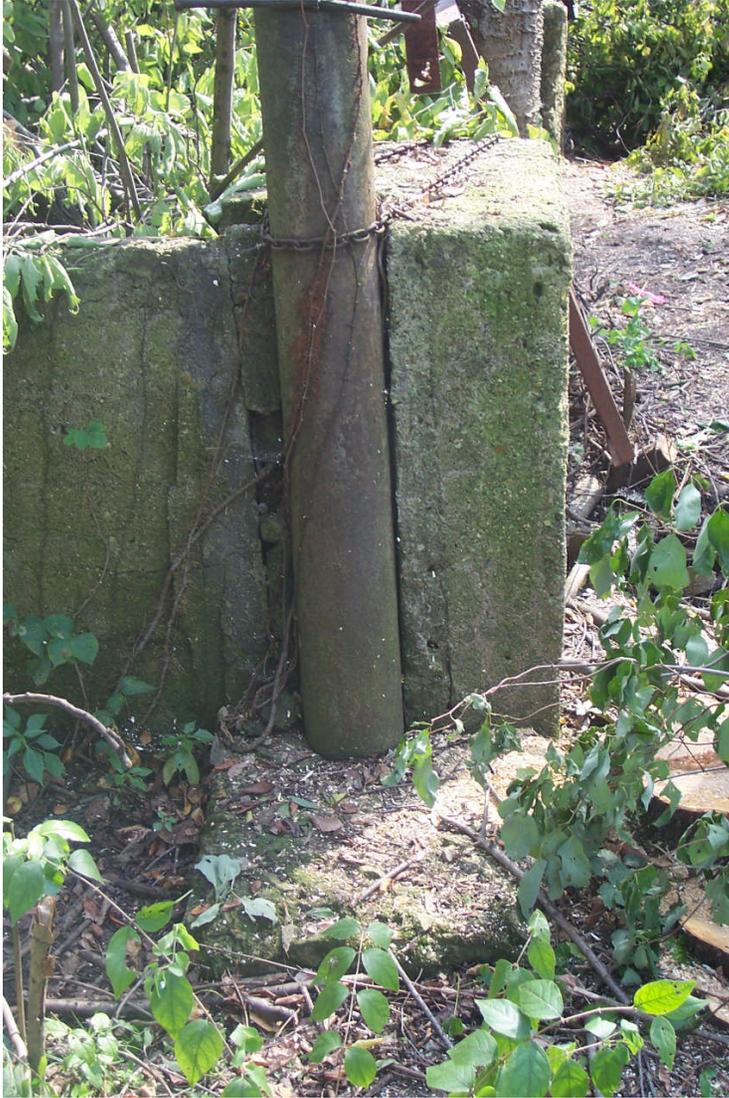
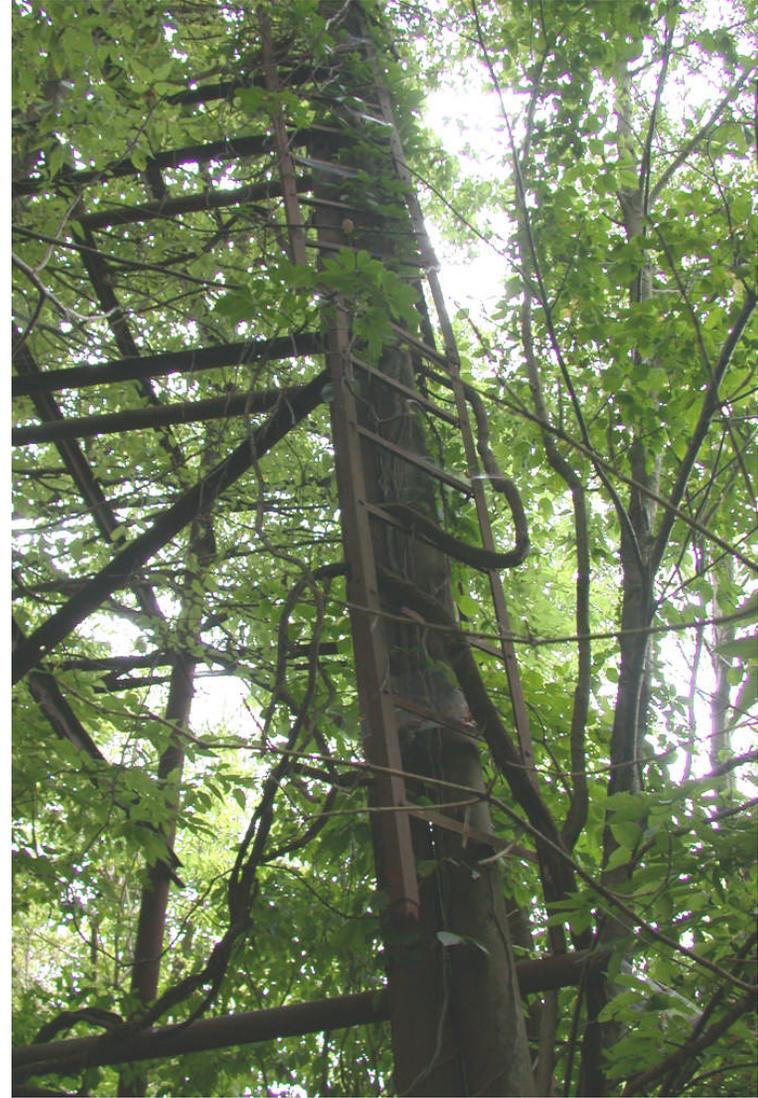
Figure 27. (LEFT) View of the base of the northwest corner post of the headframe, showing the concrete footing in which the post is set and the concrete foundation wall surrounding the shaft. (RIGHT) Photograph of the ladder on the northeast corner post (FRR August and September 2005).

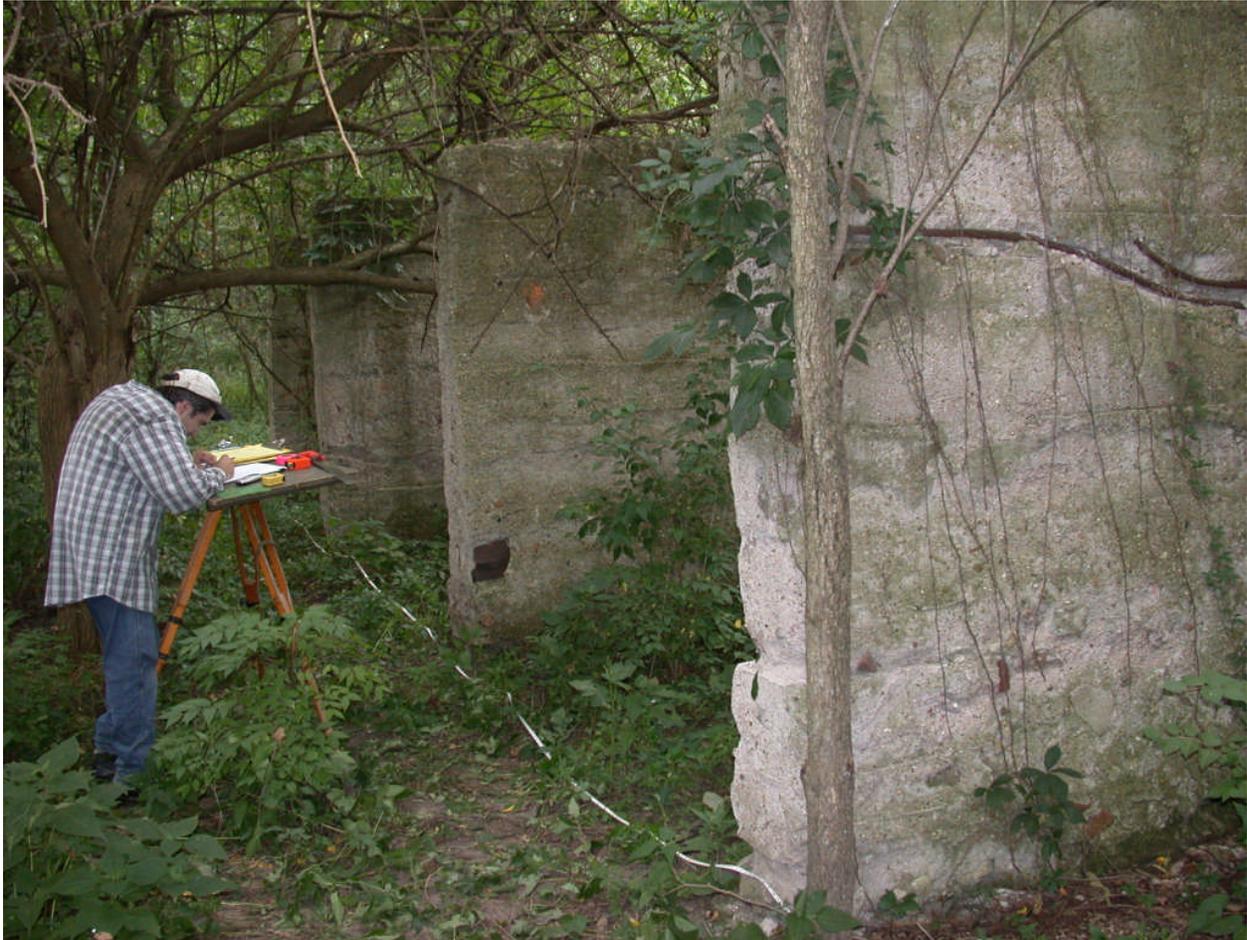
Four large concrete footings radiate out to the east of the headframe. The footings have battered sides and stand about 7' tall. These are suspected to have supported an elevated superstructure in which the coal was dumped (after being hoisted up through the headframe) and then screened and sorted according to size. The layout of the footings suggests that there may have been three or four driveways (or bays) through which trucks could pass under the superstructure and be filled with coal. The footings were constructed very expeditiously, having brick, stone, steel kegs, steel cable, and even tree branches mixed in with the concrete. A similar mix of materials was used in the concrete wall around the hoisting shaft.

Figure 28. Photograph of the concrete piers extending east of the headframe. These piers are suspected to have supported the section of the tippie in which coal was screened and separated into hoppers by size (FRR August 2005).

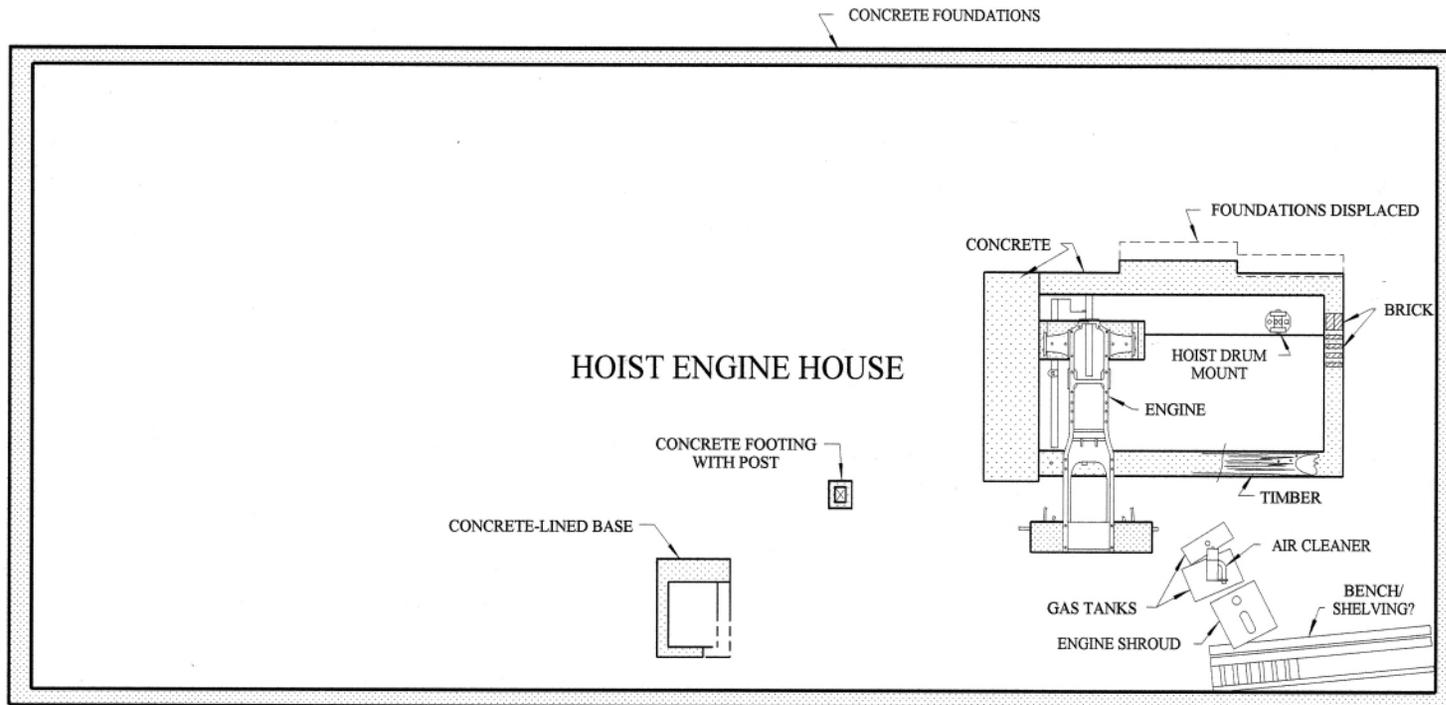
Feature 2 is the remains of a hoist engine house located 48' due west of the tipple (see Figure 29 and 30). USGS topographic maps document that this building was still standing as late as 1954, but it has since been demolished (or decayed) down to its foundations. Portions of the feature are covered with debris, and the whole is extremely overgrown with dense vegetation. The building measures 25'-2"x53'-0". The perimeter foundations are of poured concrete and vary in width between 5" and 7"—a narrow dimension suggesting that the walls were of frame (rather than masonry) construction. Most of the interior floor space is paved with concrete. Several internal features are still visible and partially intact, including remnants of the hoist engine at the east end of the building. Although the arrangement of the hoist engine within the building is similar to that documented at previously documented mine sites, the power source used here is very distinct. Hoist engines commonly were powered by steam and, later on, by electricity. At the Young Shaft, however, a gasoline tractor engine provided the motive power for the drum on which the hoisting cables wound. The tractor appears to have been literally parked in the building, and then had concrete footings poured around its axles; once the concrete had set, the tires were removed. At some point after the mine was abandoned, the hoisting drum was salvaged out, along with the upper half of the engine body. The lower half of the engine remains in place, along with a small section of the hoist drum frame. The footings on which the drum rested also remain. Two gasoline tanks, an air cleaner,² and shroud likely associated with the engine lie in the southeast corner of the building. Lying in this same area are fragments of what appears to be a wood bench. Several other internal features are located to the west of the hoist engine. One of these is a small concrete footing on which a 4"x6" wood post once sat. Another is a concrete-lined base, or box, measuring 2'-10"x3'-10". The function of this base is not known. The west end of the building appears to have been largely open, and it is possible that this space may have served as a workshop or similar activity area.

Figure 29. Plan view of the hoist engine house (Feature 2) (FRR 2005).

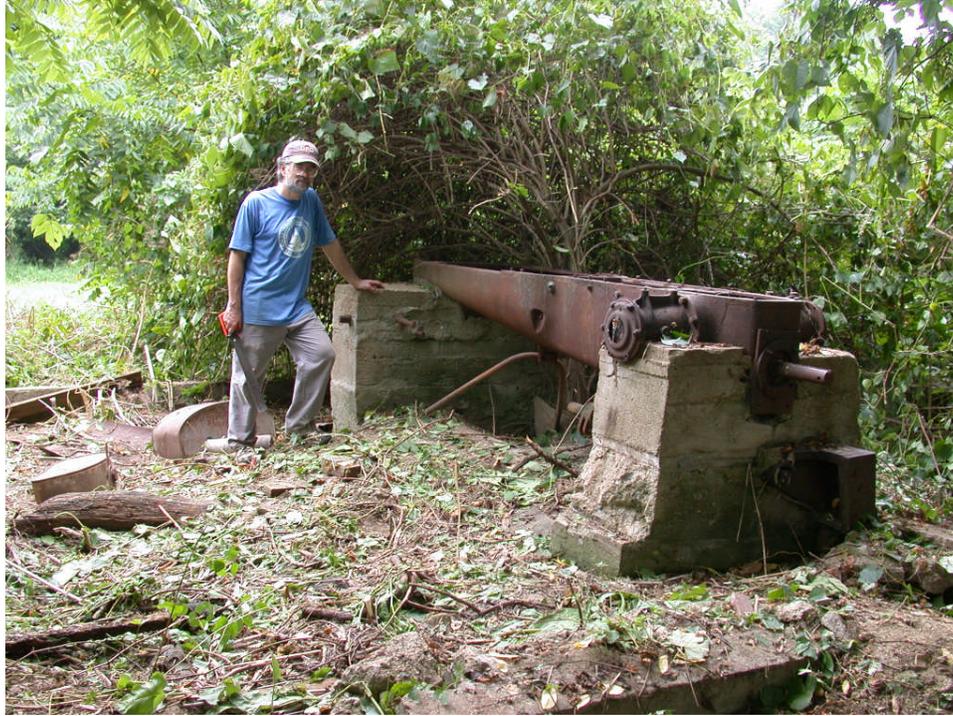
Figure 30. Photograph of the remnants of the hoist engine mechanism. Power for the hoist was provided by a gasoline engine salvaged from a farm tractor, the lower portion of which remains in place, encased within concrete footings (FRR August 2005).

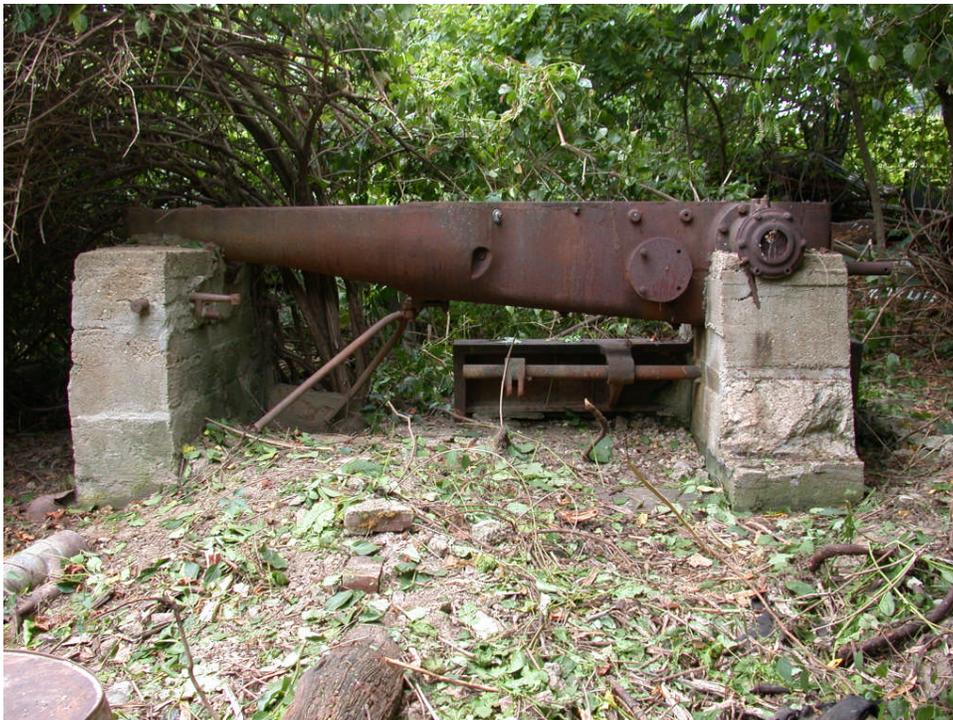
Figure 31. Another view of the tractor engine associated with the hoist engine, looking due west (FRR August 2005).

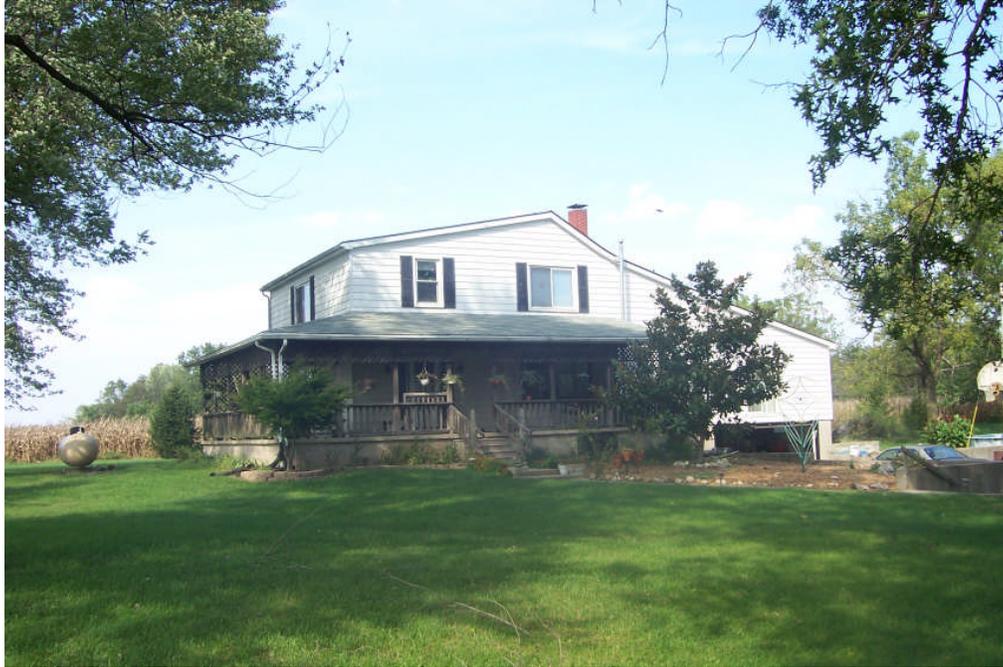
Feature 4 is a two-story, frame, gable-roofed dwelling located in the northwest corner of the site (see Figures 31 and 32). Oral tradition holds that the residence served as the office for the mine during the period that it was in operation.³ The mine operator or superintendent may also have lived here during this period. The house is depicted on the 1941 aerial photograph, which shows a distinctly different roof profile and orientation than that seen today. The photograph suggests that the house faced west and had a large dormer on the front (or west) slope of the roof. The residence has seen many modifications since that time, including the construction of a large rear addition, the raising of the roof line to create a full two stories, and a reorientation of the "front" of the house to the south elevation.

Figure 32. Photograph of the residence at the Young Shaft Site, looking northeast. This house, identified as Feature 4, reportedly functioned as the mine office during the period it was in operation (FRR September 2005).

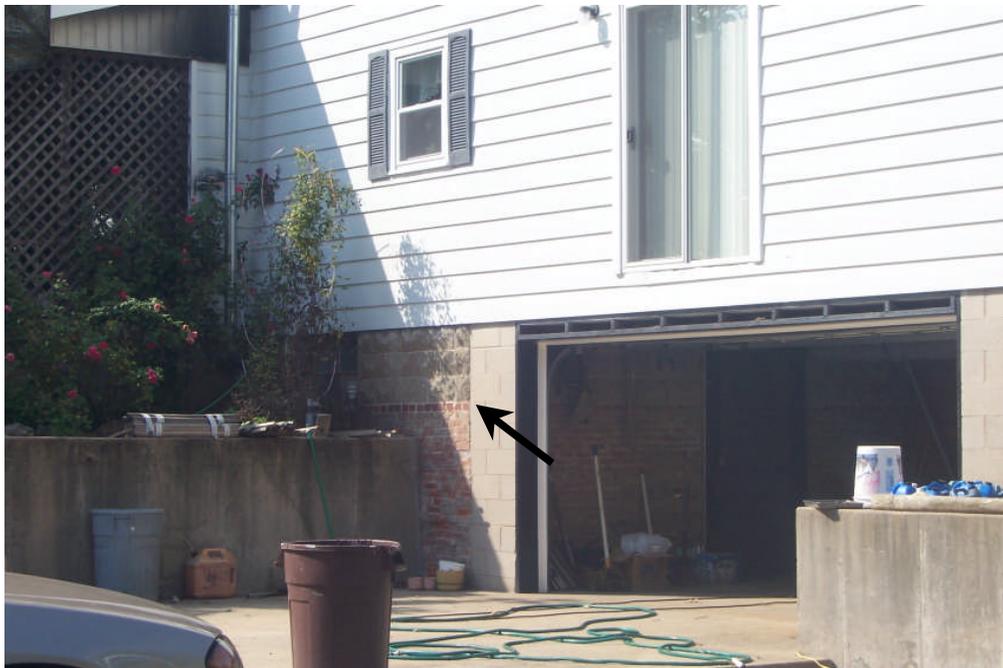
Figure 33. The house has seen considerable modifications in recent decades. The image above shows the southeast corner of the original house foundations (marked with arrow) (FRR September 2005).

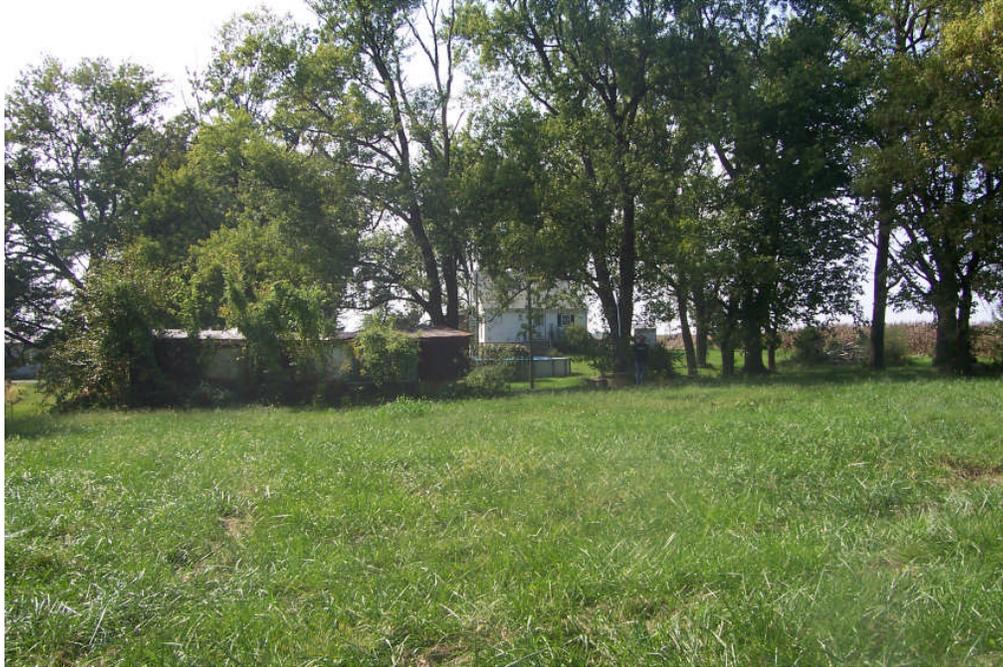
Feature 5 is remnants of building foundations located on the terrace directly north of the mine shaft (see Figure 33). A building is documented at this location on the 1942 aerial photograph, and apparently stood as late as 1954—based on USGS topographic maps. The structure had concrete foundations, brick walls, and a concrete floor on the interior. Sections of the brick walls were still standing when John Brockmann, the present landowner, purchased the property nine years ago. Brockmann later graded the area around the feature, reducing the walls to, or below, grade. It cannot be stated with certainty whether Feature 5 was associated with the mine or was an agricultural-related, outbuilding, such as a barn.

Figure 34. Photograph of the pasture in which the building foundations identified as Feature 5 are location. The foundations have been reduced to grade. The residence at the site appears in the far background (FRR September 2005).

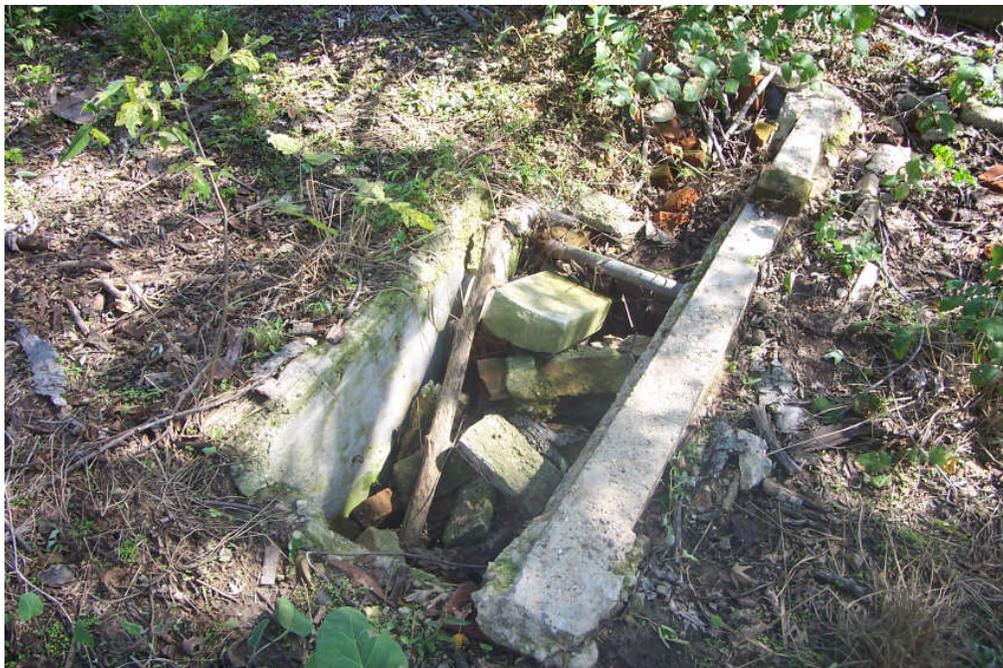
Additional Features and Buildings: There is a cluster of concrete foundations scattered around an active well, a short distance west of Feature 5 (see Figures 34 through 36). It is not clear whether these are mine or agricultural related. A storage shed lies directly south of the well in question. This building, which serves as a machine shed, has concrete foundations, steel siding, and a shed roof. It dates to the middle twentieth century, and does appear to be mine related. A modern pole barn also is present on the property, lying due south of the residence.

Figure 35. View of an unidentified set of foundations located west of Feature 5. It is unclear whether these foundations are mine or agricultural related (FRR September 2005).

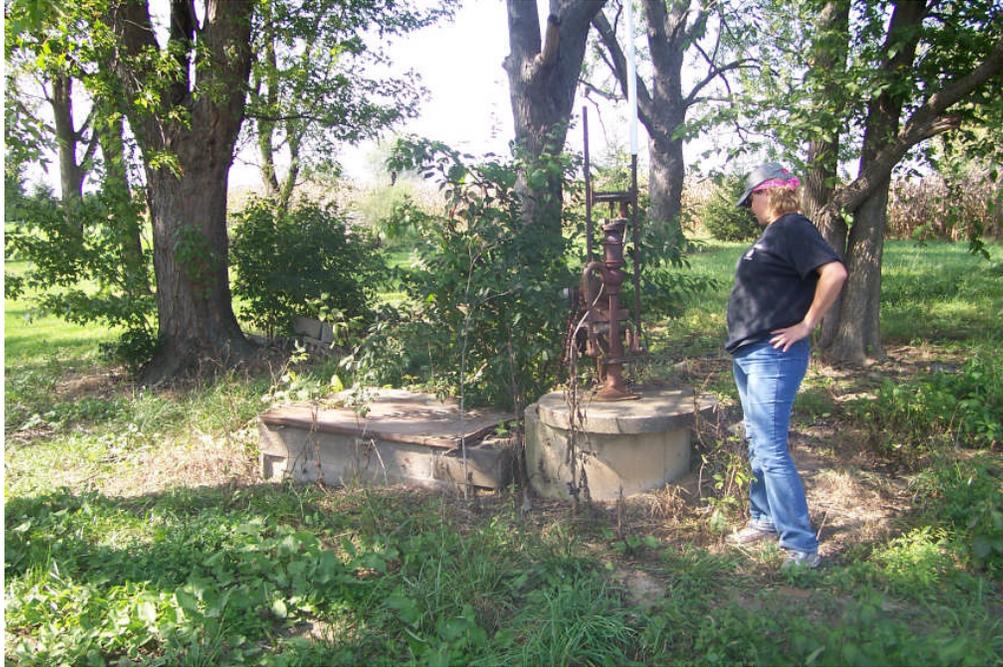
Figure 36. View of a well located directly south of the foundations shown in the previous figure (FRR September 2005).

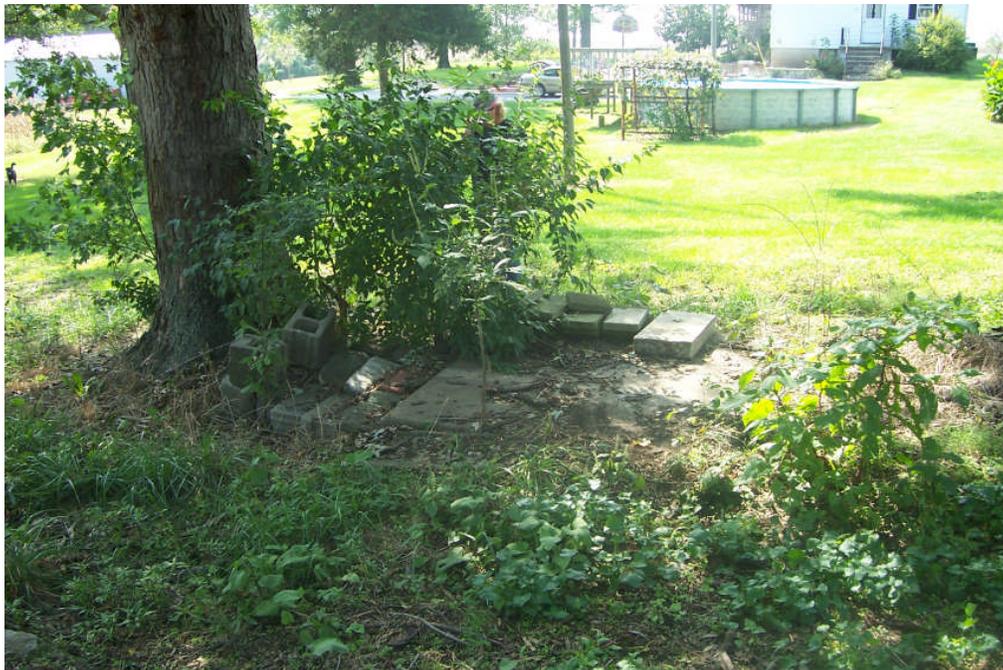
Figure 37. Photograph of a small concrete (building?) pad located west of the well shown in the previous figure. It is not known what originally sat here (FRR September 2005).

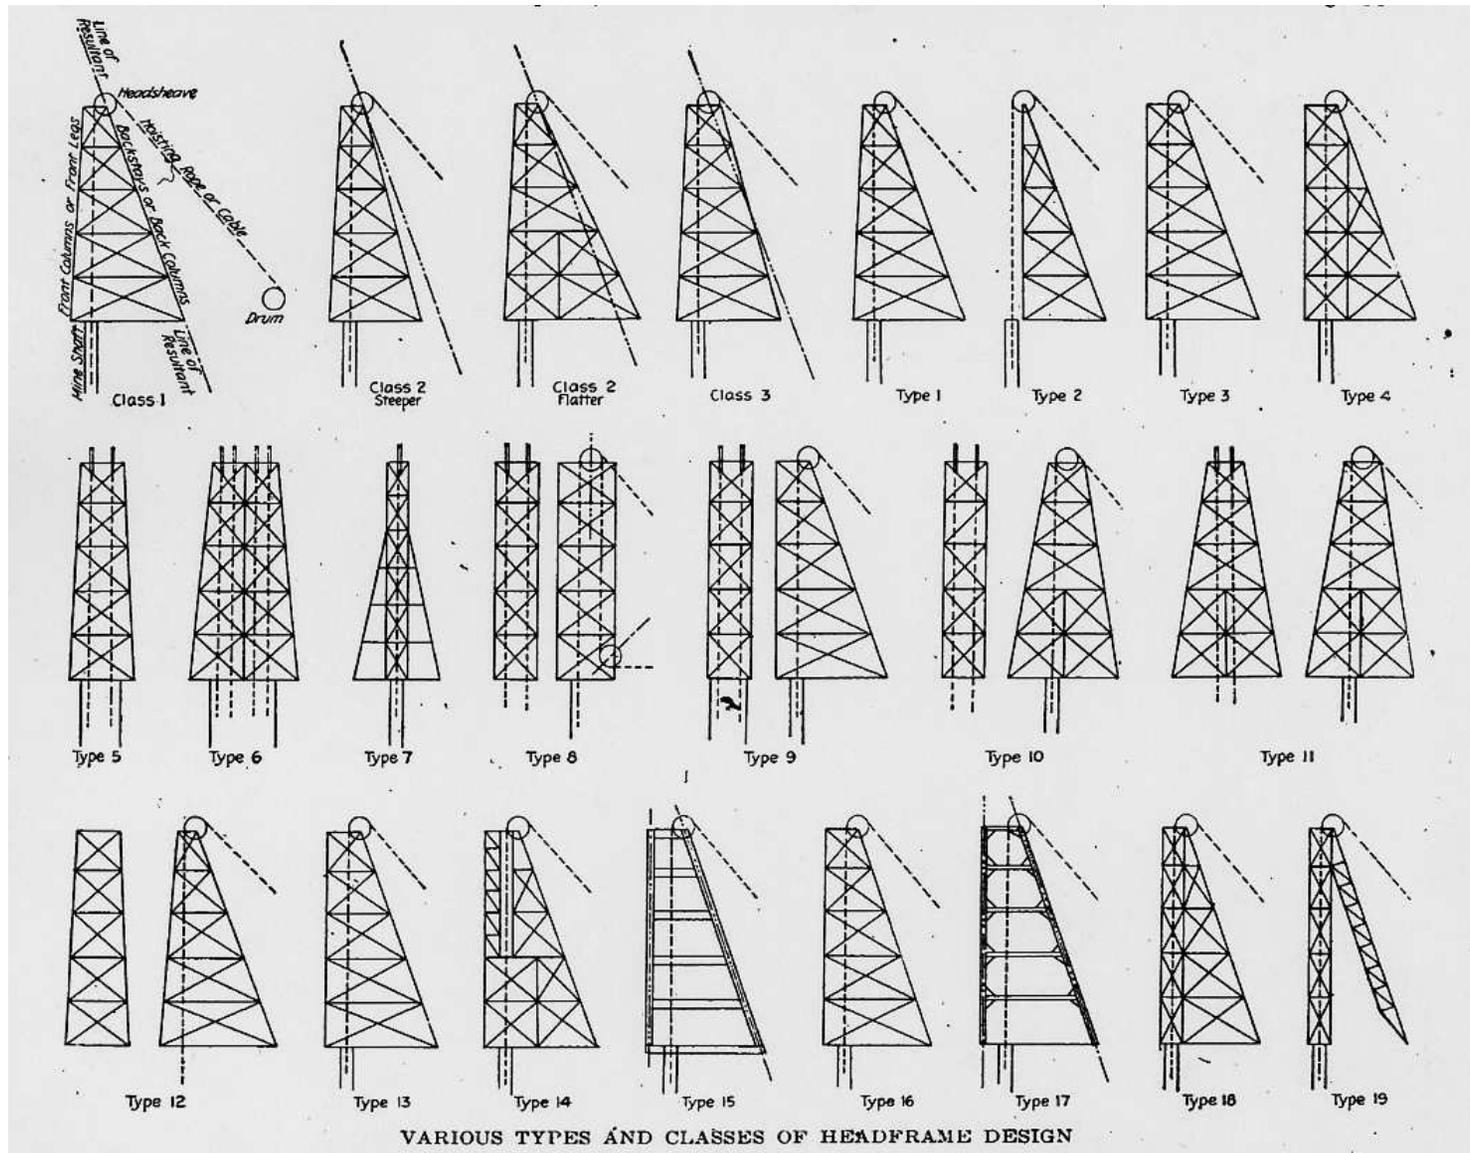
Figure 38. Headframe typology devised by Floyd Burr in 1917 (Burr, 1917). The Young Shaft tippel resembles the Type 11.
