ILLINOIS DEPARTMENT OF NATURAL RESOURCES CULTURAL RESOURCE MANAGEMENT PROGRAM ABANDONED MINED LANDS RECLAMATION CULTURAL RESOURCES EVALUATION

WORDEN COAL COMPANY MINE NO. 1 WORDEN, MADISON COUNTY, ILLINOIS

prepared by Fever River Research Springfield, Illinois

January 2003

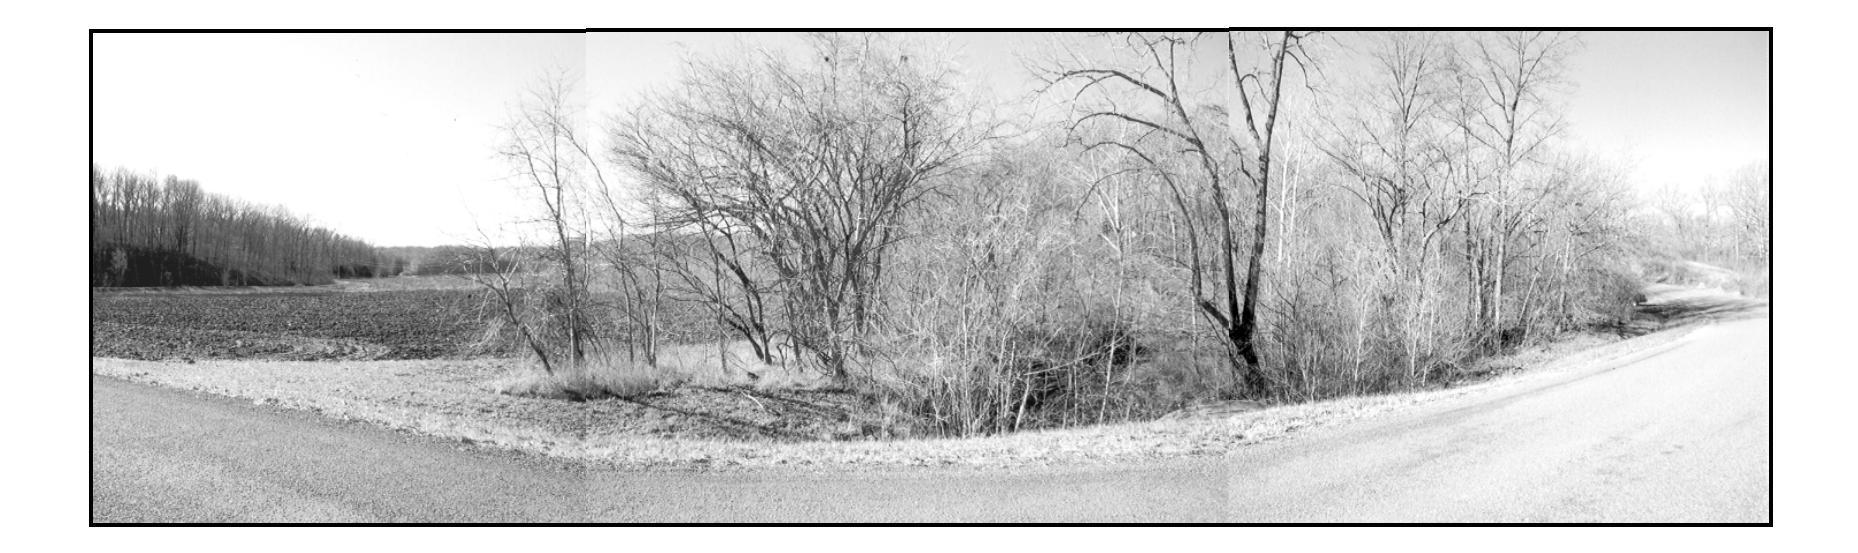
Figure 2. Panoramic view showing the general setting of the Worden Coal Company Mine No. 1 Site. The site is located to the right of the view, on the west side of an unnamed tributary of Cahokia Creek, whose tree-lined banks are shown in the center. Brickyard Road, which appears in the foreground, runs along the north side of the site and is the point from which the mine was accessed historically. Agricultural fields extend along the east (left) side of the creek (FRR December 2002).

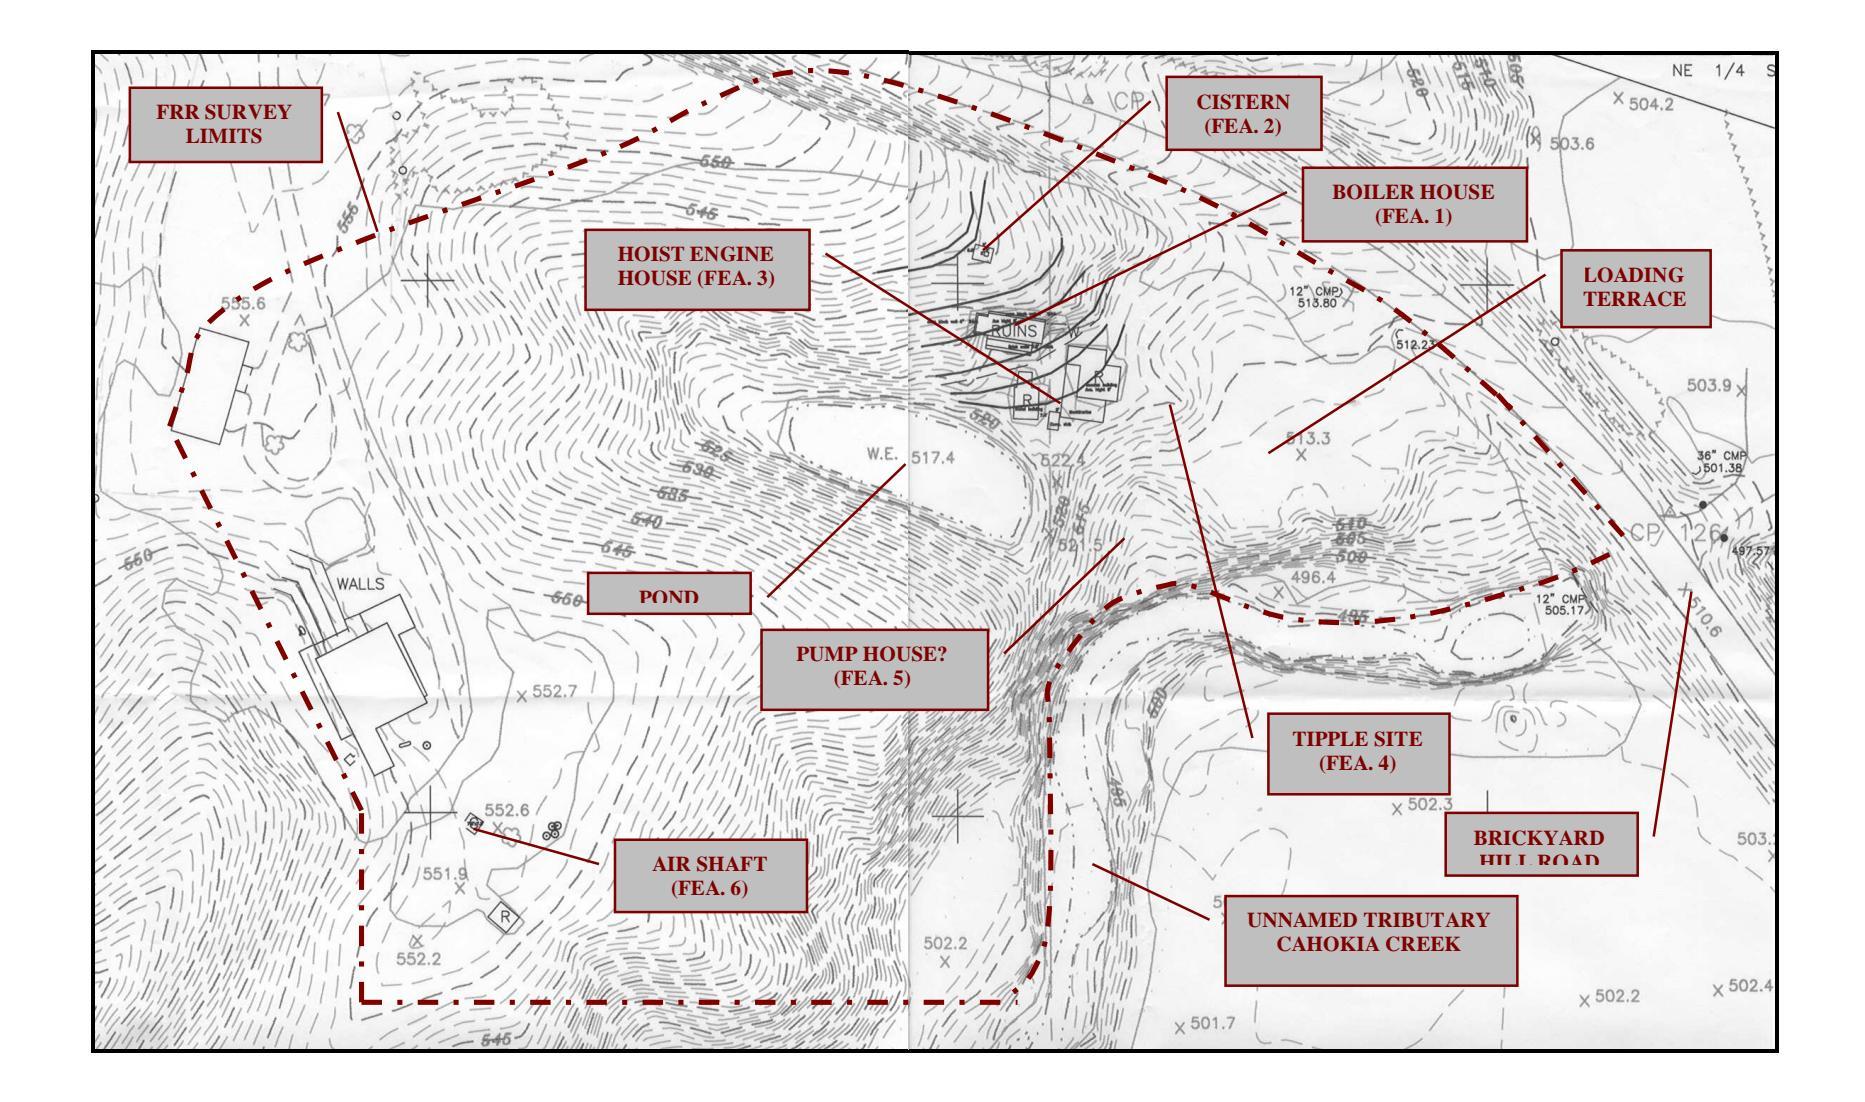
Sites/Features Found: The locations of features documented during the field survey are identified on a site plan attached as Figure 8. Photographs and drawings also have been included.

Figure 8. Site plan of the Worden Coal Company Mine No. 1 Site, showing Fever River Research survey limits and features identified.

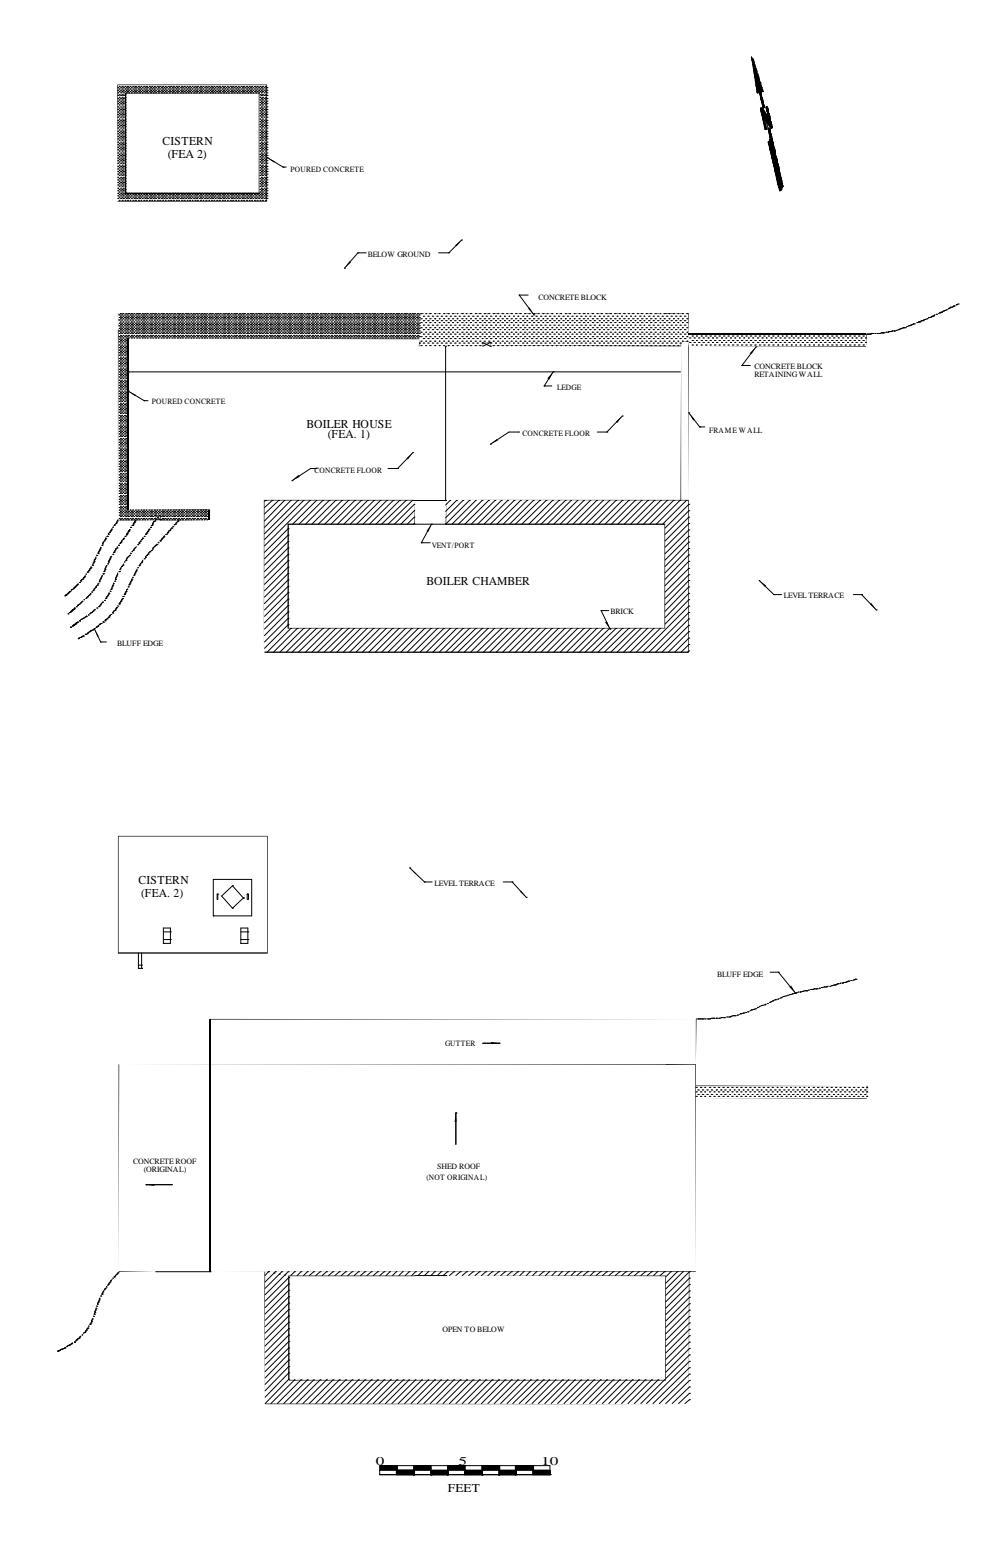
<u>Feature 1</u> represents the ruins of a boiler house that was built back against the bluff slope. This building formerly housed one or more coal-fired boilers that generated the steam used to power a hoist engine and other equipment and possibly used to heat the other buildings at the site. We do not know what the boiler house looked like originally. The only historic image that shows the building only provides a glimpse of a tall smokestack to the rear of the tipple (reference Figure 5). Two sections of the boiler house are still standing. One of these is a brick boiler chamber measuring 9'x25' on the exterior and 6'x22' on the interior. The chamber has 1'-6"-thick walls laid with four-courses of hard-pressed brick. The boiler machinery itself has been removed, possibly as scrap after the abandonment of the site. Running along the north side of the boiler chamber is an aisle that measures 9'-0"x32'-6" on the interior. The retaining wall of this aisle serves as a retaining wall for the cut bank behind it. The retaining wall is constructed with an odd assortment of irregularly sized and finished concrete blocks. The west end of the aisle extends past the west end of the boiler chamber and can be accessed through a doorway on this end (see Figures 9 through 11, 13).

<u>Feature 2</u> represents the remains of a large concrete cistern located on the rise above the boiler house. This structure was used to hold water, large amounts of which were required by the boiler in the adjoining building. The cistern measures 6'-10"x8'-10" on the surface and has a roof that is set nearly flush with the ground. The walls, floor, and roof of the structure are all poured concrete. On the interior, the cistern measures 6'-0"x8'-8" and has a 7'-0" depth. A 1'-10"-square scuttle on the roof, which can be covered with a vented cap, provides access to the interior. There are two small concrete cradles, or footings, with threaded bolts (serving as tie-downs) on top of the cistern that may have formerly held a pump or some other mechanism. A 2" pipe extends out of the south side of the cistern; it is unclear whether this pipe was the means by which water was drawn from, or into, the cistern (see Figures 12 and 13).

Figure 13. Field drawings illustrating Features 1 and 2, showing them at the level of the boiler house (TOP) and at the level of the cistern (BOTTOM). The arrows on the roofs in the lower figure indicate roof pitch.
