Cherry Mine Fan House  
SE1/4, NW1/4 and NW1/4, SW1/4  
Section 27  
Township 17 North, Range 11 East of 4<sup>th</sup> P.M.  
Ladd Quadrangle  
Bureau County  
Illinois

IL HAER No. BU-2002-2

Prepared by  
Christopher Stratton  
Floyd Mansberger  
and Heather Stanley

## ILLINOIS HISTORIC AMERICAN ENGINEERING RECORD

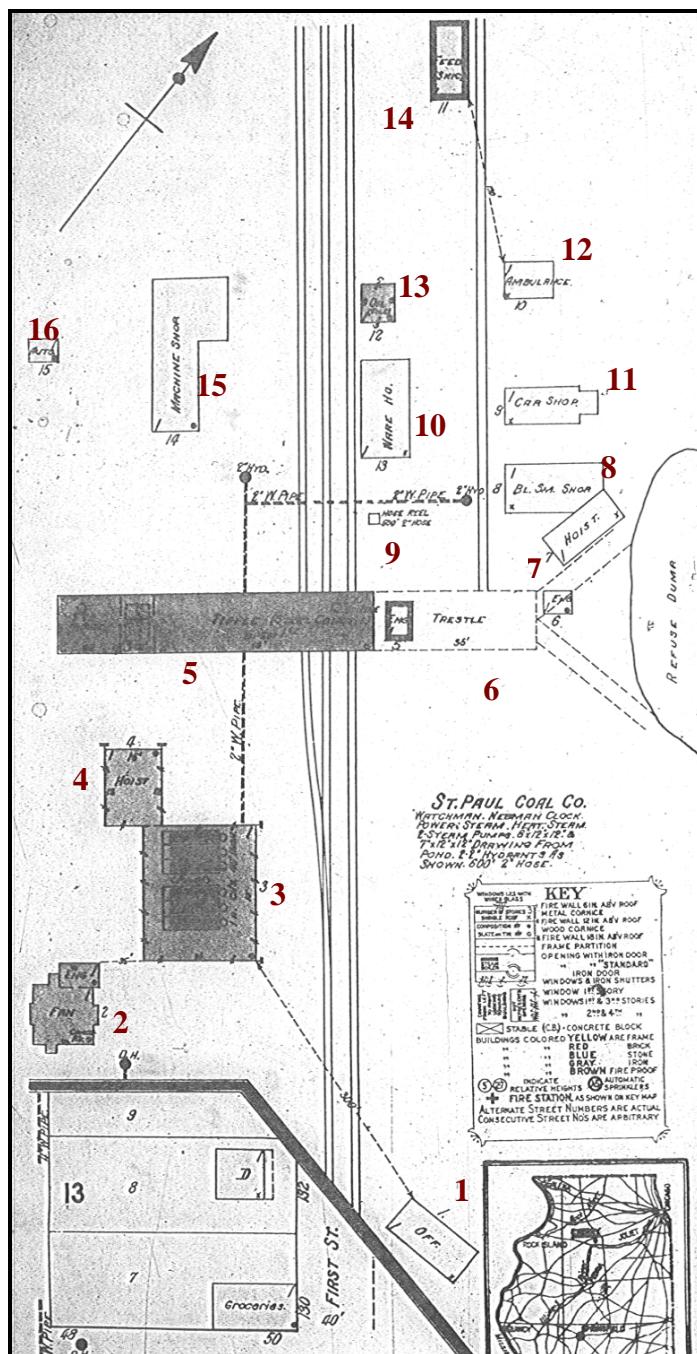
**Figure 3.** A 1915 Sanborn map illustrating the surface complex of the Cherry Mine. Building numbers have been added to the map for clarity: (1) office; (2) fan house; (3) boiler house; (4) hoist engine house (for tipple); (5) tipple complex; (6) elevated trestle; (7) hoist engine house (for mine dump); (8) blacksmith shop; (9) hose reel; (10) warehouse; (11) car shop; (12) ambulance (first aid) building; (13) oil house; (14) feed shed; (15) machine shop; and (16) automobile garage. Although published six years after the 1909 mine fire, this map illustrates most of the buildings present at the time of the disaster, with a few exceptions (Sanborn Map Company 1915).

Like most mine complexes, the Cherry Mine evolved over the years. The major addition to the surface complex in the years that followed the fire was the construction of a tile-block wash house, which apparently was constructed at some point after the publication of the 1915 Sanborn fire insurance map (See Figure 3).

linearly along the spur line constructed by the Chicago, Milwaukee, and St. Paul Railroad to haul coal from the mine (see Figure 3). At the center of the complex was a large steel-frame tipple structure, which was positioned over the main shaft and extended over the rail line servicing the mine. Waste material, known as gob, brought up from the mine was moved out of the tipple by rail onto an elevated trestle and from there dumped onto piles extending along the east side of the site. Coal, on the other hand, was dumped from the upper floor of the tipple into a lower room, where it was screened and sorted by size. After being sorted, the fuel was fed into hoppers and dumped into coal rail cars waiting on three tracks below. Trains of empty coal cars were backed up beyond the tipple onto an earthen incline, which was steep enough to allow the coal cars to move forward largely of their own weight, without the need for a locomotive to remain on site. Once a coal train was fully loaded, it was picked up by a locomotive and hauled south to the main line of the Chicago, Milwaukee, and St. Paul Railroad at Ladd.

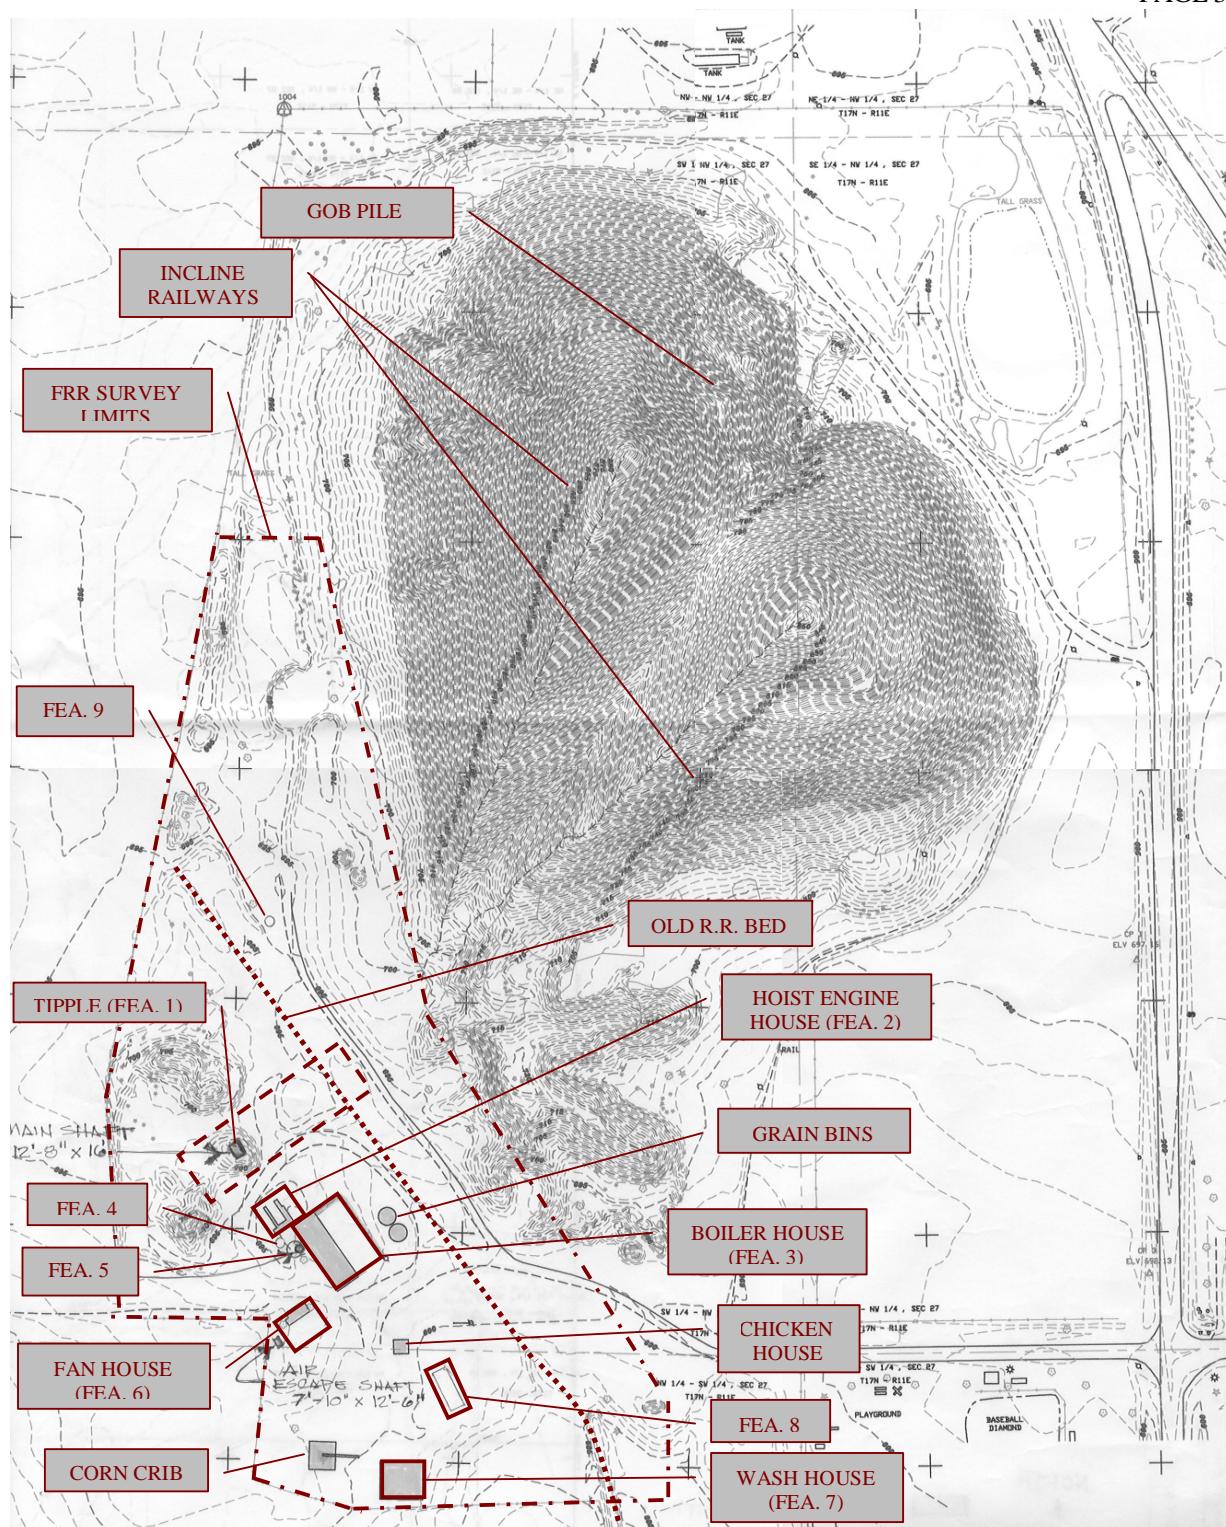
Figure 4. Site plan of the Cherry Mine Site, showing the site topography and the mine-related features identified during the field survey. Later agricultural buildings/structures also have been labeled.

house, which is the focus of this study, several other building remnants were noted during the course of these investigations and are discussed here. The locations of the features documented during the field survey are identified on a site plan attached as Figure 4 and illustrated on a photograph of the mine model (see Supplemental Material S15).

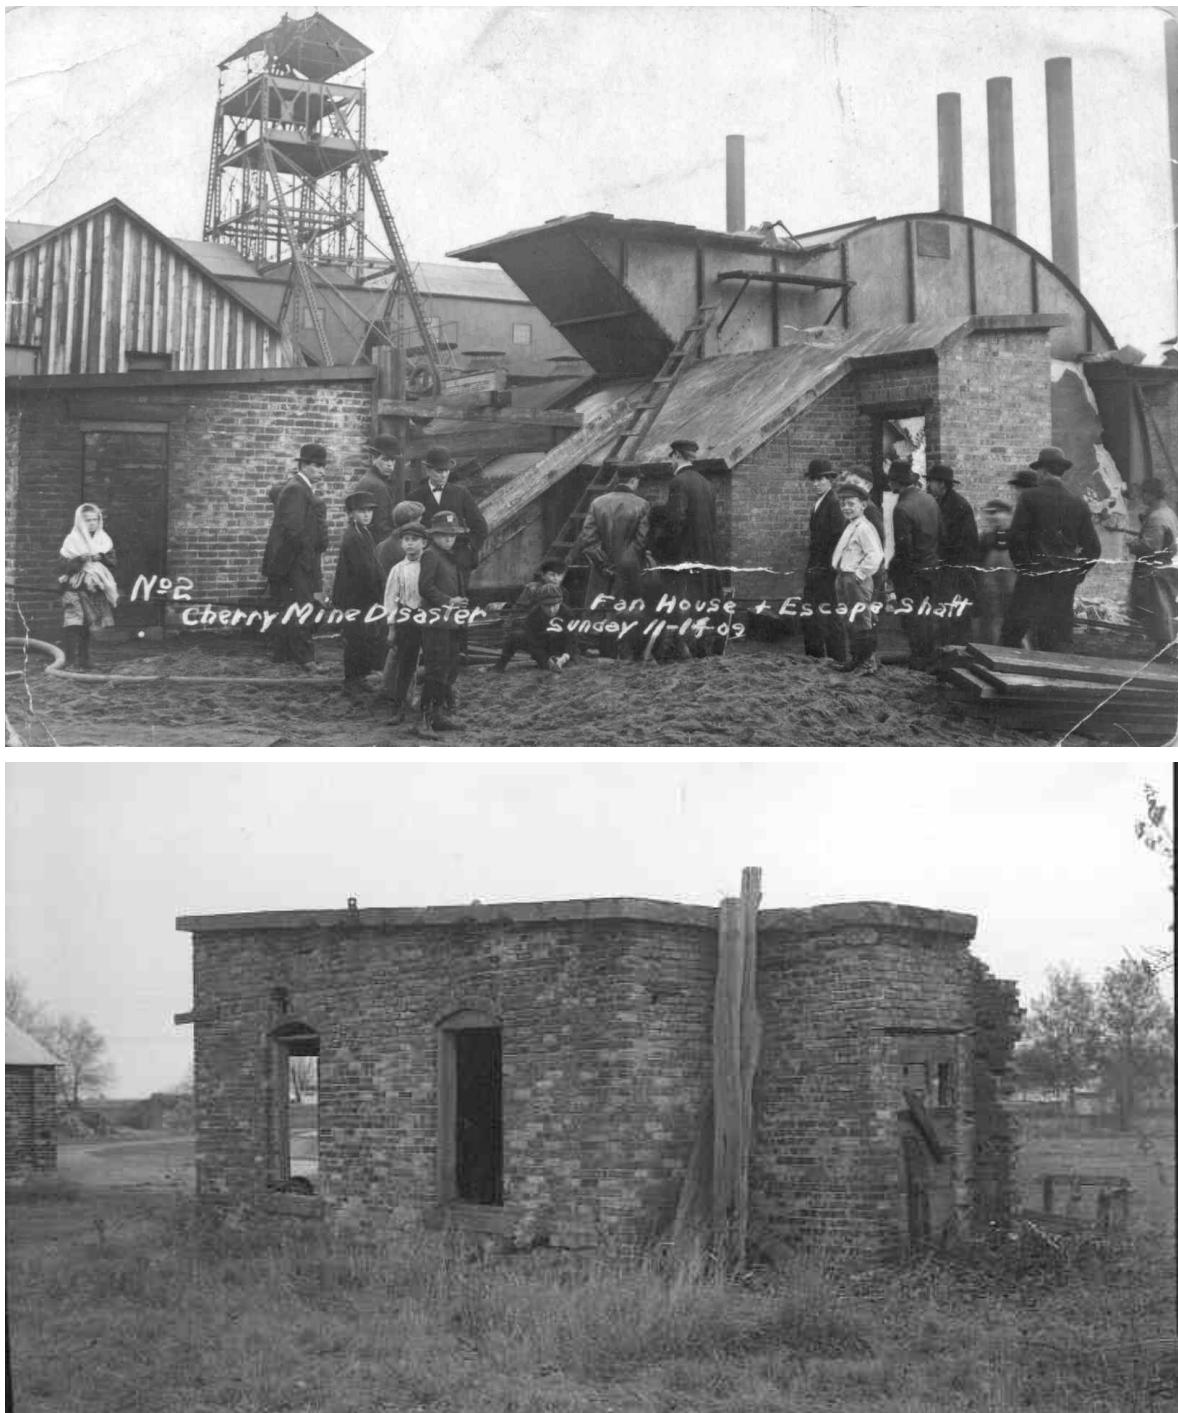
Figure 5. Historic (top, 1909) and contemporary (bottom, 2003) views of the Cherry Mine Fan House, 1909.

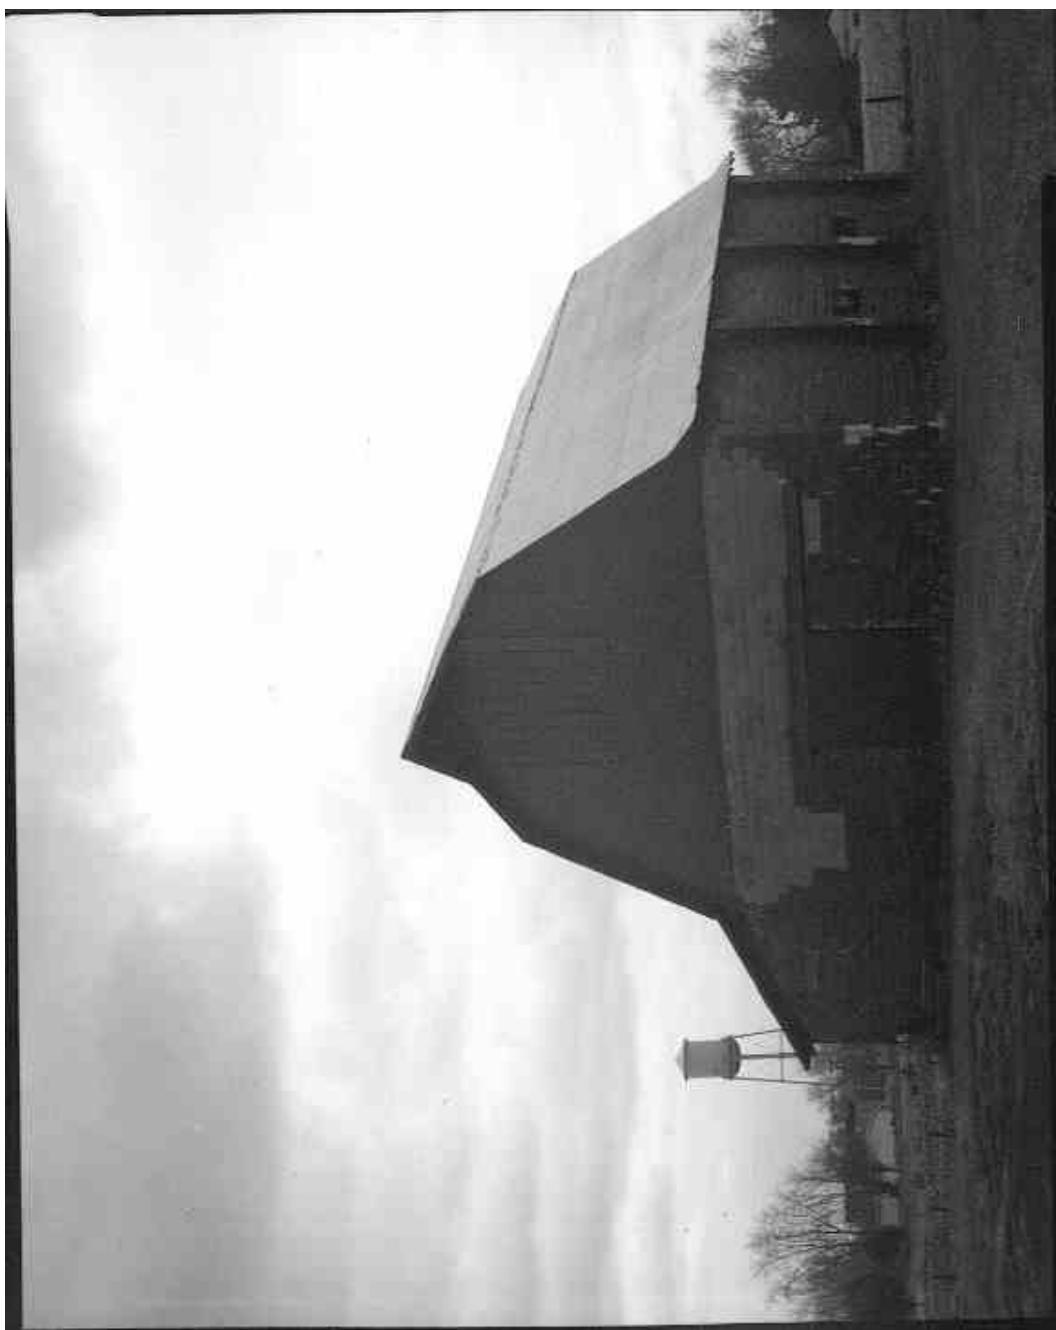
PHOTOGRAPHIC VIEW SHEET  
IL HAER No. BU-2002-2.13

| BU-2002-2.13 | Exterior view of the wash house converted to a barn (2002). |
